Driver's Seat Cushion Leg Adjustment Inoperative

Service Category Vehicle Interior

Section Seat

YEAR(S)	MODEL(S)	ADDITIONAL INFORMATION
2023 - 2024	Sequoia HV	
2022 - 2024	Tundra, Tundra HV

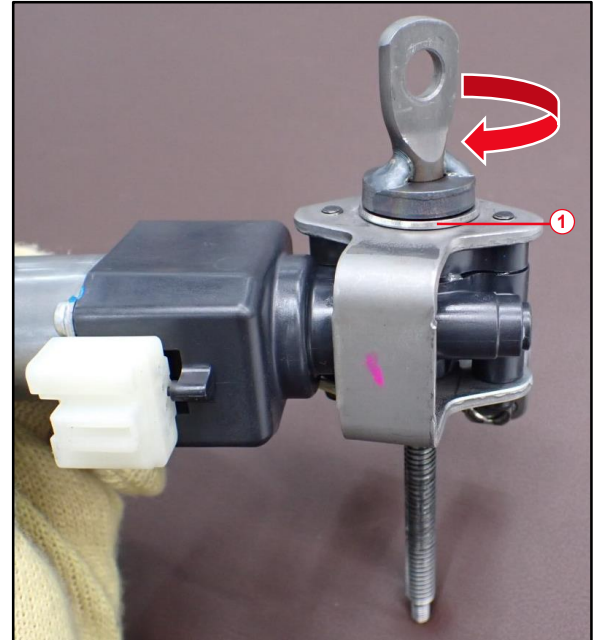
Figure 8.

1 Spacer Added to Screw

7. Add a spacer to the screw, turning the screw clockwise.

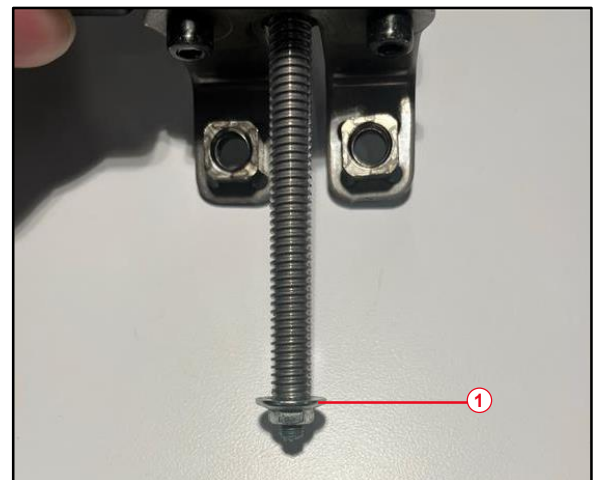
Figure 9.

1 Nut Installed Onto Screw

8. Install the nut on the screw.
Torque: 2.45 N*m (25.0 kgf*cm, 21.7 in*lb)
