Technical Service Bulletin (TSB)
Flash: Powertrain Control Module (PCM) Updates

REFERENCE:	TSB: 18-011-25 GROUP: 18 - Vehicle Performance	Date:	March 8, 2025	REVISION:	–
VEHICLES AFFECTED:	2024 (JL) Jeep Wrangler This bulletin applies to vehicles built on and before January 30, 2024 (MDH 0130XX) equipped with a 2.0L I4 DOHC DI Turbo Engine W/ESS (Sales Code EC1).			MARKET APPLICABILITY: <div><input checked="" type="checkbox"/> NA<input type="checkbox"/> MEA <input type="checkbox"/> SA<input type="checkbox"/> IAP <input type="checkbox"/> EE<input type="checkbox"/> CH</div>	
CUSTOMER SYMPTOM:	Customers must experience a Malfunction Indicator Lamp (MIL) illumination and the vehicle must exhibit/set one or more of the following Diagnostic Trouble Codes (DTCs): <ul style="list-style-type: none">P0420 - Catalyst System Efficiency Below Threshold Bank 1.P0017 - Crankshaft/camshaft Timing Misalignment - Bank 1 Sensor 2.P000A - Bank 1 Camshaft 1 Position Slow Response.P219A - Bank 1 Air-fuel Ratio Imbalance. Customers may also experience the following: <ul style="list-style-type: none">A no crank/no start condition. In addition, the following software enhancement is available: <ul style="l

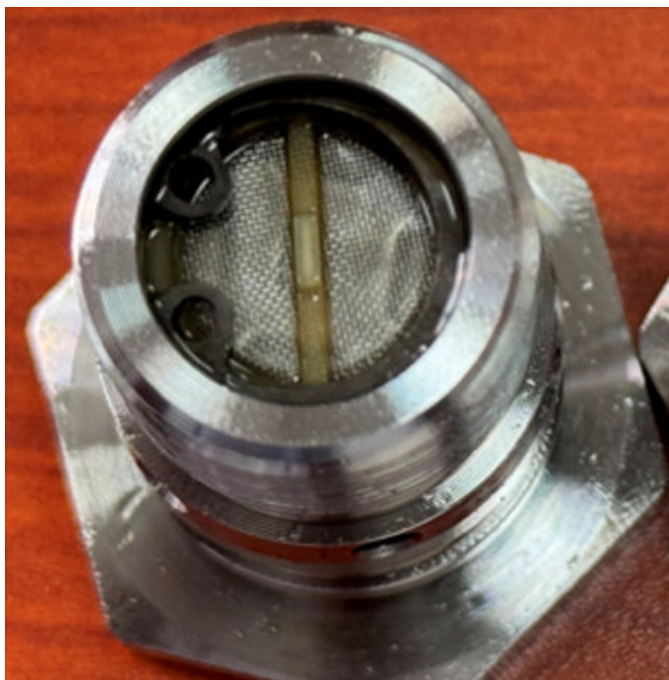
Fig. 1
OCV Filter OK

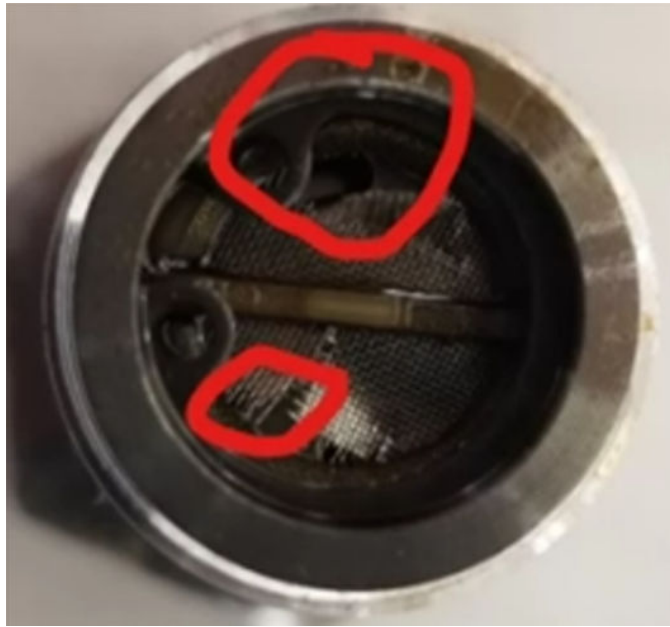
Fig. 2
OCV Filter Torn

5. Are the OCV filter screen(s) torn?

- YES>>> Replace the OCV(s) and change the engine oil and filter. Refer to the detailed service procedures listed in DealerCONNECT>Service Library>Service Info>under: 09 - Engine, 2.0L / Lubrication / Standard Procedure Engine oil and filter change. Use LOPs (09-05-37-91) and (26-99-00-10). Proceed to [Step 11](#).
- NO>>> Proceed to [Step 6](#).

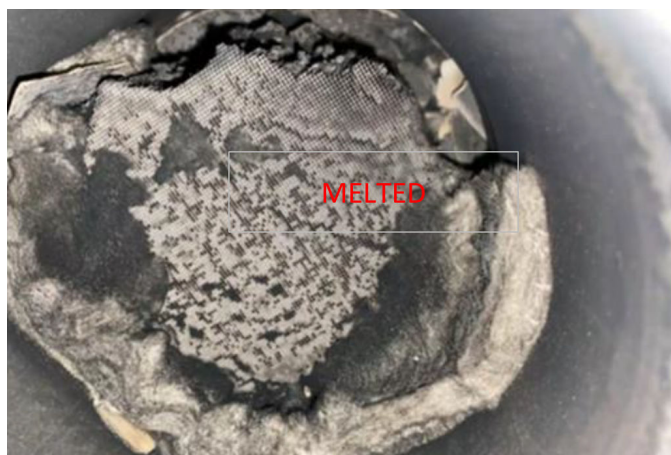
Fig. 3
Melted Catalyst

10. ● YES>>> Replace the catalytic converter. Refer to the detailed service procedures listed in DealerCONNECT>Service Library>Service Info>under: 11 - Exhaust System / Converter, Catalytic / Removal and Installation. Use LOP (11-50-01-91). Proceed to [Step 11](#).
- NO>>> Use Inspect LOP (11-50-01-90). Proceed to [Step 11](#).
