# INSTRUCTION TO SERVICE

| ITS: 61283 | | March 4, 2025 |
| SUBJECT: | Replace existing turbo outlet exhaust elbow with redesigned elbow and gasket | |

# ITS61283

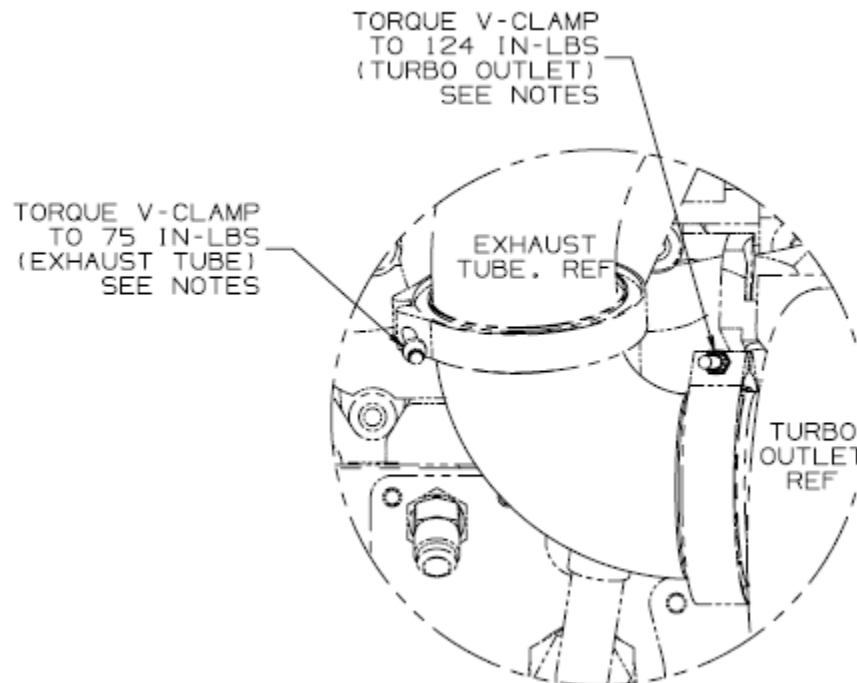
**Figure 1: Align Turbo Exhaust Elbow and Torque Clamps**

| ITS: 61283 | | March 4, 2025 |
|---|---|---|
| ISSUE: | Exhaust leak present at the turbo outlet and exhaust elbow joint | |

1. Set park brake and chock wheels.
2. Turn the main battery disconnect switch to the “OFF” position.
3. In the engine compartment of the bus, locate and remove and retain the existing turbo outlet exhaust elbow and clamps.
4. Inspect the existing gasket on the exhaust tube side of the elbow for gasket integrity. If any damage is found replace with a new gasket (NF PN 395859).
5. Insert the new gasket into the turbo outlet end of the exhaust elbow and install the redesigned exhaust elbow (NF PN 1115025).
6. Ensure the turbo exhaust elbow is aligned with both the turbo outlet and the exhaust tube. Torque the existing clamps as shown in Figure 1.

7. Tap lightly around the perimeter of the clamps with a rubber mallet to ensure the elbow and gaskets have properly seated, then recheck the torque on the clamps. Repeat as required until the torque value is consistently maintained.
8. Return the removed turbo exhaust elbow to your New Flyer Regional Product Support Manager.
9. Clean up all tools and debris and return the bus to service condition.
10. Turn the main battery disconnect switch to the “ON” position.
