This Service Information Bulletin (Revision 1) replaces SI B41 01 25 **dated February 2025**.

E-Series	Model Description	Production Date
F74	2 Series Gran Coupe	January 9, 2025 – January 15, 2025

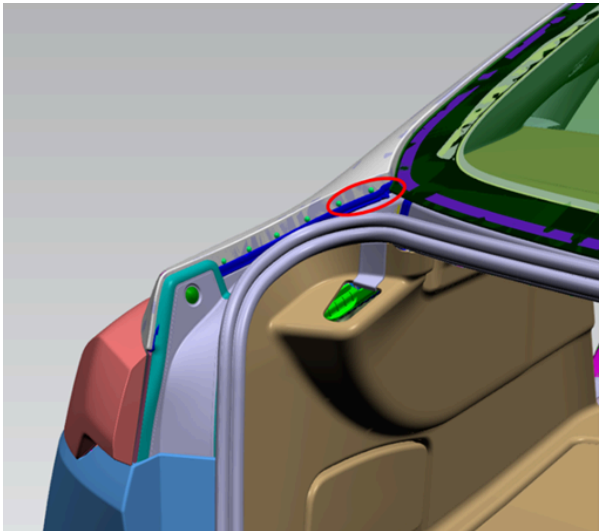
A crack may have formed in the upper left corner of the trunk opening (circled in red), where the quarter panel contacts the left lower corner of the rear window and trunk water channel.

Illustration of the inward-facing metal shows the general location of the possible crack, though the area to be checked in the Procedure is on the “back side”/outward-facing surface.

The PVC seam sealant applied to the water channel may not sufficiently seal the channel in the presence of the crack, resulting in a small water leak into the trunks interior.

1. Check the inner surface of the trunk metal/water channel for the presence of a crack or metal tear.
2. If a crack/tear is observed, pour water into the water channel and observe if water passes through the crack/tear.
3. If water is observed passing through the crack/tear, rework the trunk corner and weld the crack/tear, then perform localized painting.

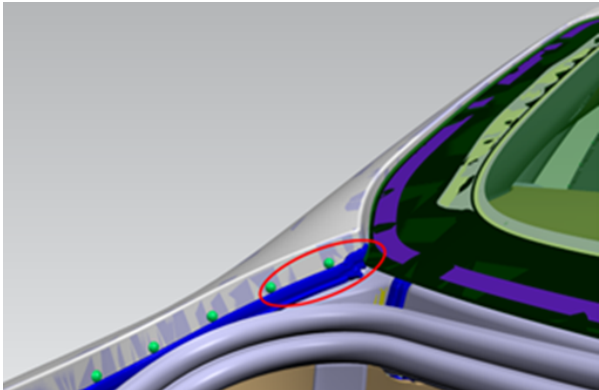
The green dots represent the location of spot welds.

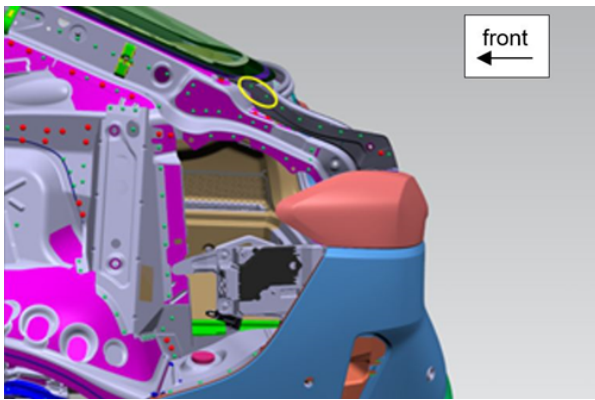
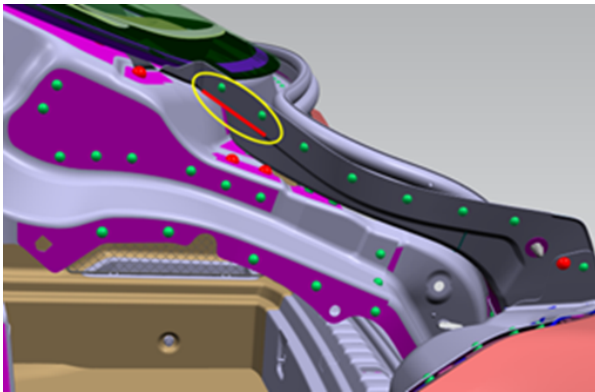
3. Using the borescope camera, inspect the area shown in the photo for a crack/tear where the panel curves/bends (see photos).

- If **NO** crack/tear is seen/found on the panel, the vehicle can be reassembled, and the campaign can be closed
- If **A** crack/tear is seen/found on the panel, continue to step 4

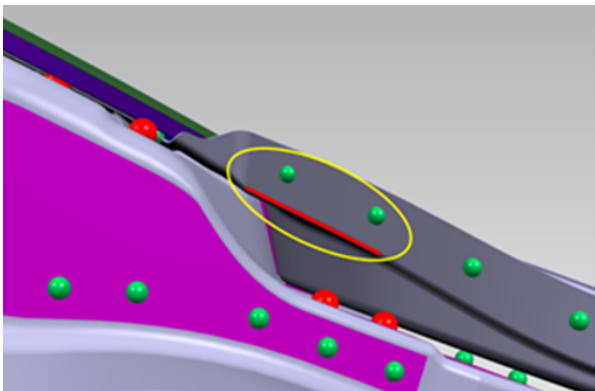
Note: Red line demonstrates where the possible crack/tear would be located, on the “outboard facing” surface of the metal.
