This Service Information Bulletin (Revision 2) replaces SI B61 20 24 dated **September 2024**.

E-Series	Model Description	Production Date
G70	7 Series Sedan	November 10, 2022 – March 28, 2023

BMW AG has issued a Delivery Stop (effective August 12, 2024) on certain Model Year 2023 BMW vehicles that were produced between November 10, 2022, and March 28, 2023.

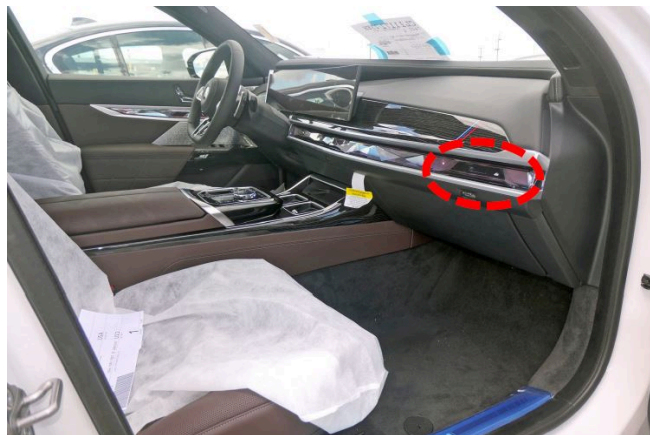
In the event of a voltage drop, comfort functions of the BMW interaction bar may fail and not respond.

Software error in the BMW interaction bar.

This can lead to a failure of the air vent functions on the passenger side of the bar (circled).

Replace the BMW interaction bar.

Replace the BMW interaction bar following the repair instructions listed in ISTA/AIR 61 31 147.
