Rear Side Window Reversed When Opening or Closing Soft Top - Convenience Closing

Topic number	LI67.30-P-076917
Version	2
Function group	67.30 - Side windows
Date	3/10/25
Validity	238.4
Reason for change	Remedy added

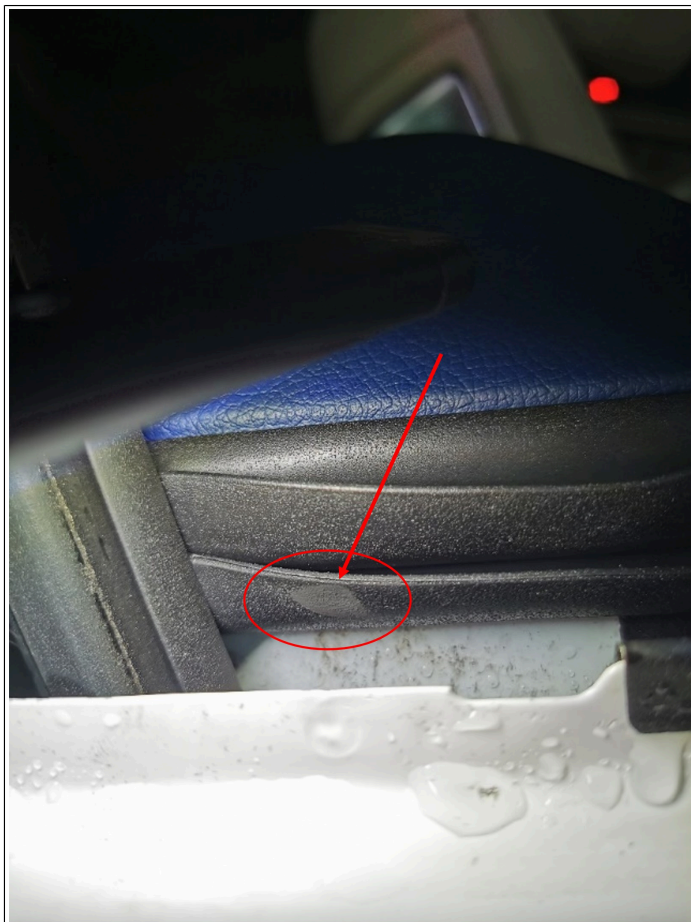
Attachments	
File	Description
Bild1.jpg	Inner sealing rail abrasion marks

1. Rear side window setting
2. Damage to inner rear side window sealing rail (abrasion marks at sealing rail, see picture, folding of the sealing lip, see picture 2)
3. Body-in-white side wall shaft width too low. To this end, check the shaft width of the side wall for dimensional accuracy; see picture 3

2. Check inner sealing rail for damage. Replace in the event of damage
3. Enlarge shaft width of side wall of body-in-white; see picture 4.

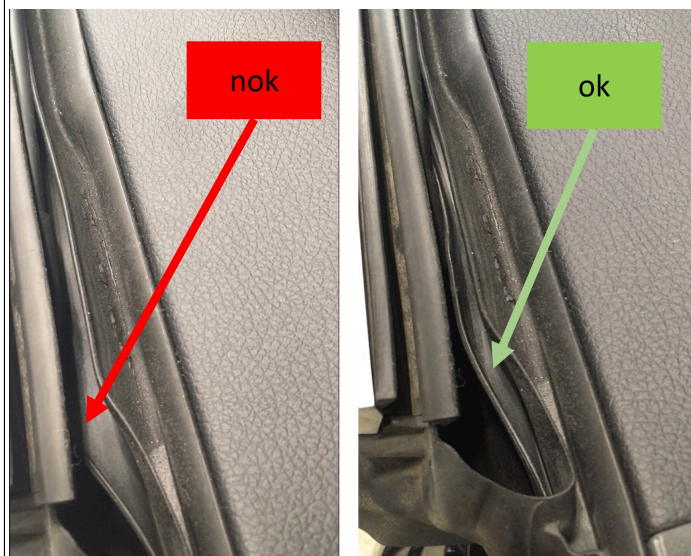
Bild2.jpg

Folding of the inner sealing rail sealing lip

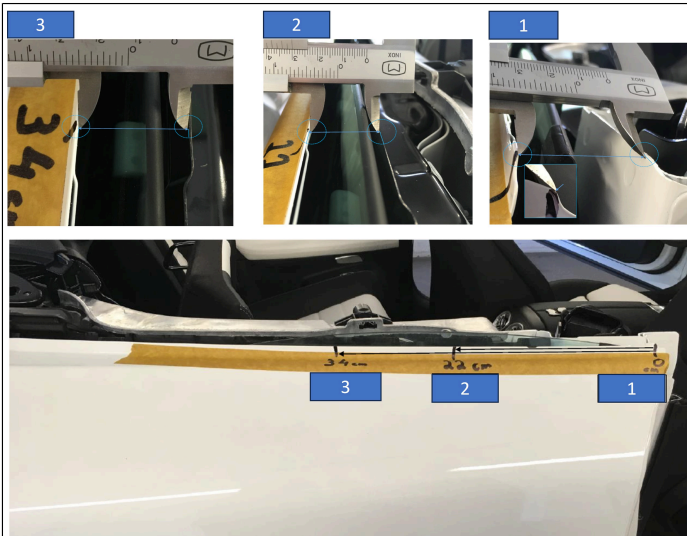
Bild3.jpg

Measuring points 1, 2, 3

Measuring point 1 at 0 cm: Nominal dimension 37.7 mm

Measuring point 2 at 22 cm: Nominal dimension 31.0 mm

Measuring point 3 at 34 cm: Nominal dimension 33.5 mm

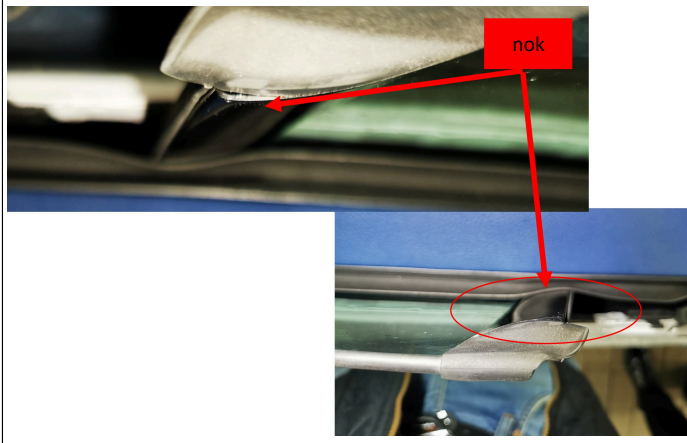
Bild5.jpg

4. Window divider at rear side window, metal insert sticks out, see picture 5

Window divider at rear side window, metal insert sticks out
