Noise from (panoramic) roof in area of C-pillars at high speeds (75+mph)

| Topic number | LI65.10-P-074275 |
| Function group | 65.10 - Roof paneling |
| Validity | Model series 223 with SA code 413 |

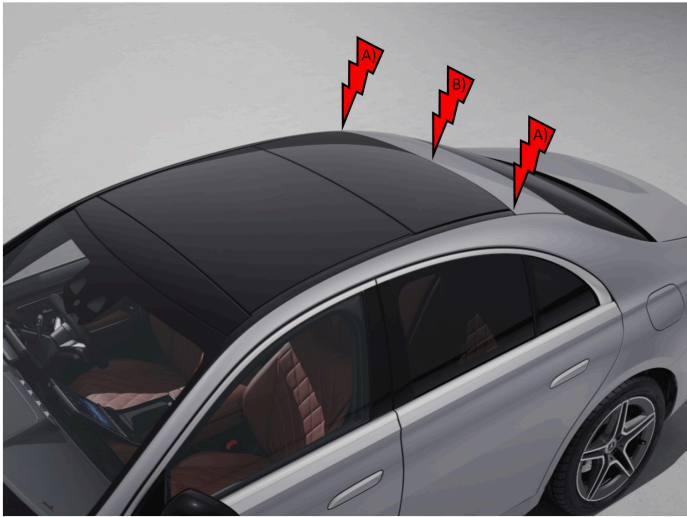
| Attachments | |
|---|---|
| Bild I.jpg | |

A) Wind noise in area of rear edge of rear fixed element of panoramic sliding sunroof (EPC item 78/150/550) at speeds over approx. 75mph (Picture I)

B) Wind noise in area of rear edge of rear fixed element of panoramic sliding sunroof (EPC item 78/150/550) at speeds over approx. 120mph (Picture I)

A) Lifting and vibrating of sealing lip of rear roof paneling (EPC item 65/015/310) on outer left and right, at the contact surface with the end cap of the drip rail (EPC item 69/060/250)

B) Lifting and vibrating of sealing lip of rear roof paneling (EPC item 65/015/310) in the center of the vehicle (Y=0), at the contact surface with the rear fixed element of the panoramic sliding sunroof (EPC item 78/150/550)

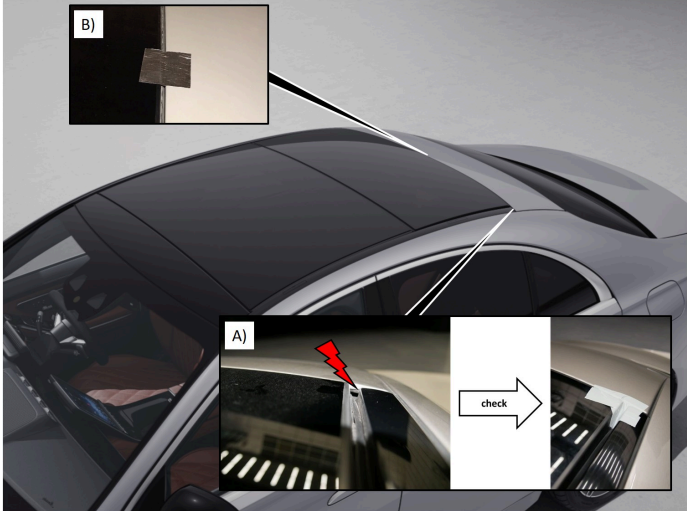
| Attachments | |
|--|---|
| Bild II.jpg | |

Identification of source of noise by masking off of (Picture II):

A) Joint between drip rail (EPC item 69/060/250), rear roof paneling (EPC item 65/015/300) and rear fixed element of panoramic sliding sunroof (EPC item 78/150/550)

B) Joint between sealing lip of rear roof paneling (EPC item 65/015/310) and rear fixed element of panoramic sliding sunroof (EPC item 78/150/550), with approx. 5 cm-long adhesive strip - CAUTION: Sealing lip is very sensitive, do not damage!
