## Paint damage on door paneling in area of door handle

Topic number	LI72.00-P-073141
Version	1
Function group	72.00 - General
Date	3/10/25
Validity	BR 292 with code 889 BR 253 up to manufacturing date July 2020 with code 889
Reason for change

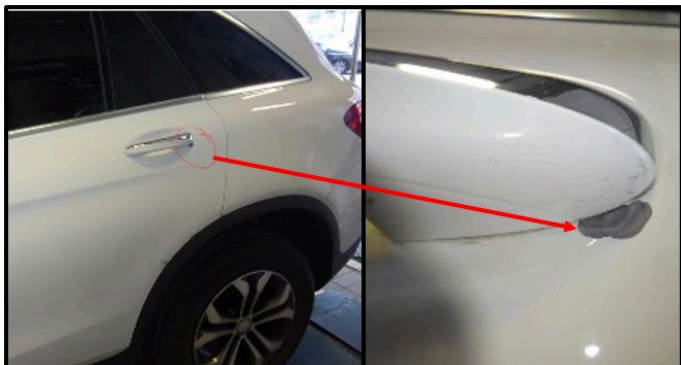
Attachments	
File	Description
Bild 1.JPG	Fault profile - rear door as example

Paint damage on door paneling in area of door handle (see picture 1).

Possible tolerance complaint regarding the door handle

1. Paint the affected area of the door paneling using the spot repair procedure in accordance with the manufacturer's specifications.
2. Replace door handle, ensuring that the door handle bearing bracket is installed correctly (see picture 2).

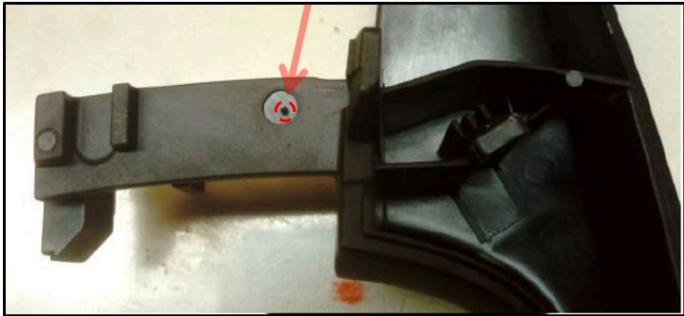
Note: The optimized door handles are marked as shown in the illustration (see picture 3).

<p>Marking - Optimized door handle</p>
