Service Bulletin

Bulletin No.: 22-NA-094

Subject: Loss of Cabin Heat

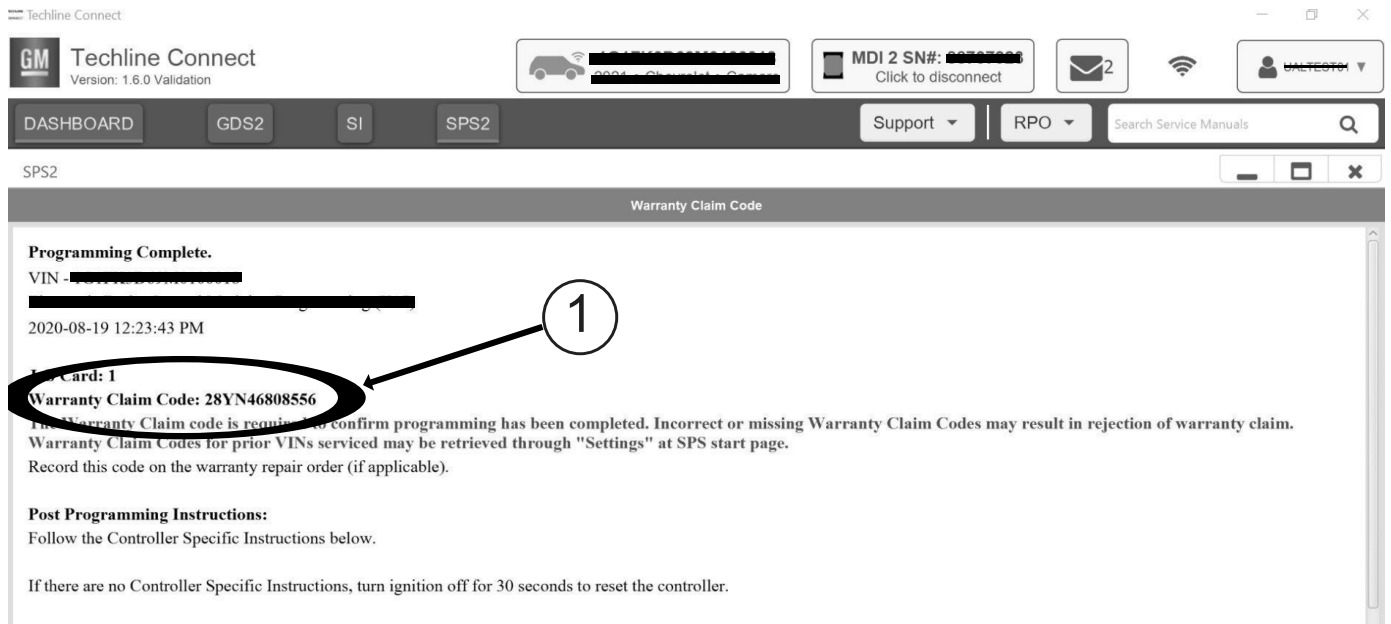
5644478

Note: The screenshot above is an example of module programming and may not be indicative of the specific module that is being programmed. Module selection and VIN information have been blacked out.

Important: To avoid warranty transaction rejections, you MUST record the warranty claim code provided on the Warranty Claim Code (WCC) screen shown above on the job card. Refer to callout 1 above for the location of the WCC on the screen.
