Service Bulletin

Bulletin No.: 24-NA-046

Subject: Suction Cup Marks on Window Glass

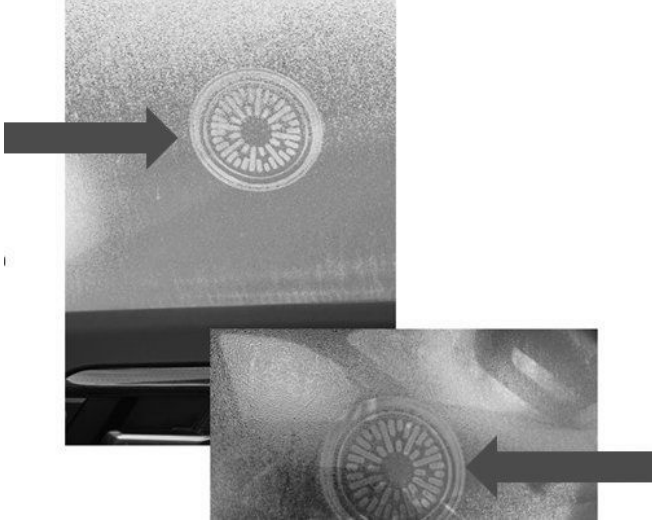
<p data-bbox="1425 943 1489 965">6568172</p> <p data-bbox="528 954 1445 1010">Some customers may comment on geometric marks on side door or windshield glass, visible in cold conditions when moisture condenses on the glass.</p>
Cause	<p data-bbox="528 1021 1433 1077">The cause of the condition may be the supplier had glass-handling suction cups that were not properly maintained.</p> <p data-bbox="528 1077 1477 1155">The suction cups picked up abrasive dust from the environment and when the tools were used, they caused a "scuff" on the glass that holds moisture in a geometric pattern matching the suction cup.</p>

Correction	Using the products listed below polish the location.
