STAR ONLINE PUBLICATION

Case Number: S2405000002 Rev. B

Symptom/Vehicle Issue: Brake Light Switch Service Information.

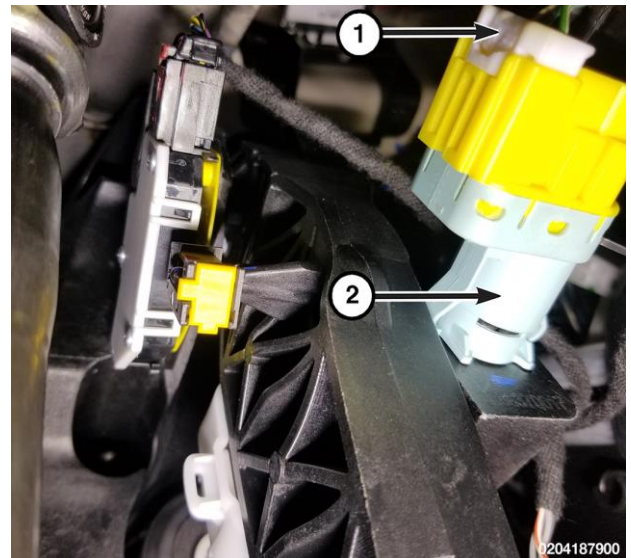
3. [Press the brake lamp switch against the bracket while rotating the switch housing clockwise 45° to align the tabs to the keyed hole in the brake pedal support bracket.](#) 1 - Wire Harness Connector
2 - Brake Lamp Switch
4. [Pull the brake lamp switch straight out of the keyed hole and remove it from the vehicle.](#)

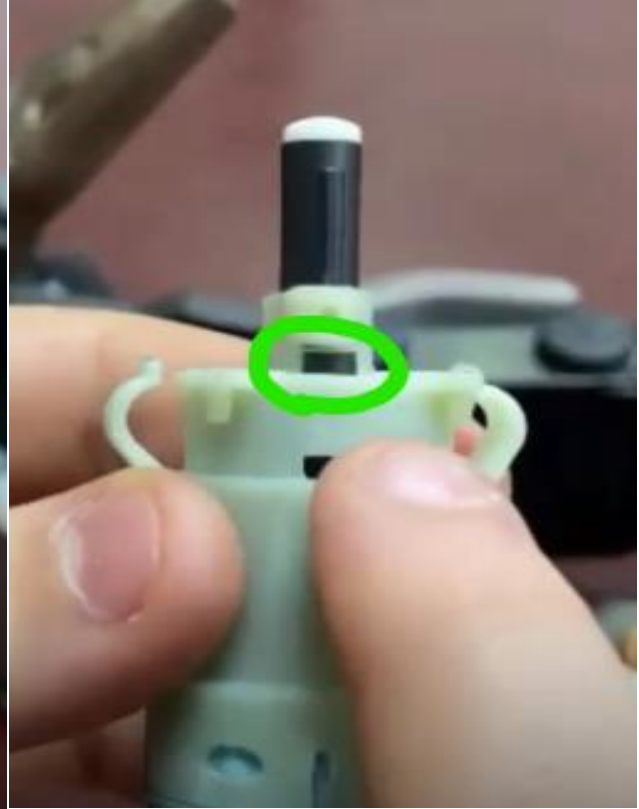
OK.
