Unintentional Opening Of The Tailgate - Recoding Of Long Press On Double-Click

Topic number	LI72.20-P-075746
Version	3
Function group	72.20 - Tailgate, rear door
Date	3/10/25
Validity	118, 167, 177, 206, 213, 223, 238, 243, 247, 254, 257, 293, 295, 296, 297, 214, 236 Facelift: 205, 253, 217, 222
Reason for change	New model series added (214 + 236)

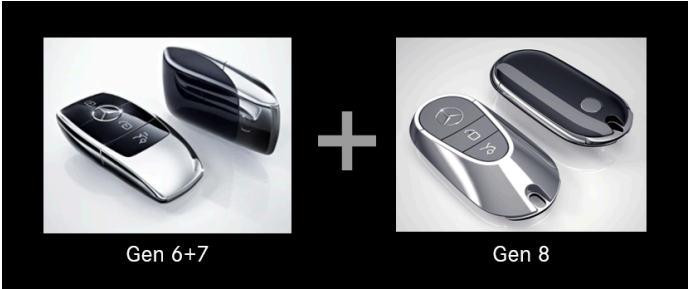
Attachments	
File	Description
Gen 6+7+8 Key.png

6th, 7th and 8th generation keys can be deactivated as follows:

Up to modification year 22/1 double-click on the locking button

As of modification year 22/1, by pressing and holding the locking button + double-clicking on the release tab
