REFERENCE:	TSB: 08-067-25 GROUP: 08 - Electrical	Date:	March 15, 2025	REVISION:	-
VEHICLES AFFECTED:	2024 (JL) Jeep Wrangler 2024 (JT) Jeep Gladiator This bulletin applies to vehicles equipped with a Uconnect 5 Nav W 12.3" Display (CHN) (Sales Code UQX).			MARKET APPLICABILITY: <input type="checkbox"/> NA <input type="checkbox"/> MEA <input type="checkbox"/> SA <input type="checkbox"/> IAP <input type="checkbox"/> EE <input checked="" type="checkbox"/> CH	
CUSTOMER SYMPTOM:	<p>Customers may experience one or more of the following:</p> <ul style="list-style-type: none"> • Unable to select the Turn by Turn Navigation. • Blank Performance Pages (Rearview Camera (RVC) Functions Normally). • Android Auto® Voice Recognition (VR) inoperative. • Media tuner delayed. • Charge Schedule not accepting updates via phone (RVC Functions Normally). • Ambient light inoperative. • Map in Instrument Panel Cluster (IPC) inoperative. • Media Widget blank. • Navigation map black. • Off-Road Pages inoperative (RVC Functions Normally). • VR inoperative. • Incorrect song title displayed (Carplay® only). • Radio display switches from Media Page to Home Page (RVC Functions Normally). • Ghost touch on Navigat

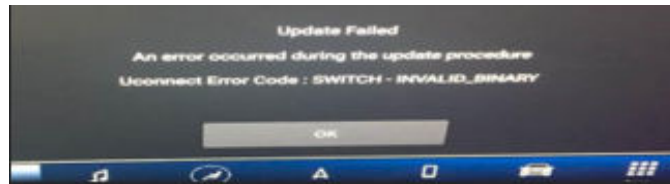
Fig. 7
Switch-Invalid_Binary Error

NOTE: Sometimes the radio throws an error pop up "Switch-Invalid_Binary" after successful radio update. Please ignore this error and click ok [Fig. 7](#).
