REFERENCE:	TSB: 08-063-25 GROUP: 08 - Electrical	Date:	March 11, 2025	REVISION:	-						
VEHICLES AFFECTED:	<p>2021 - 2023 (WL) Grand Cherokee / Grand Cherokee L 2022 - 2023 (WS) Wagoneer / Grand Wagoneer</p> <p>This bulletin applies to vehicles built equipped with one of the following radios:</p> <ul style="list-style-type: none"> ● Uconnect 5 W 8.4" Display (ROW+DAB) (Sales Code UUF). ● Uconnect 5 Nav W 8.4" Disp (ROW+DAB) (Sales Code UUL). ● Uconnect 5 Nav w 10.1" Disp (ROW+DAB) (Sales Code UUN). ● Uconnect 5 Nav w 12.0" Disp (ROW+DAB) (Sales Code UUQ). 			<p>MARKET APPLICABILITY:</p>

REPAIR SUMMARY:

This bulletin involves inspecting and if required, updating the radio software level to U33.43. Depending on the radio's current software level the radio may need a one or two USB update.

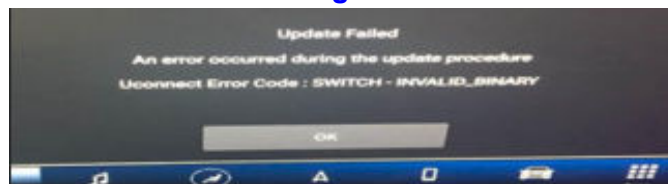
Fig. 7
Switch-Invalid_Binary Error

NOTE: Sometimes the radio throws an error pop up "Switch-Invalid_Binary" after successful radio update. Please ignore this error and click ok [Fig. 7](#).
