## Technical Service Bulletin

GROUP <b>CAMPAIGN</b>	NUMBER <b>25-01-020H</b>
DATE <b>MARCH 2025</b>	MODEL(S) <b>SEE BELOW</b>

**SUBJECT:** CENTRAL COMMUNICATION UNIT (CCU) MULTIPLE SUBSYSTEM SOFTWARE UPDATE (SERVICE CAMPAIGN TCTA)

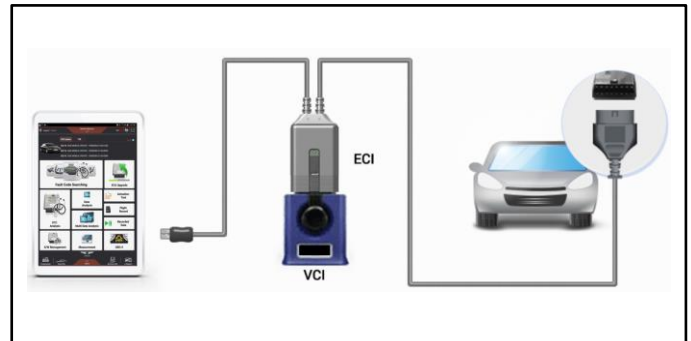
1. Connect the Ethernet Communication Interface (ECI) DLC cable to the OBD connector of the vehicle.
2. Connect the VCI DLC cable to the ECI.
3. Select the appropriate tablet cable (type C, 5-pin) to the ECI.
4. Connect the cable to the tablet PC.

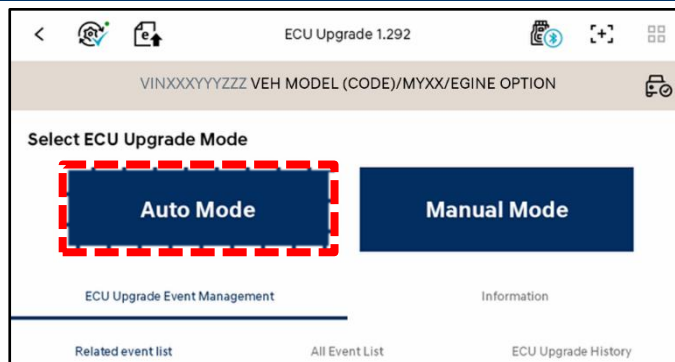
1. Perform the **first** of 2 required ECU updates in **Auto Mode (AP)**.

Use the **ID Check** to verify the ROM ID before updating the software.

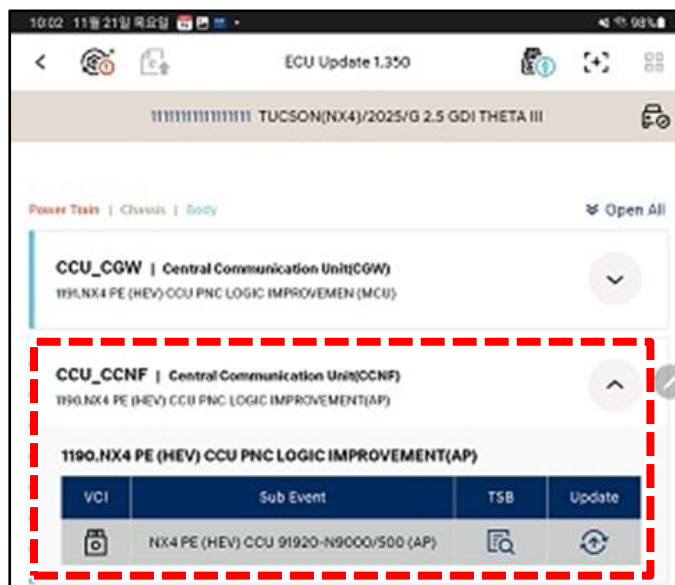
2. Select the **CCU\_CCNF** system to scan the vehicle's current ROM ID.

Check the current ROM ID version and compare it to the ROM ID Information table before attempting to perform the software update.

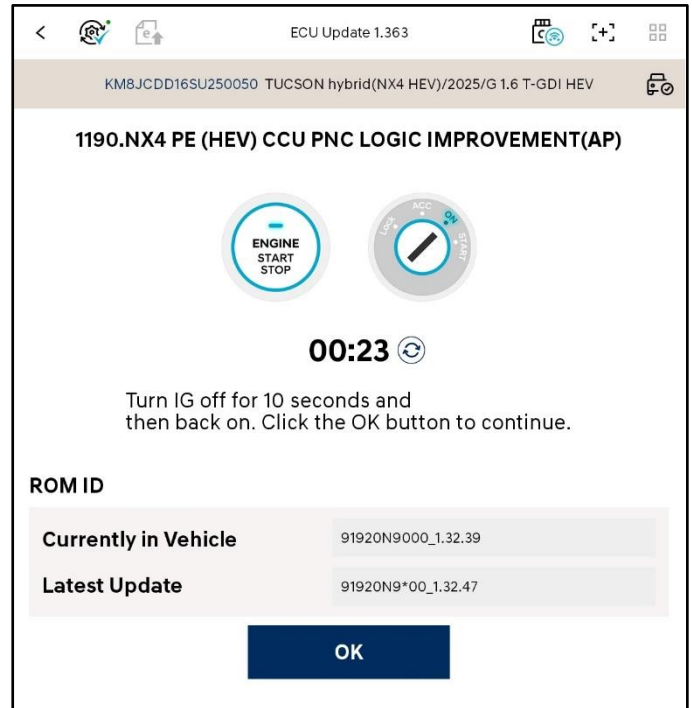
3. After the ECU update process shows **100%** complete, follow the prompts on the screen to cycle the ignition **OFF** for at least **10 seconds** to reset the control unit (certain models may take up to **30 seconds**).

Use the **Refresh** button to reset the timer.

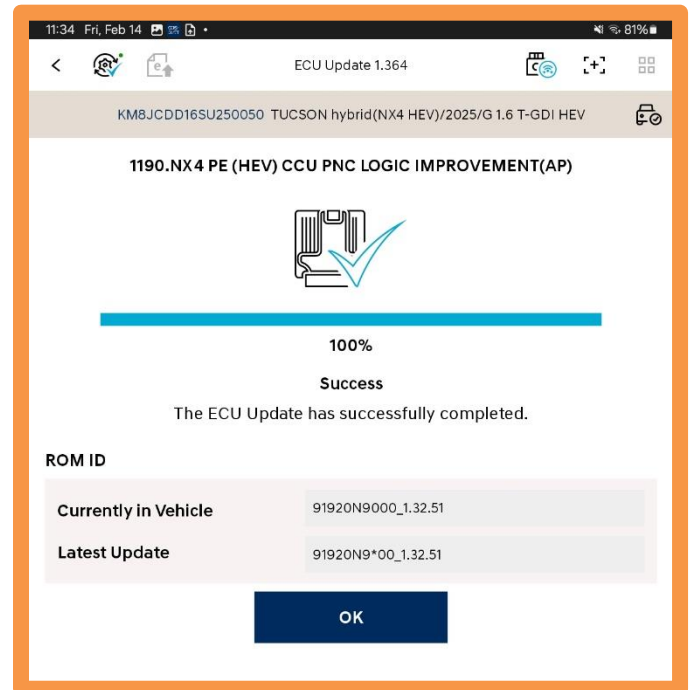
Take a screenshot of the ECU update complete screen using your tablet and upload to STUI (AP, 1 of 2 required).

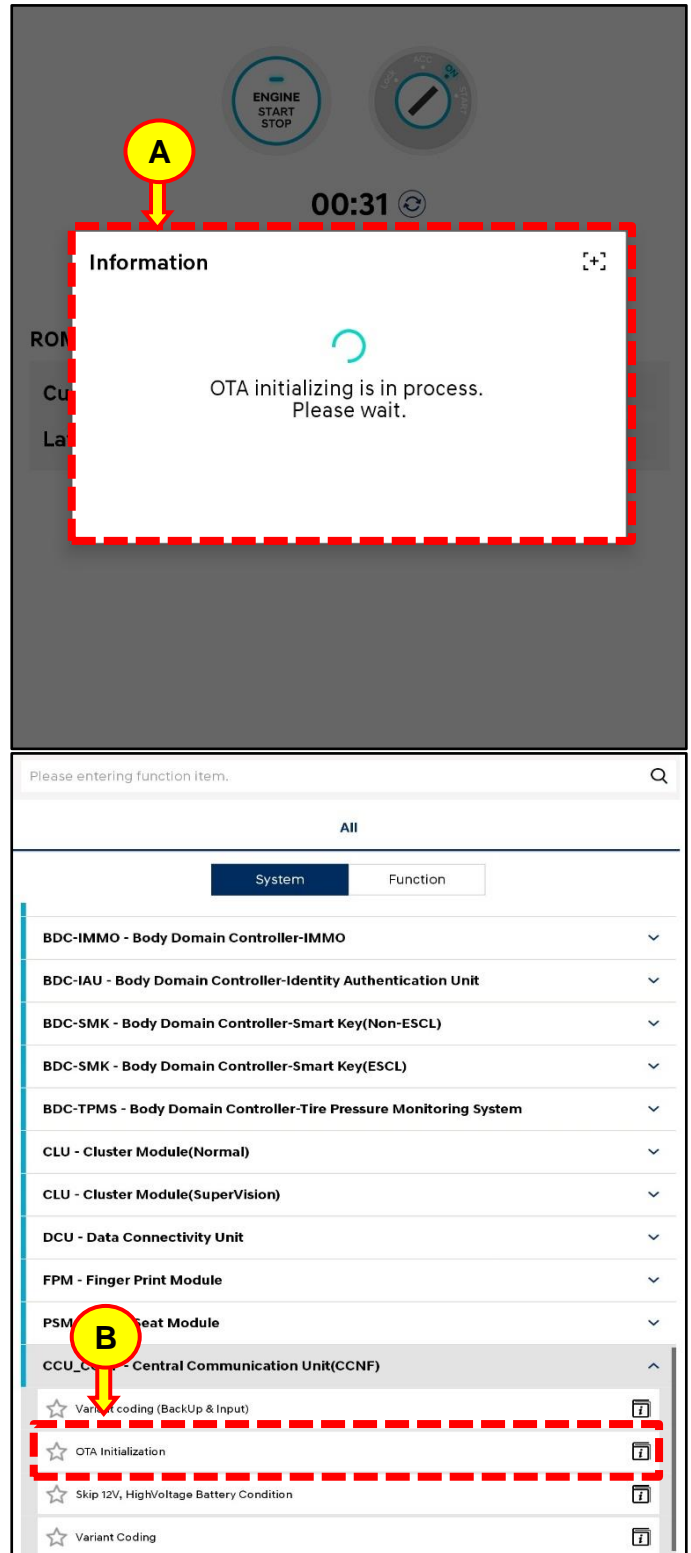
5. OTA initialization should perform automatically (A):
- If OTA initialization performs automatically, then proceed with the service procedure.
  - If the OTA initialization process fails, complete it manually under:  
**S/W Management > CCU\_CCNF - Central Communication Unit (CCNF) > OTA Initialization (B).**

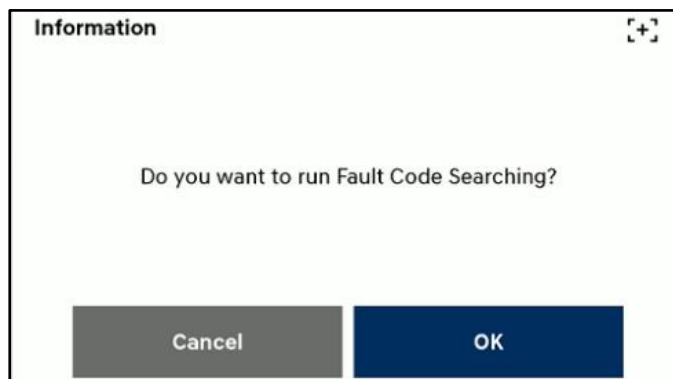
6. Perform an **All Systems Fault Code** search and erase DTC history that had incidentally occurred from the ECU update.

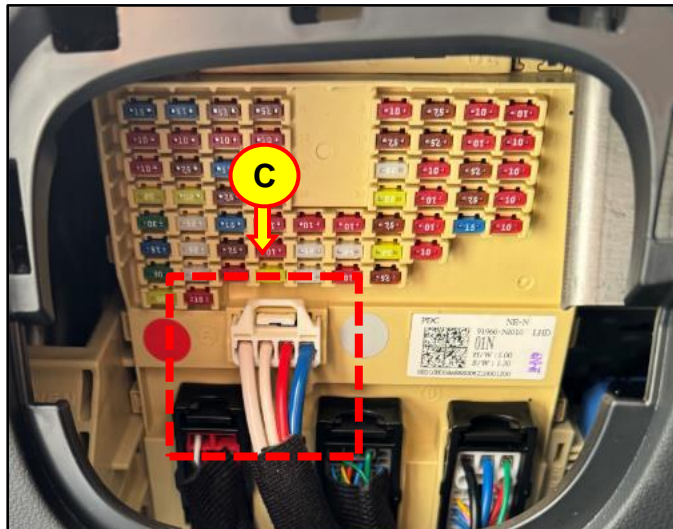
7. After the OTA initialization, disconnect the power connector (C) in the indoor fuse box, wait at least **5 seconds**, and reconnect.

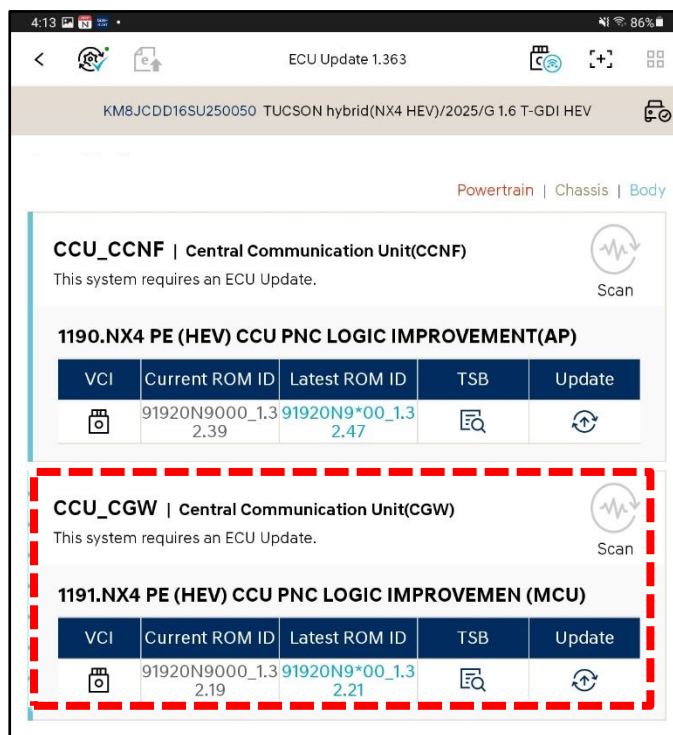
8. Perform the **second of 2** required ECU updates in **Auto Mode (MCU)**.

Use the ID Check to verify the ROM ID before updating the software.

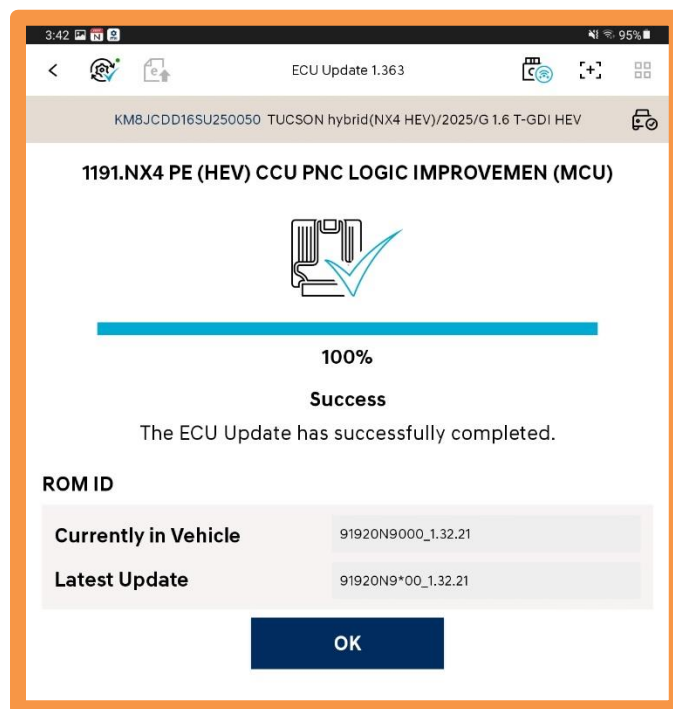
**Take a screenshot of the ECU update complete screen using your tablet and upload to STUI (MCU, 2 of 2 required).**
