TECHNICAL SERVICE BULLETIN

2021-2023 Bronco - Soft Top Roof - Headliner Detaching From Soft Top Material

25-2077

10 March
2025

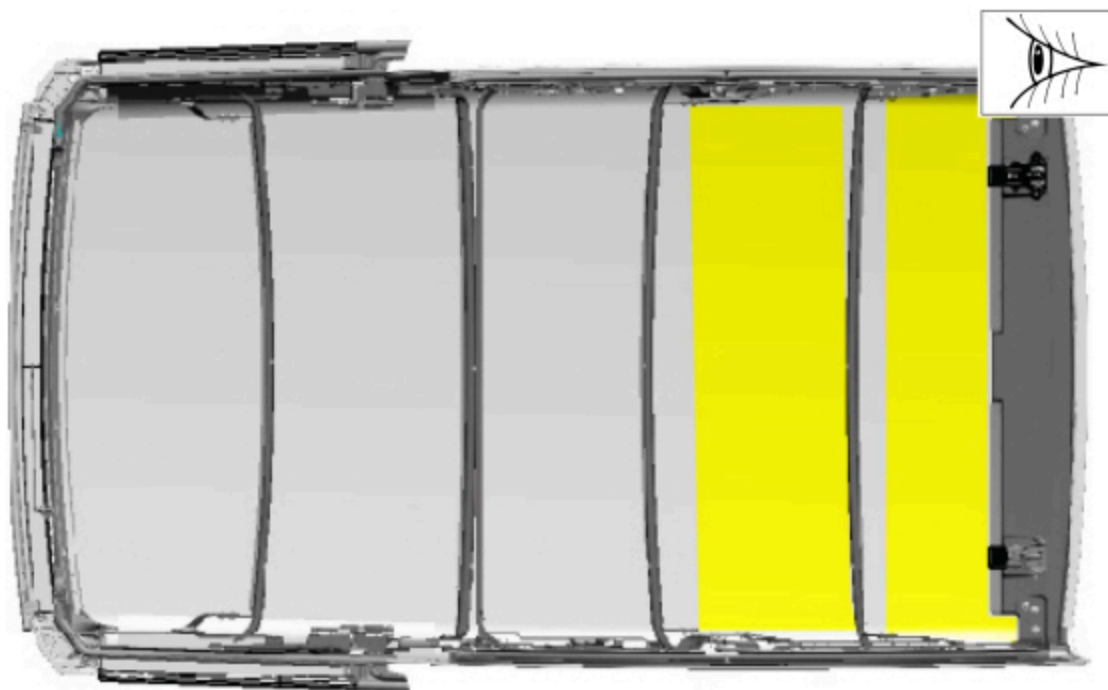
1. The soft top material has 2 separate sections of headliners, refer to Figure 1 for locations. Are either of the 2 headliners completely detached from the soft top material and/or damaged, such as stretched, cut and/or warped? (Figures 1-3)

Figure 1 - View from underside of the soft top assembly. Both headliner locations shown.

(1). Yes - replace the soft top material. Refer to WSM, Section 501-18A. Repair is complete.

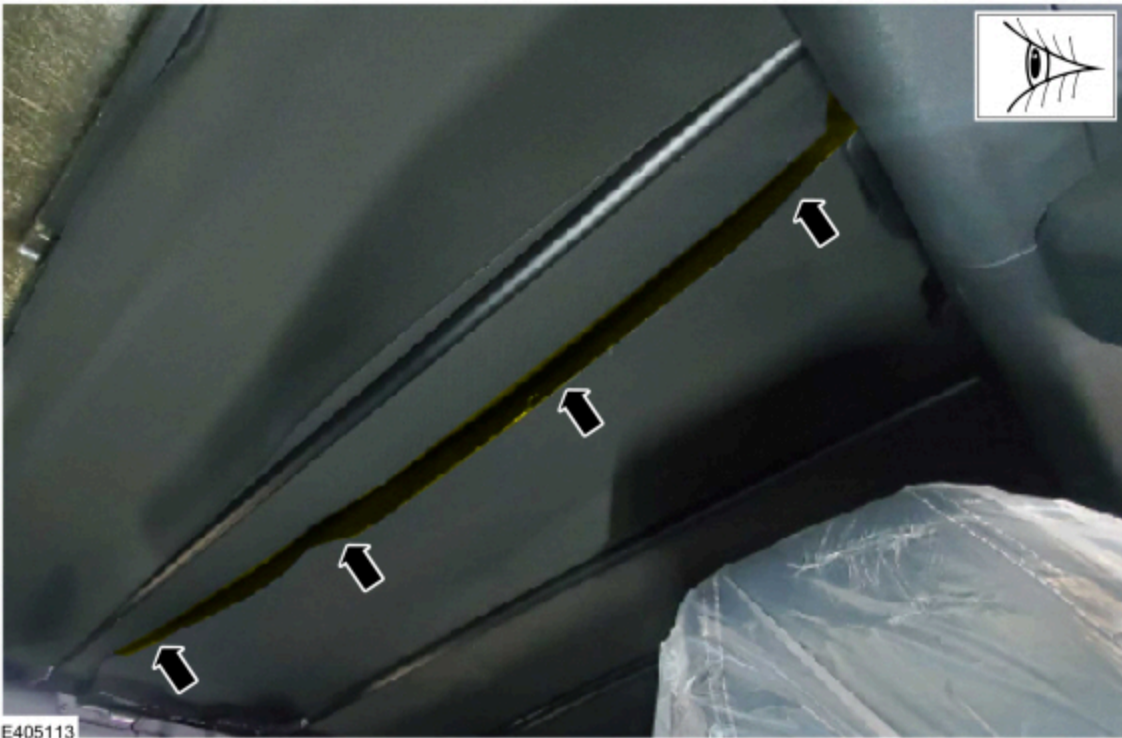
Figure 2 - Example of an undamaged, partially detached headliner that can be repaired

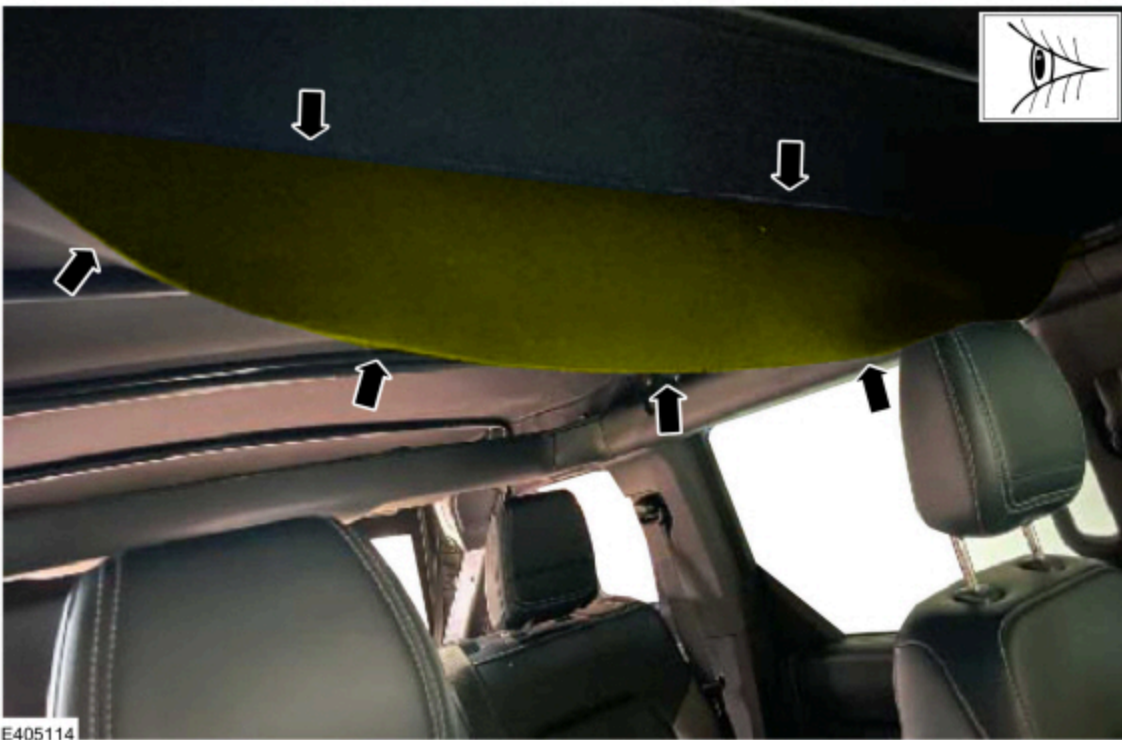
Figure 3 - Example of an undamaged, partially detached headliner that can be repaired

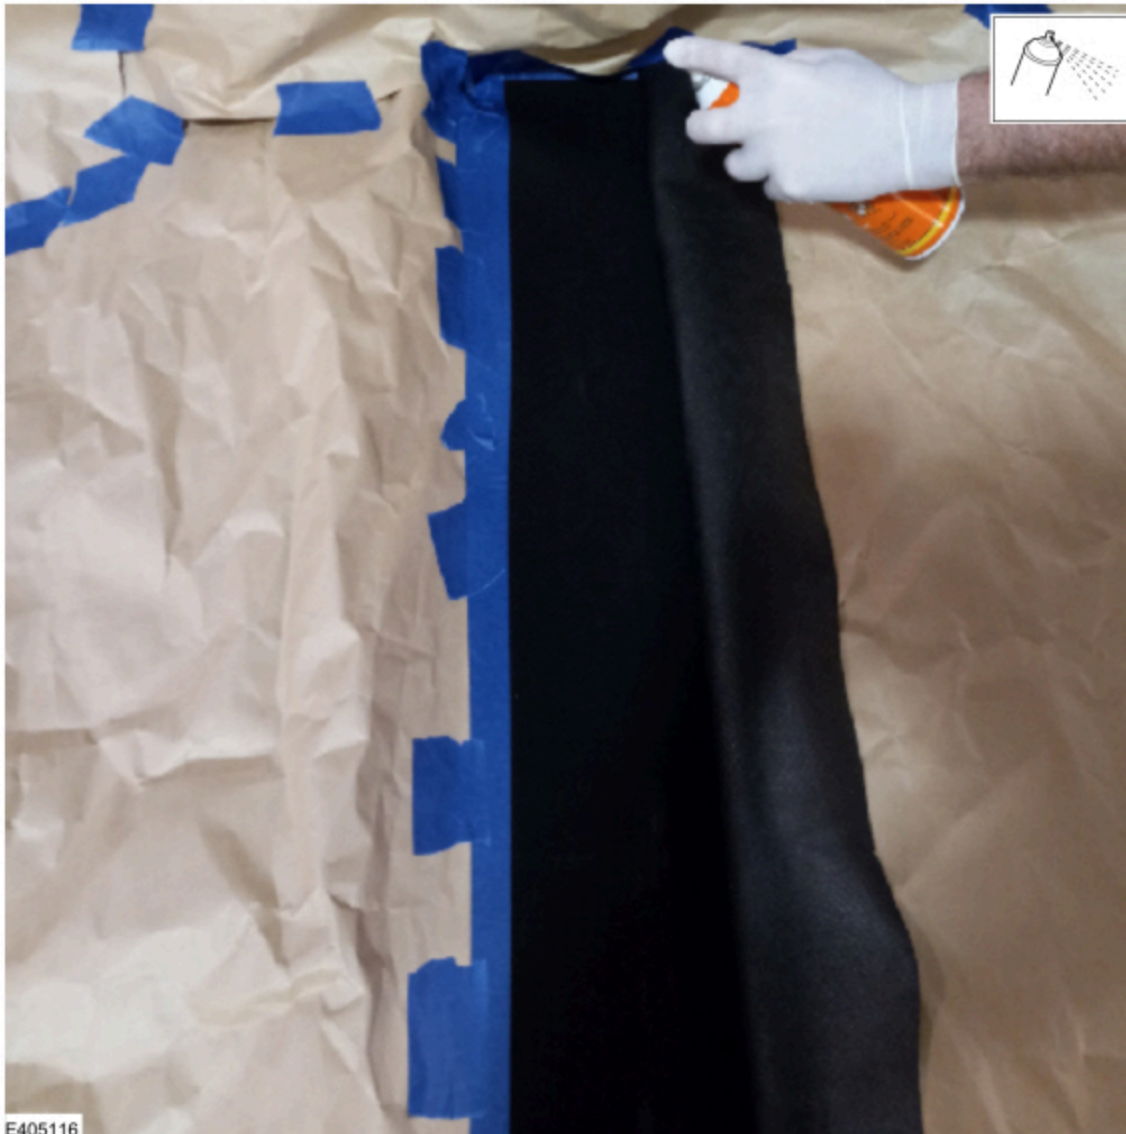
Figure 5 - Showing a properly covered area ready for spray adhesive

5. Use a damp, clean, lint-free cloth to wipe down the entire inside fabric of the soft top material and headliners. If needed, a vacuum can be used to assist with cleaning.
6. Reattach the applicable headliner(s) to the soft top material using the Gorilla® Heavy Duty Spray Adhesive.
 - (1). Perform this step on all sections of the headliner(s) that have become partially detached.
 - (2). Prepare the soft top material and headliner(s) for reattachment with the spray adhesive by taping off the surrounding areas with painter's tape. Use paper and/or cardboard to add further protection. Only the inner section of the headliner (that has detached) and the mating surface of the headliner (soft top material) are sprayed with the adhesive. Make sure that adhesive overspray does not occur to the surrounding areas or components, or soft top material replacement may be required. (Figure 5)

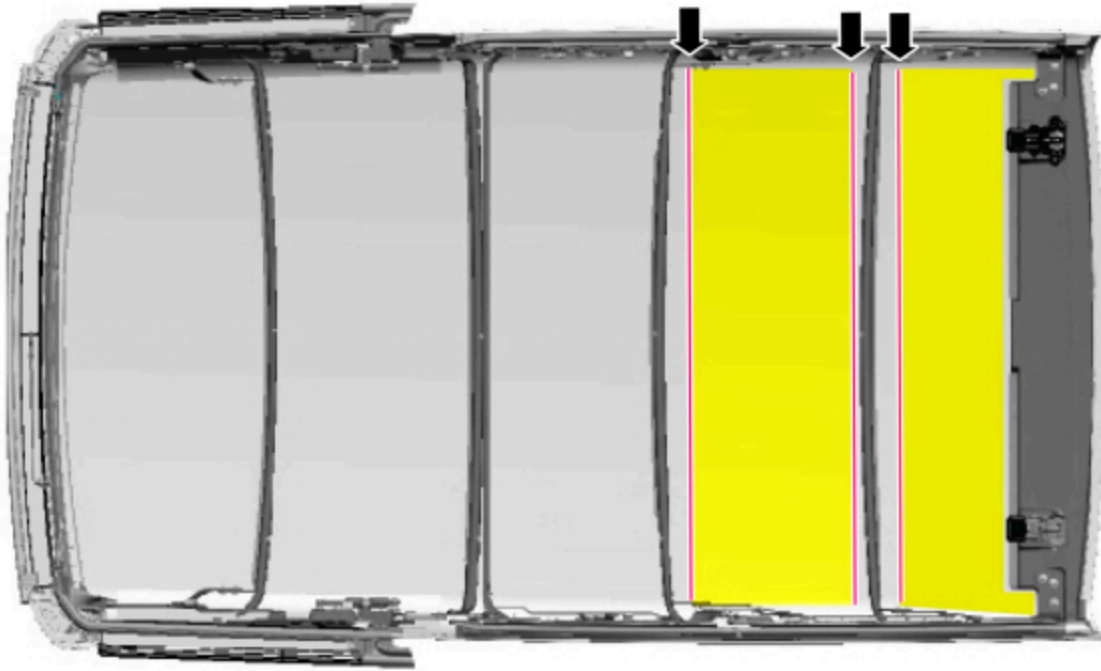
Figure 6 - Showing all 3 headliner seams that must be taped

(1). Tape all 3 cross-car headliner seams regardless of if they were becoming partially detached or not. Refer to Figure 6 for cross-car headliner seam locations.

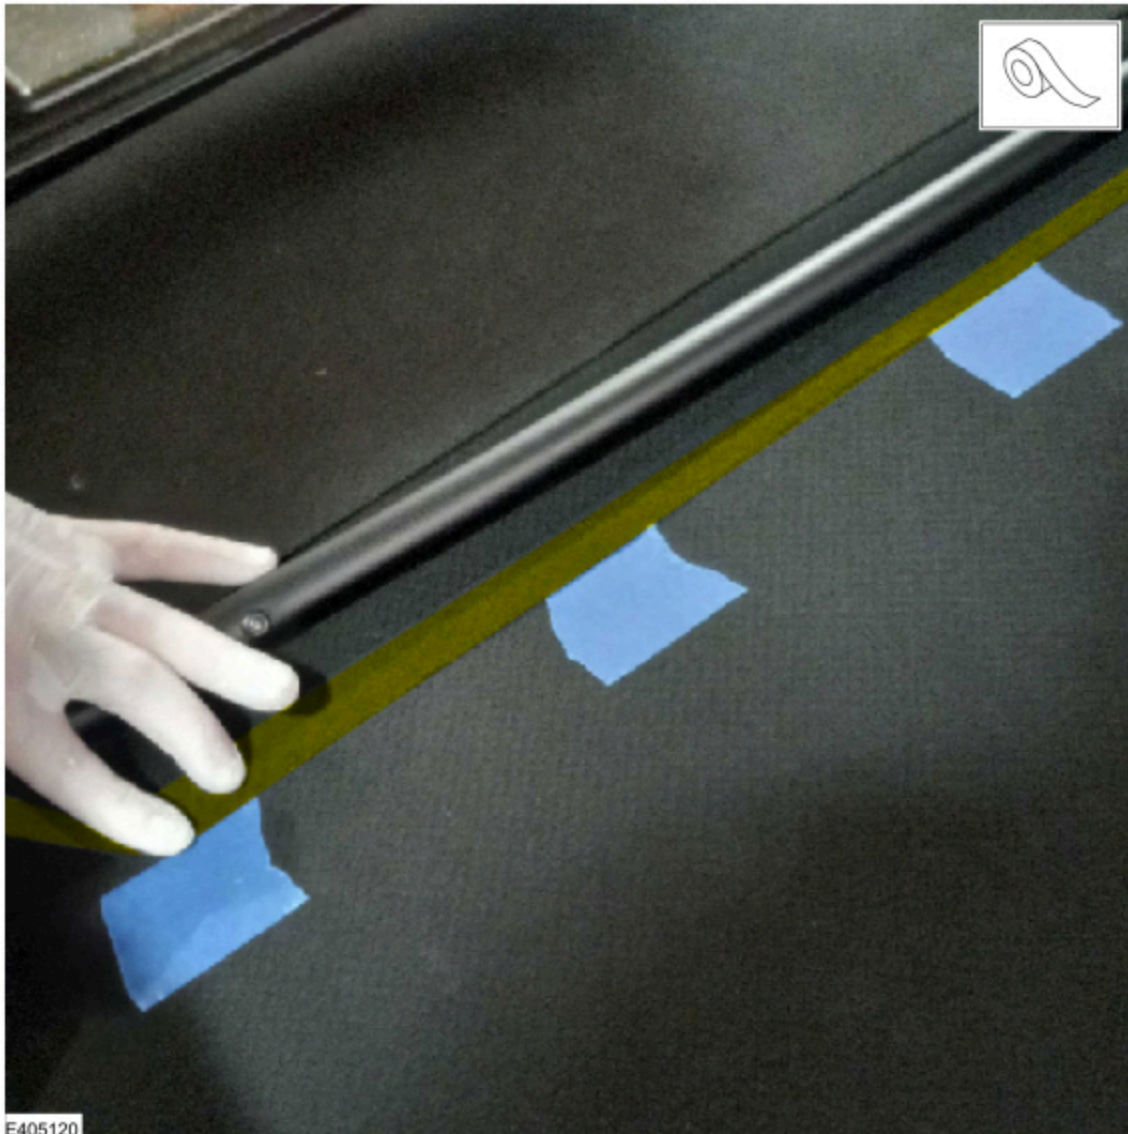
Figure 9 - Showing proper tape Installation following the taped guidelines.

(6). Set the center point of the cut section of film tape on the middle of the soft top assembly. This leaves extra tape on each end of the soft top assembly. Beginning on one side, approximately 12 in. (30 cm) away from one edge of the seam, peel the tape backing in small increments as needed (do not remove the entire length of the tape backing all at once) and lightly install the tape following the 0.5 in. (13 mm) tape guidelines. Be sure that half of the tape width is on the headliner and the other half on the soft top material, creating a straight/uniform line, refer to Figures 9-10. Do not stretch the tape at any point before or during the application. Film tape is extremely pliable which allows it to have excellent adhesion to the fabric. If it is installed while being stretched, it retracts over time which causes it to lose adhesion, refer to Figure 10.

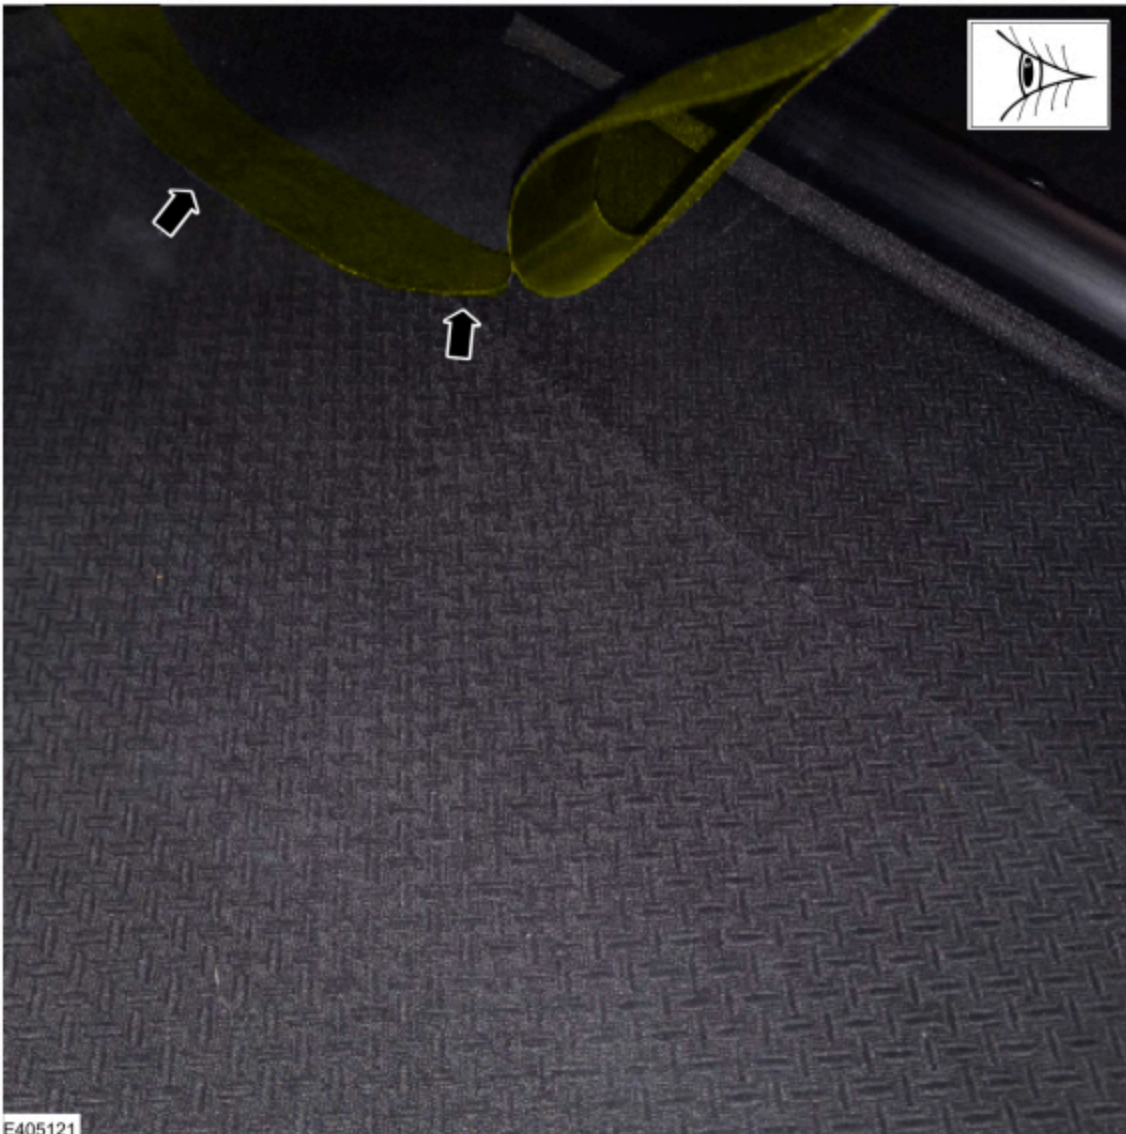
Figure 10 - Showing proper tape installation. Do not stretch tape and only remove backing as needed.

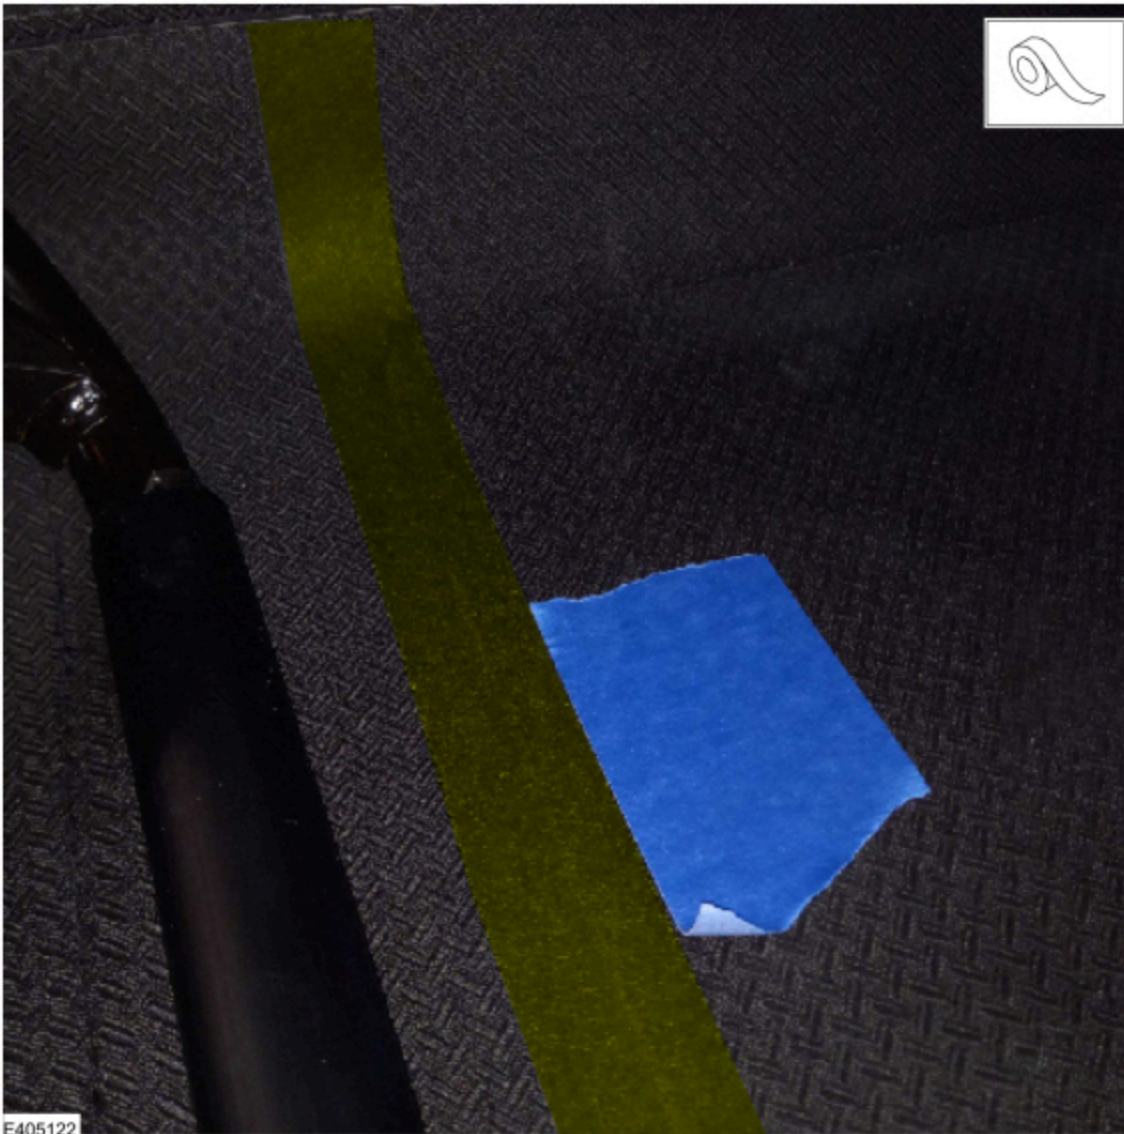
Figure 11 - Showing proper tape installation on the edge of the soft top material.

(7). When the section of film tape reaches the end of the headliner seam, continue to tape in a straight line all the way to the edge of the soft top seam. Allow the tape to stay loose during application. Cut the end of the film tape so that it ends just before the soft top material edge but do not tape past the edge, which runs perpendicular to the tape routing. Be sure that 100% of the film tape is secured and flat to the surface. Do not leave any sections of tape loose/unattached, as this causes tape to peel over time. Perform this step on the opposite edge of the section of film tape, then proceed to the next step. (Figure 11)

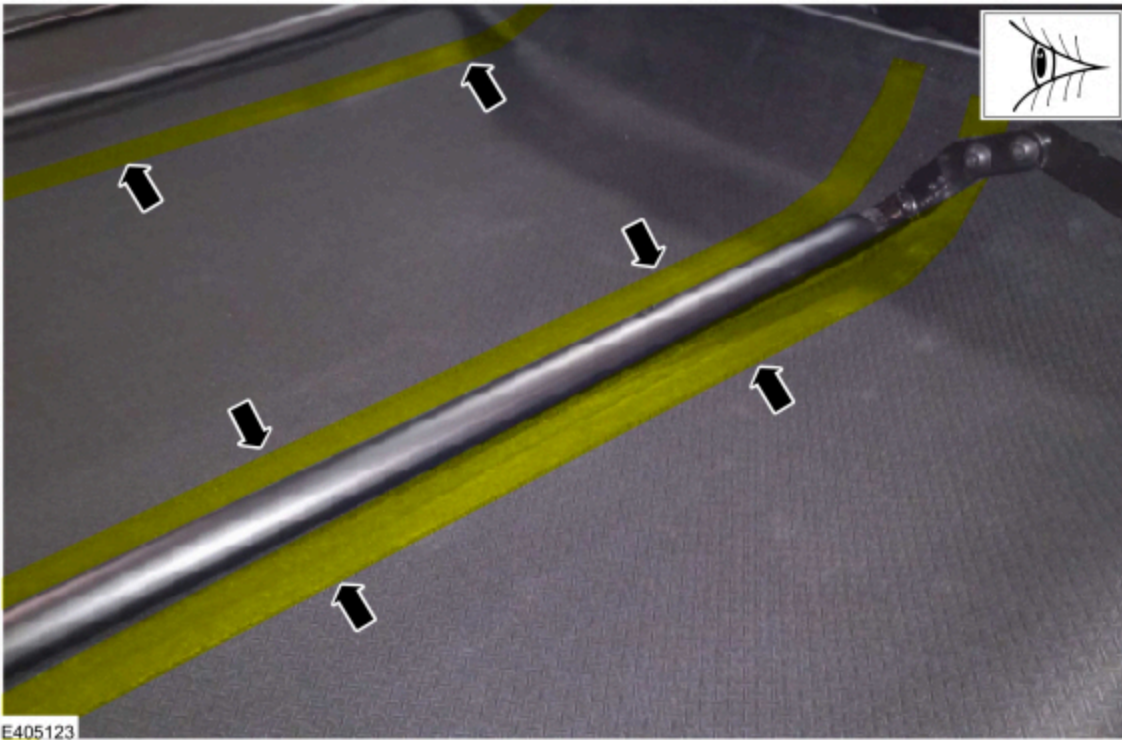
Figure 12 - Showing a complete installation of film tape along all three cross-car headliner seams

(12). Reinspect all 3 installed sections of film tape. Inspect for tape straightness, proper 50/50 adhesion to the headliner and soft top roof material across the entire length of the headliner, film tape peeling (occurs when tape is stretched during installation), and both vertical edges to ensure proper adhesion with no lift of the tape present. If any of these problems exist, repeat Step 7 on any failed sections using a fresh piece of tape.
