Technical Service Bulletin (TSB)
Air Conditioning Not Blowing Cold Or Is Inoperative

REFERENCE:	TSB: 24-001-25 GROUP: 24 - Heating and Air Conditioning	Date:	March 14, 2025	REVISION:	–
VEHICLES AFFECTED:	2025 (B1) Jeep Renegade 2025 (M1) Jeep Compass 2025 (H1) Jeep Commander This bulletin applies to: <ul style="list-style-type: none"> • B1 vehicles built on and after August 29, 2024 (MDH 0824XX) and on and before September 16, 2024 (MDH 0916XX). • H1 vehicles built on and after August 29, 2024 (MDH 0824XX) and on and before September 09, 2024 (MDH 0909XX). • M1 vehicles built on and after August 29, 2024 (MDH 0824XX) and on and before September 14, 2024 (MDH 0914XX). Equipped with one of the following: <ul style="list-style-type: none"> • 1.3L I4 Turbo MAIR DI Engine W/ESS (Sales Code EYF). • 1.3L I4 Turbo MAIR DI Engine (Sales Code EYH). • 1.3L I4 Turbo MAIR DI Engine W/ESS E100 (Sales Code EYJ). 			MARKET APPLICABILITY: <input checked="" type="checkbox"/> NA <input type="checkbox"/> MEA <input checked="" type="checkbox"/> SA <input type="checkbox"/> IAP <input type="checkbox"/> EE <input type="checkbox"/> CH

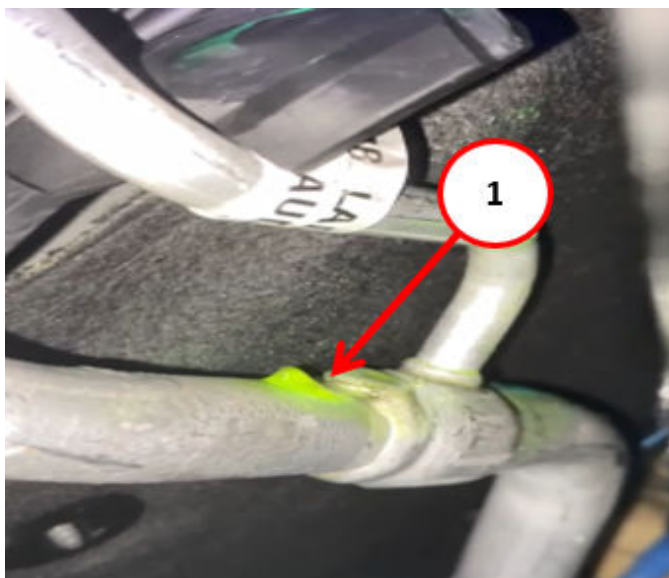
CUSTOMER SYMPTOM:	The customer or technician may describe or find one or more of the following: <ul style="list-style-type: none"> • Air conditioning provides insufficient cabin cooling. • Air conditioning is inoperative. 				
CAUSE:	Air conditioning refrigerant leak

Fig. 1
Air Conditioning Refrigerant Leak

1 - Air Conditioning Refrigerant Leak

3. Was an air conditioning refrigerant leak detected?
 - YES>>> Proceed to [Step 4](#).
 - NO>>> This bulletin has been completed, use Inspection LOP (24-45-20-91) to close the active RSU.
4. Replace the piping between expansion valve and connection to compressor piping. Refer to the detailed service procedures available in DealerCONNECT/Service Library under: Service Info> 5040A84 - Tubulação entre válvula de expansão e conexão para tubulação do compressor.
