March 07, 2025

Product Update: Electric Parking Brake (EPB) Harness Rubbing Half-Shaft Boot

Year	Model	Trim Level	VIN Range
2024	ZDX	ALL	Check iN VIN Status

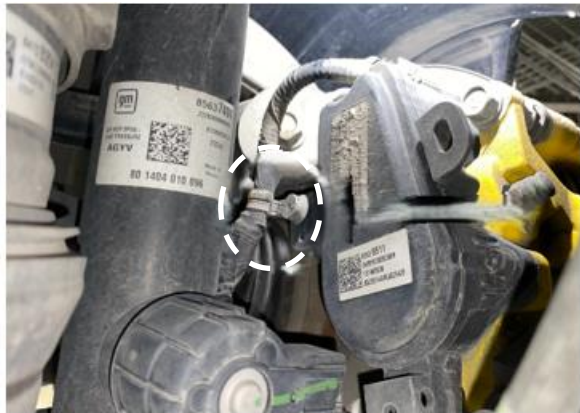
2. Locate the EPB harness clip mounted to the front of the rear brake caliper (passenger side shown).

3. Remove the clip from the caliper using a clip removal tool and carefully cut the clip from the harness
4. Wrap a new clip around the harness and leave it loose for later final adjustment, then install the clip onto the front of the brake caliper using the original mounting hole location.

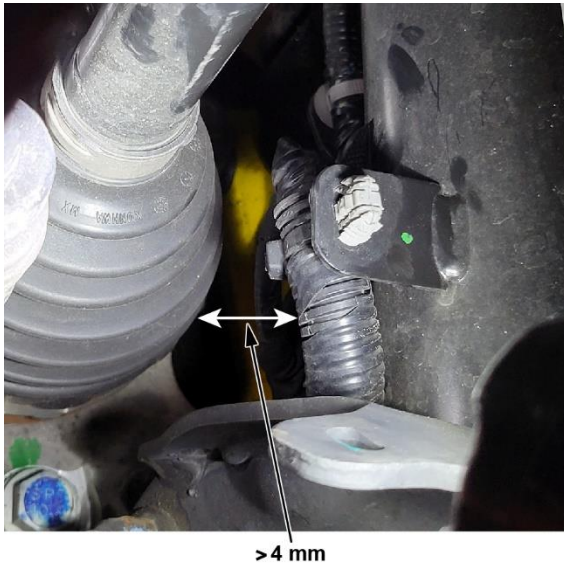
The Electric Park Brake (EPB) harness may not have enough clearance away from the half-shaft boot causing the harness to rub against the boot during normal driving and accelerating wear to the boot.

8. While tightening the clip, ensure a minimum clearance of 4mm remains between the harness and drive shaft boot.

9. Once completely tight, verify a final clearance of at least 4mm remains between the harness and the boot.
10. Trim the excess slack from the clip.
11. Repeat steps 7-10 on the other side.
