March 7, 2025

Version 1

Product Update: 2024 ZDX Multi-View Display Reversed

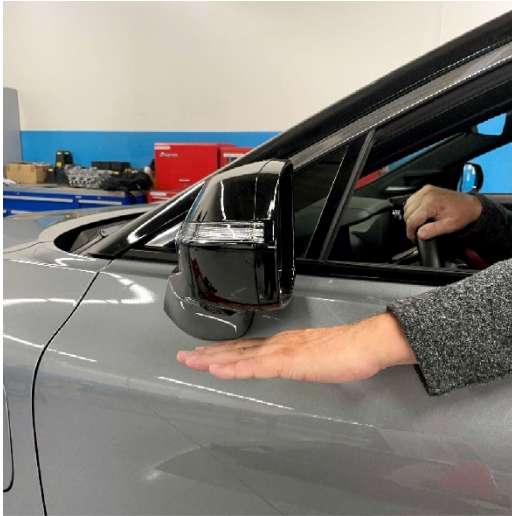
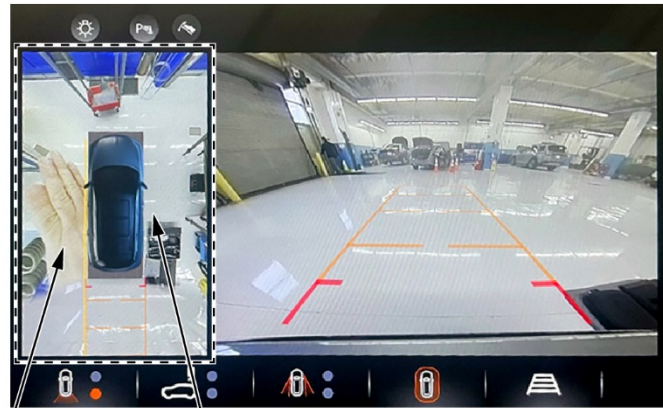
During manufacturing, wires may have been misrouted in the multi-view camera wire harness causing the left and right images to be swapped when the vehicle is in reverse.

Hand should appear here.

If hand is appearing here, complete the repair procedure.

Reverse the wiring for the outside rearview mirror cameras.

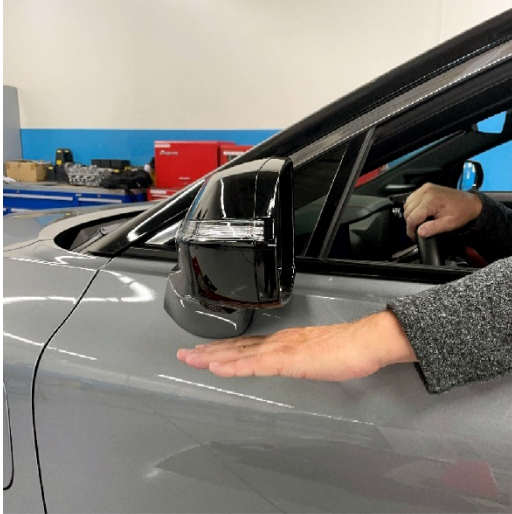
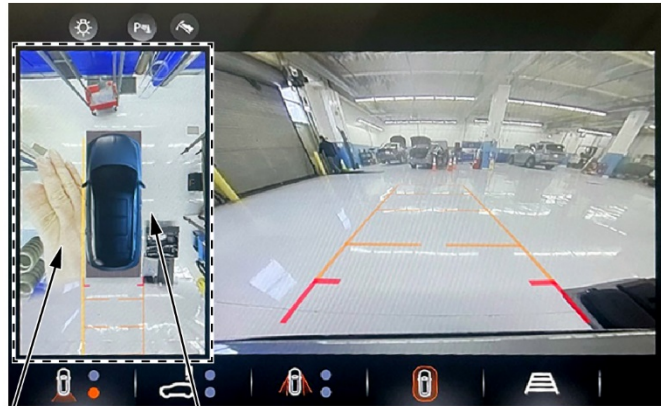
Hand should appear here.

If hand is appearing here, complete the repair procedure.

2. Hold your left hand under the driver's side sideview mirror, then confirm that it appears on the left side of the in-car multi-view display. This confirms the connector wiring is correct.
