## Technical Service Bulletin

<b>Topic</b>	60 A6: noises from panoramic sunroof
<b>Market area</b>	United States 444 Volkswagen of America, Inc. (6444)
<b>Brand</b>	Audi
<b>Transaction No.</b>	2054270/10
<b>Level</b>	EH
<b>Status</b>	Released for publishing
<b>Release date</b>	Feb 19, 2025

Rattling/cracking noises from area of panoramic sunroof. The noises occur mainly on poor-quality roads.

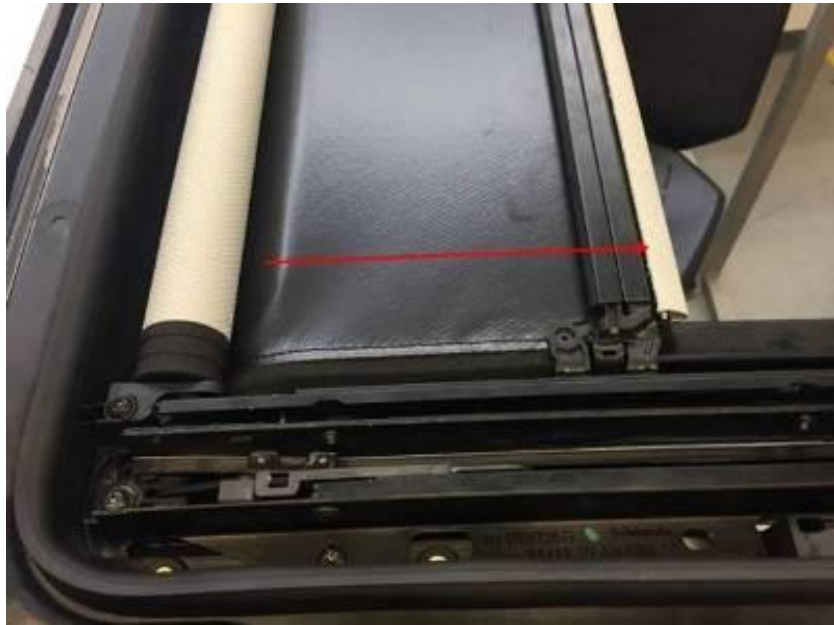
**Figure 1.** Closing the roller blind.

2. Close the roller blind by approx. 20 cm. (Figure 1).

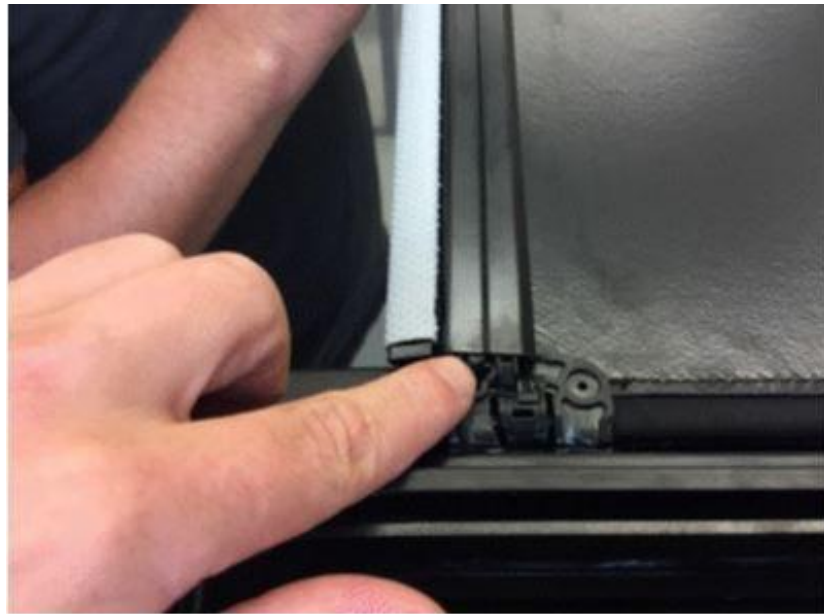
**Figure 2.** Move the blind back.

3. Disconnect the blind from the drive cable and push the material of the blind back until the bolt of the material centering becomes visible (Figures 2 -4).

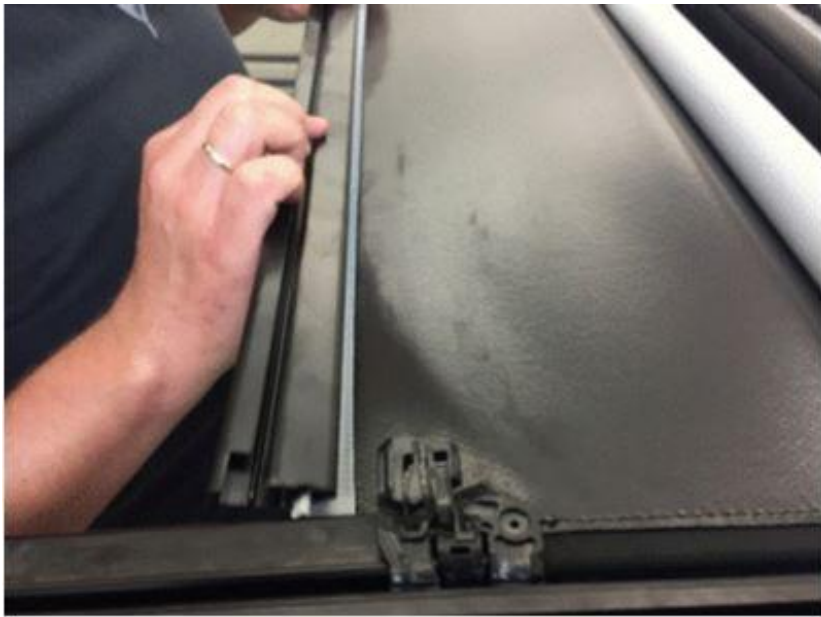
*Figure 3. Move the blind back.*

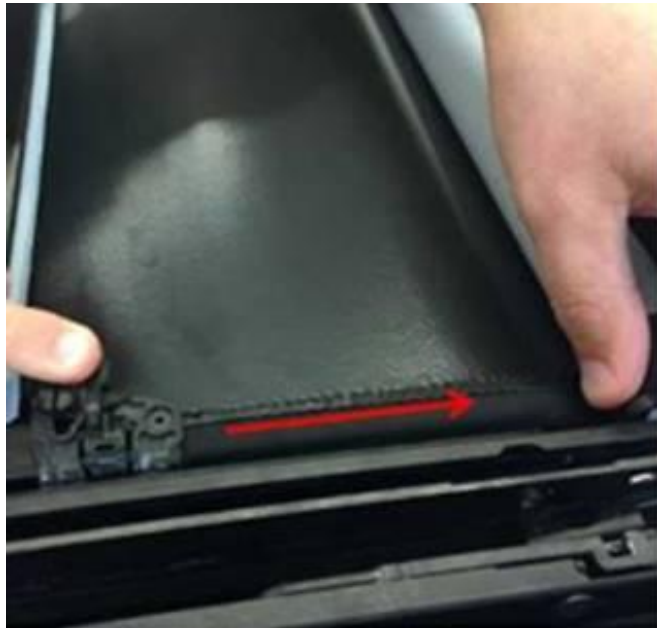
*Figure 4. Bolt visible.*

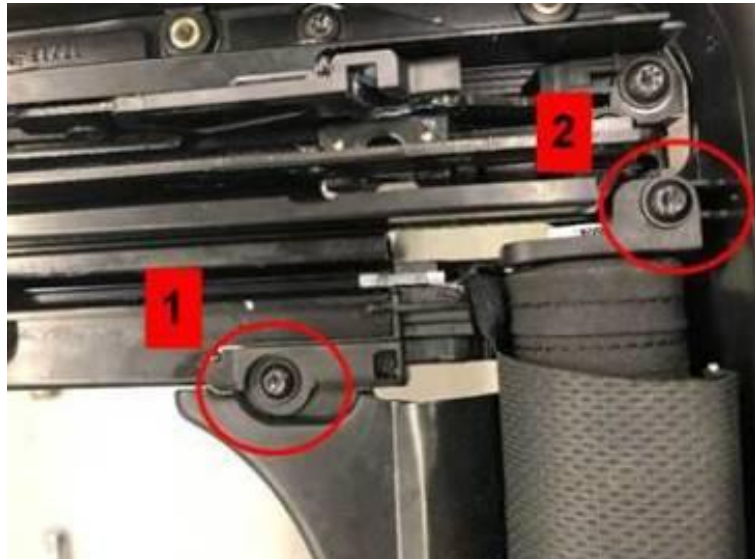
**Figure 5.** Remove the bolts.

4. Remove bolts completely (Figure 5).

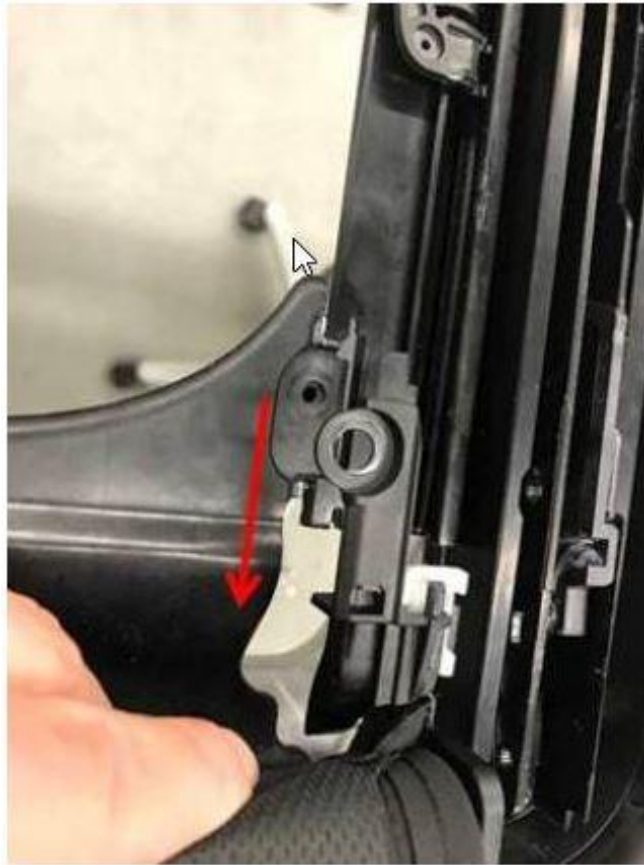
**Figure 6.** Roller blind moved toward rear.

5. Take out roller blind towards rear (Figure 6).

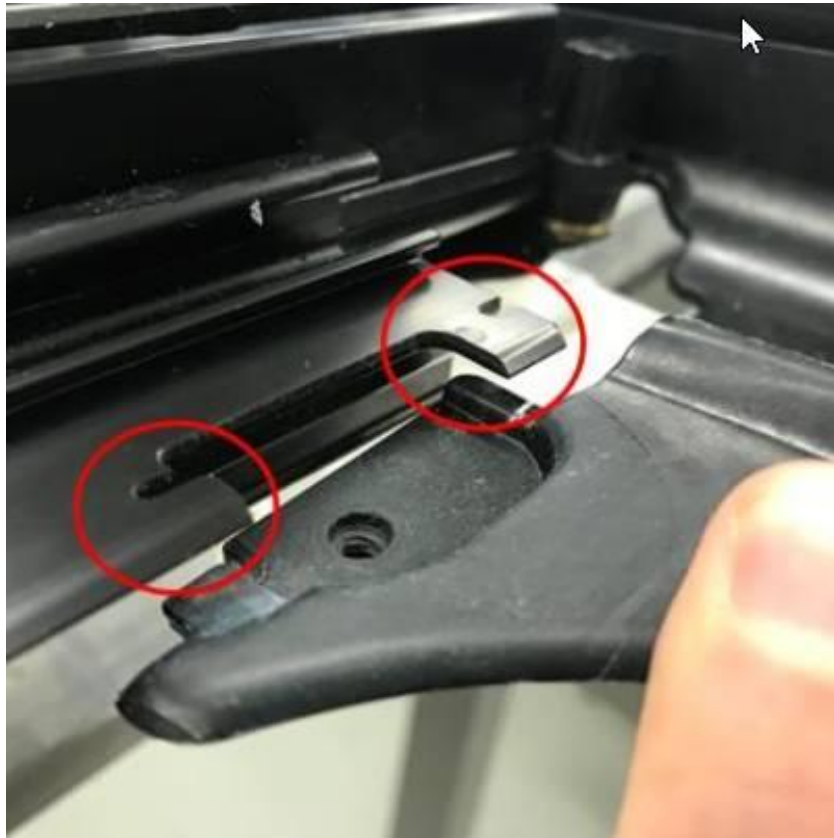
**Figure 7.** Areas to clean using cleaning solution D 009 401 04.

6. Clean the marked areas using cleaning solution D 009 401 04 (Figure 7).

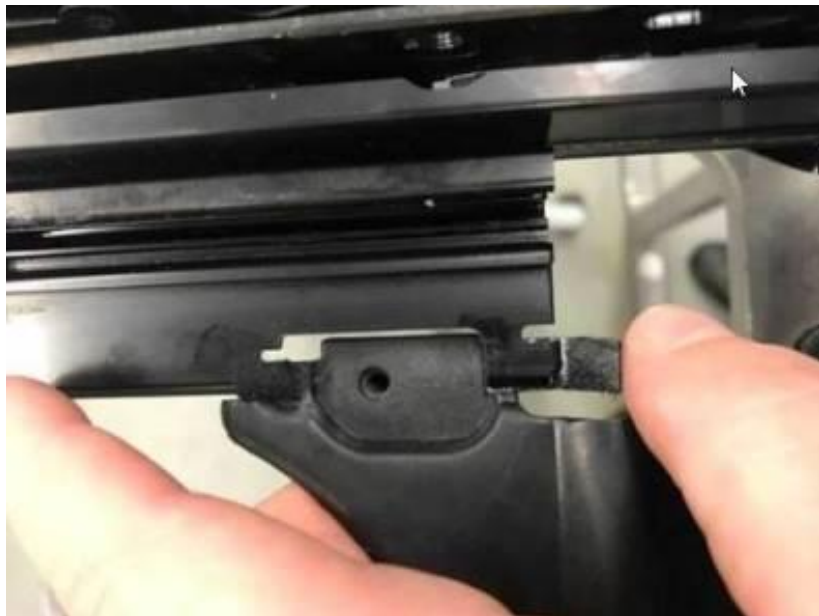
**Figure 8.** Bonding felt pieces.

7. Then press down the roller blind pan and, starting on the underside, bond on 1 mm thick felt pieces and fold them from the rear forwards over the guide rail. (Figure 8 and 9).

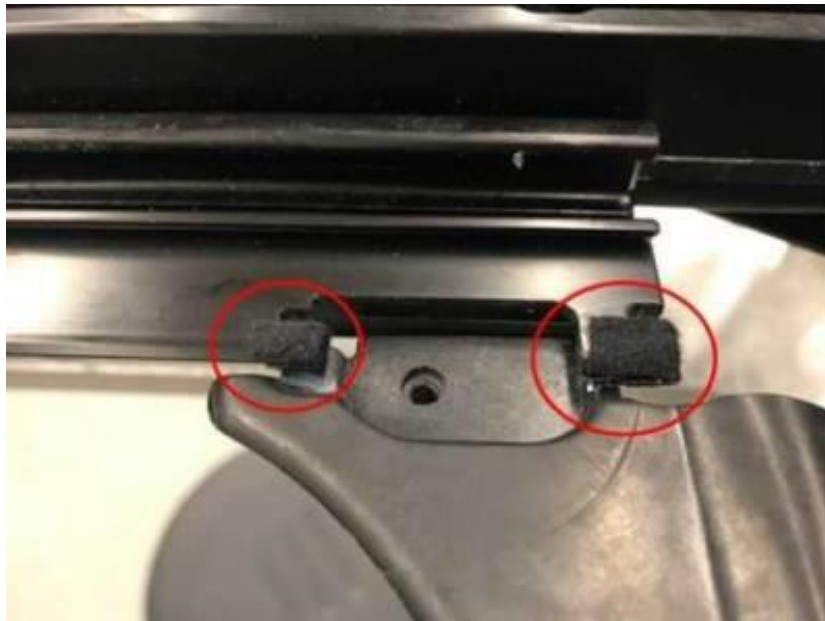
**Figure 9.** Felt pieces bonded.

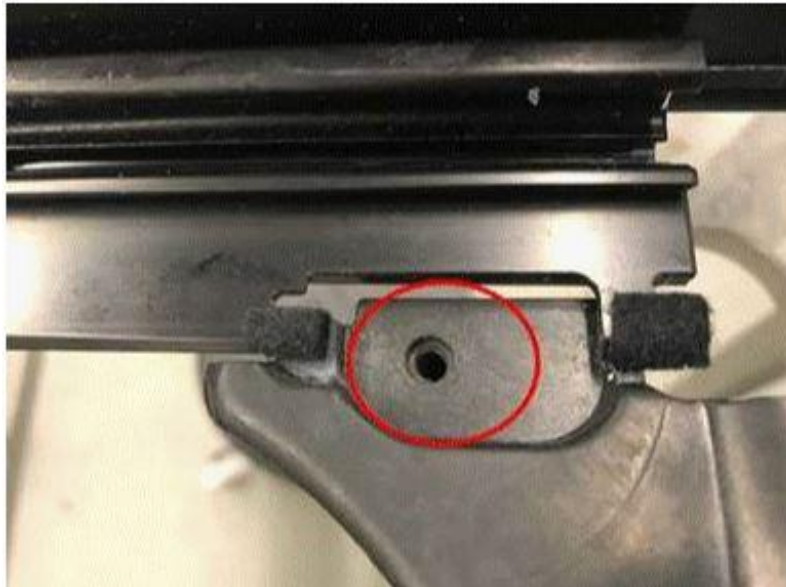
**Figure 10.** Bolt hole.

8. Finally, apply locking compound (e.g. Loctite) to the bolt and re-tighten it to 3 Nm (Figures 10 – 12).

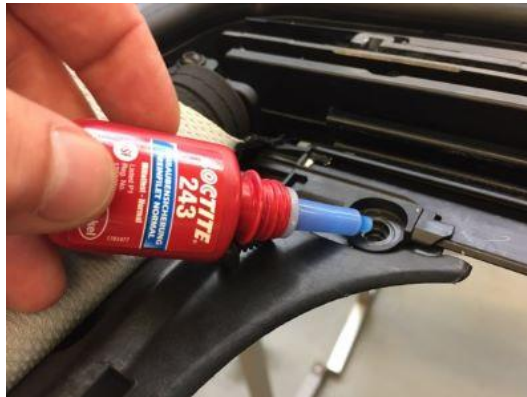
**Figure 11.** Locking compound application.

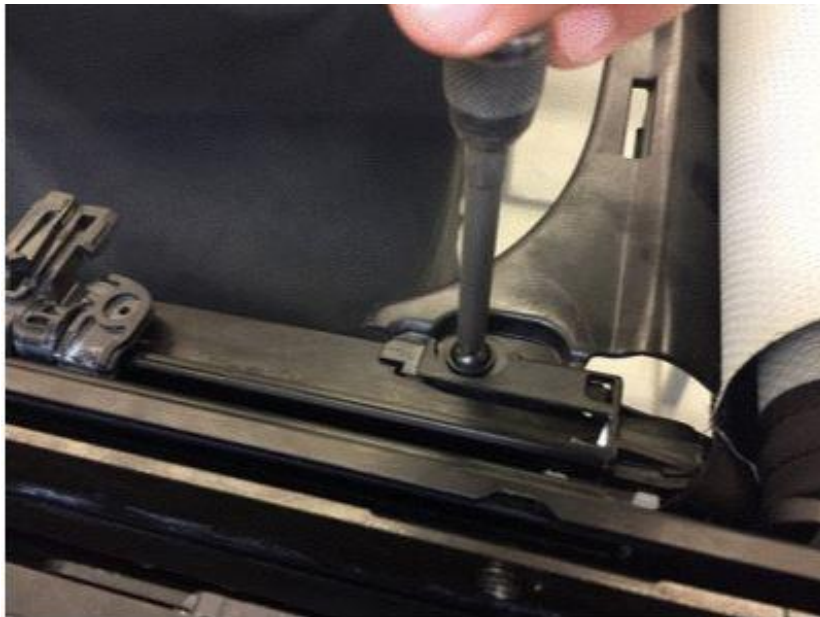
**Figure 12.** Tighten bolt to 3 Nm.

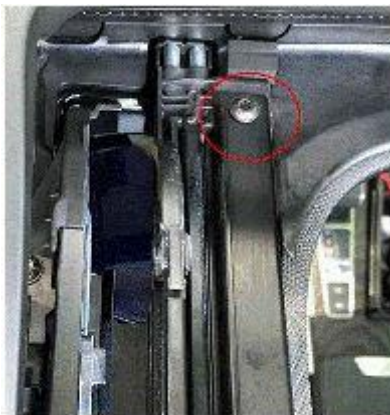
**Figure 13.** Loosen the bolt a few turns but do not unscrew completely.

9. Loosen the bolt a few turns. Do not unscrew completely (Figure 13).

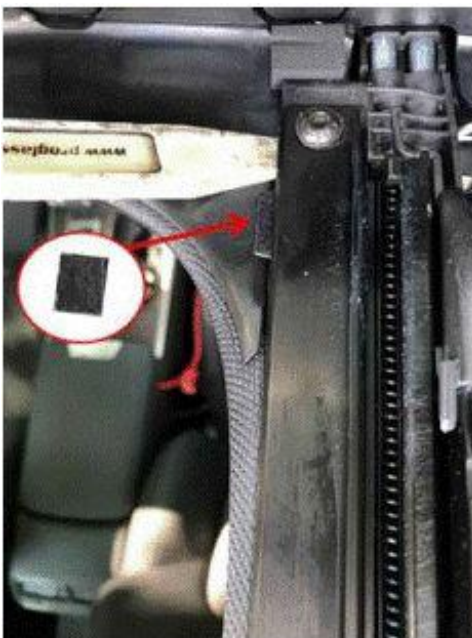
**Figure 14.** Isolation of guide rail and frame by the installation of a section of felt strip material.

10. Lift the guide rail slightly with a plastic wedge. Then place a felt strip (20 x 20 mm), as shown in the illustration, between the guide rail and the head part of the frame. The liner of the felt strip must be removed. Part number for felt strip: 533 867 910 A. (Figure 14).

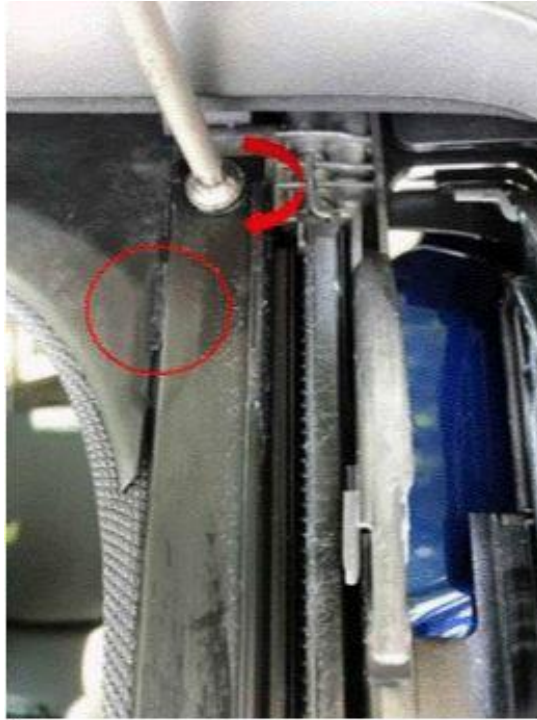
**Figure 15.** Tighten the bolt to 5 Nm.

11. Tighten the bolt to 5 Nm (Figure 15).

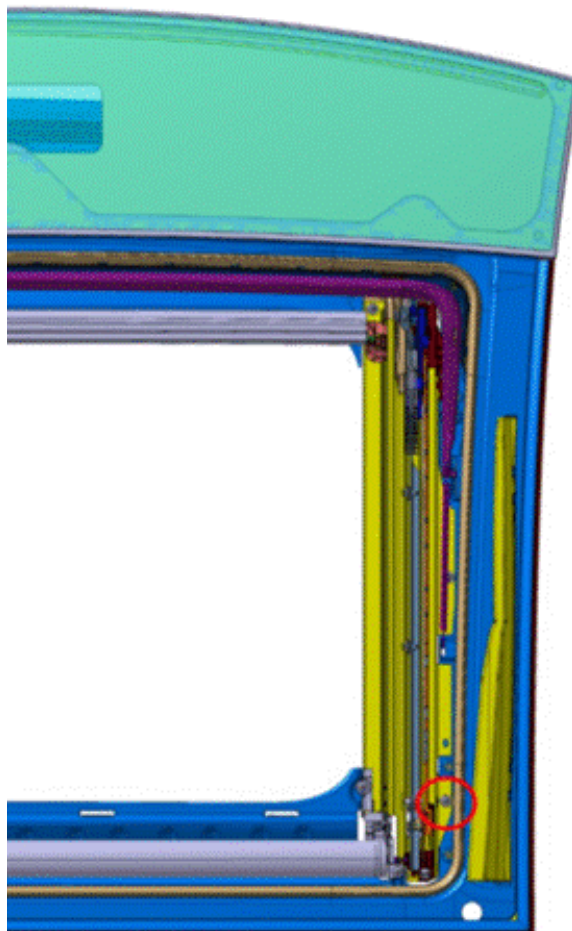
**Figure 16.** Location of the bolt.

12. The location of the bolt can be seen in the following image (Figure 16).

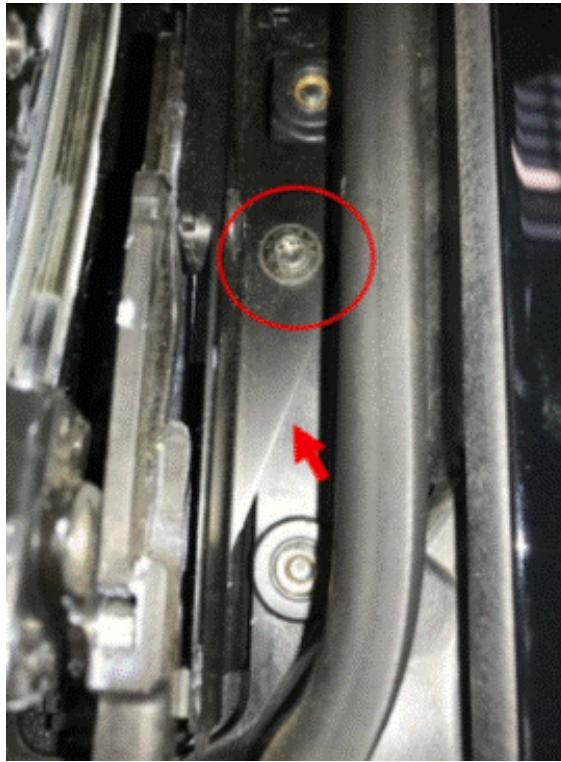
**Figure 17.** Loosen the bolt a few turns, but do not remove.

13. Loosen the bolt a few turns, but do not remove.

Insert a small plastic wedge between the metal panel and the frame (red arrow). Press the two parts slightly apart. Take spray lubricant G 060 567 A2 and spray it once or twice between metal panels as far as bolt. Then tighten bolt to specified torque again (Figure 17).

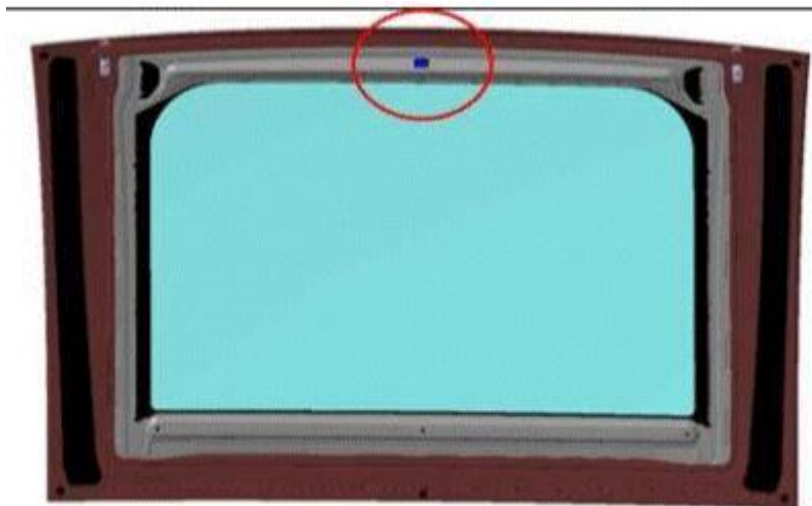
**Figure 18.** Felt strip application.

14. Attach a felt strip in the center of the front glass panel (Figures 18 – 19).

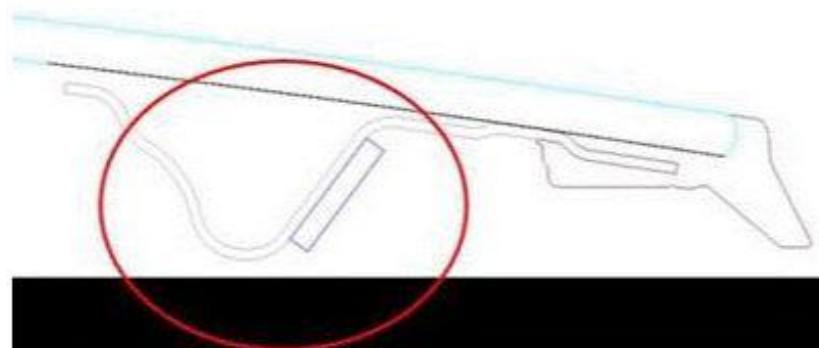
**Figure 19.** Felt strip application.

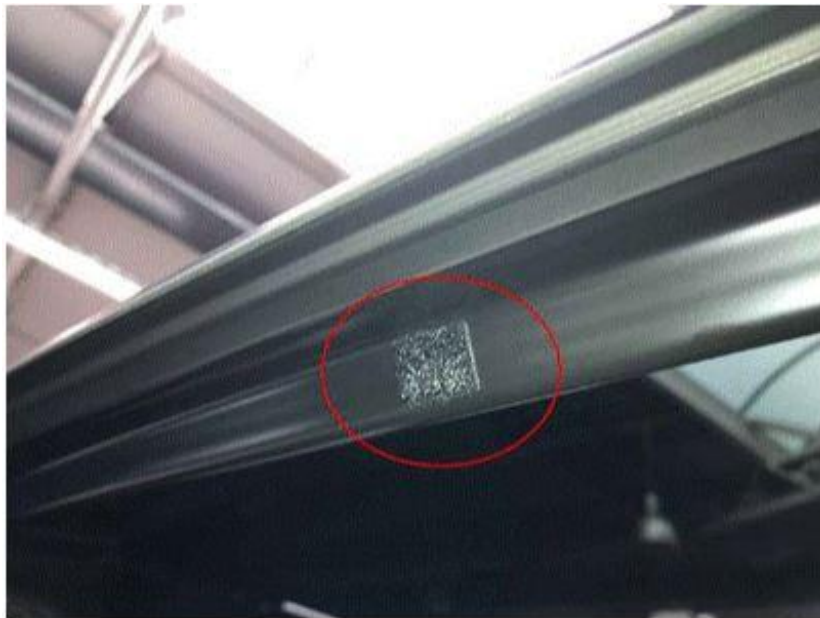
**Figure 20.** Felt strip bonded to glass panel.

15. Measure the center of the glass panel. Clean the surface with the cleaning solution D 009 401 04. Use the felt strip 533 863 288 A. Cut a 20 x 20mm piece and bond it onto the glass panel (Figure 20).
