Technical Service Bulletin

Transaction No.: **2073858/7**

93 e-tron GE various warning messages in the cluster, electric motor leaking P0AA600

Release date: Feb 20, 2025

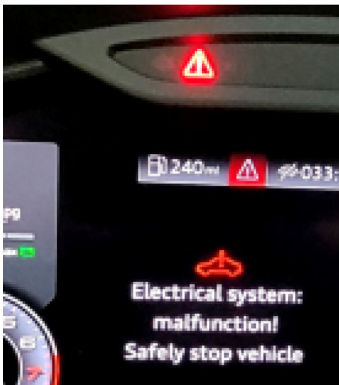
- A Drive System/Electrical System Malfunction message (Figure 1) appears in the in the instrument cluster; the warning may not be present at the time of inspection.

Figure 1. Warning lamp associated with message.

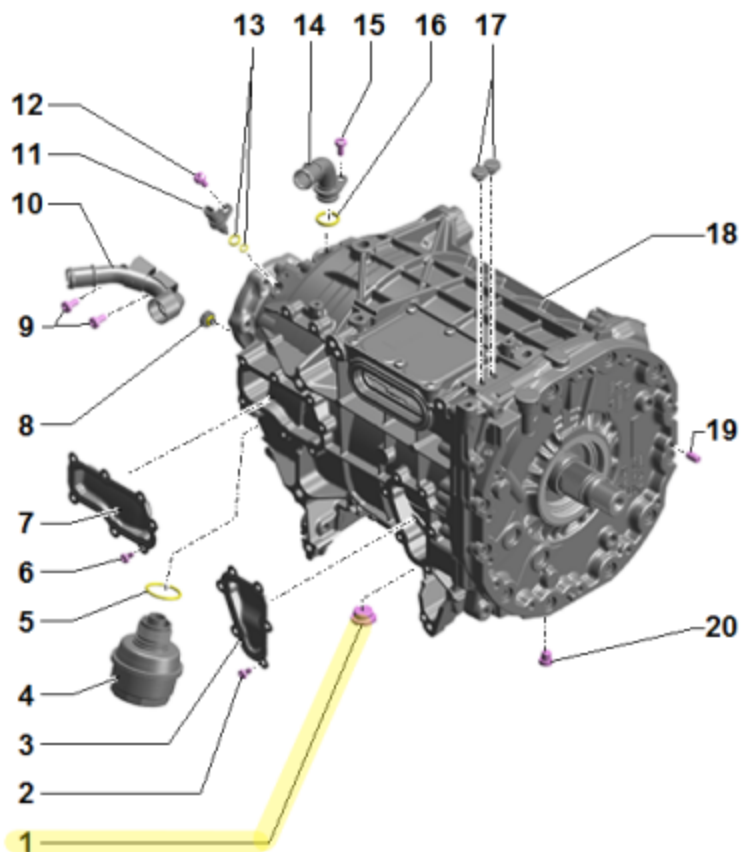
Electric drive motor damaged due to internal coolant leak.

Rear axle (Figure 2):

Drip container is overflowing:

- Coolant leaking from active chamber.

Drip container is empty:

- Coolant leaking from active chamber, particularly on vehicles with low mileage.

Figure 2: (1) Drain plug.

The power electronics must not be replaced if the electric drive motor is leaking.

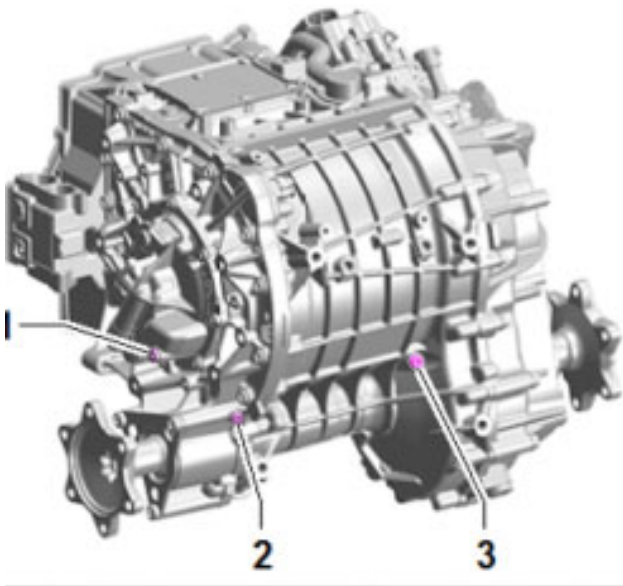
Front axle (Figure 3):

- Coolant leaking from active chamber.

Figure 3: 1) *Resolver cover:* A few milliliters of coolant leakage is not an issue from a technical perspective. 2) *Active chamber:* No coolant may escape from the bores.
