### Q4 e-tron, and Q4 Sportback e-tron

91 PSS Reversing camera - rear corner view cannot be activated via the MMI

Transaction No.: **2077066/1**

Release date: Feb 26, 2025

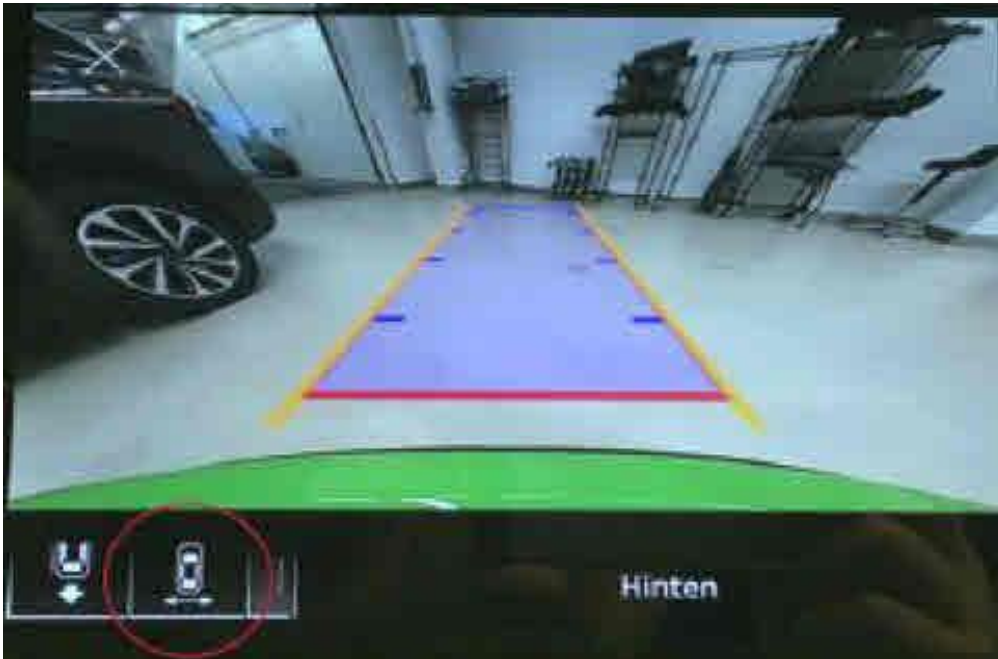
The reversing camera view cannot be changed via the MMI. The rear corner view cannot be activated.

Please compare the complaint to the attached image.

Software issue. The soft keys shown have no function and should not appear in the reversing camera view.

1. Explain to the customer that this matter is being reviewed, and you will be advised if any action is determined to be needed. A result should be available by the end of the 2nd quarter of 2025 (subject to change) and that no repairs are necessary at this point.

2. Do not replace any components for this condition since this will not resolve the customer's concern.
3. Create a PSS record in the PSS application through the Pending Service Solutions (PSS) link in AccessAudi (under *Related Links >> Service*).
