Service Bulletin

Bulletin No.: 25-NA-047

Subject: Information on A/C Inoperative/Heat Dropping Out, Whistling Noise - Service High Voltage Message - DTC P0534 Set

Brand:	Model:	Model Year:		Build Date:		Engine:	Transmission:
		from	to	from	to		
Chevrolet	Blazer EV	2024	2025

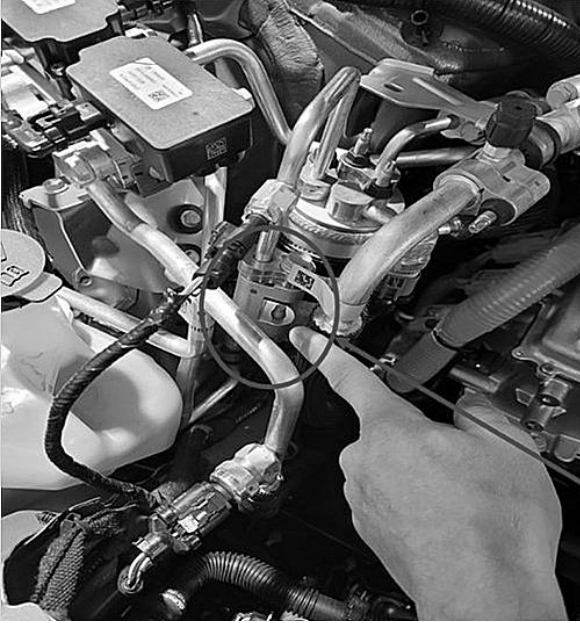
6856025

1. Set the HVAC system to auto high (Max Heat).
2. Using GDS2 monitor refrigerant temperature sensors 6 and 8. There should be a minimum of 50°F (10°C) difference between them.
3. Monitor Air Conditioning Condenser Refrigerant Flow Valve-External Command for a reading of zero.
 - If the variance between sensors 6 and 8 is more than 50°F (10°C) or the flow valve command is more than zero, follow SI diagnostics for the code or symptoms experienced.

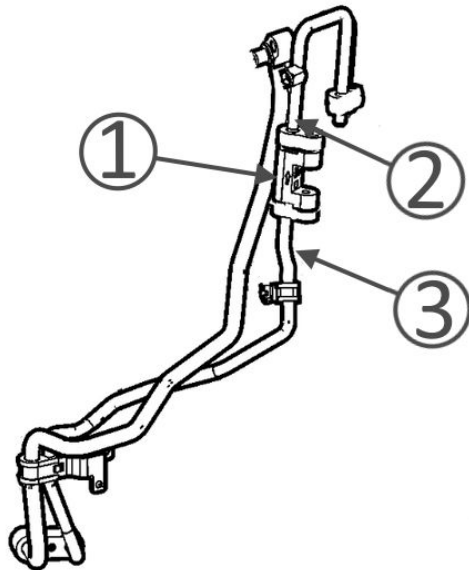
6856045

- If the variance is 50 deg or less and the flow valve command is zero, verify the reading by measuring the temperature above (2) and below (3) the AC condenser check valve (1) by utilizing an infrared temperature gun.
 - If the variance is less than 50 deg. inspect to make sure the arrow on the check valve is pointing up in the direction of refrigerant flow and then remove and inspect the valve.
4. Inspect the pintle and spring to ensure they are not loose or missing from the check valve. When the valve is shaken, it should not rattle.

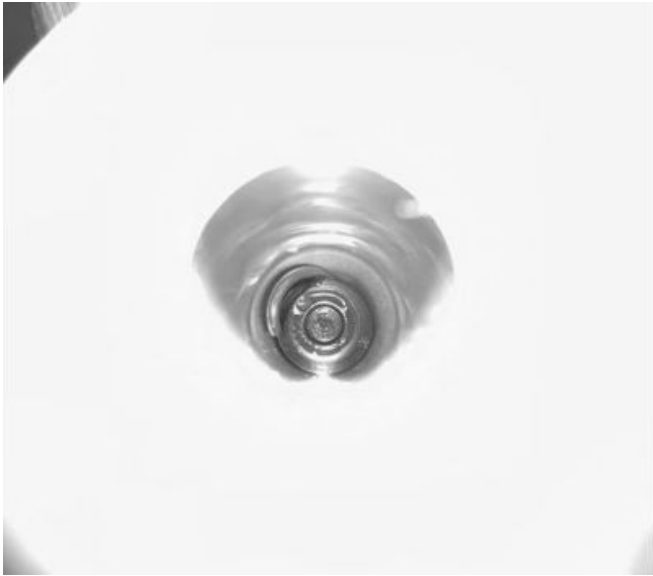
6856028

5. Inspect the seals for being pinched or cut.

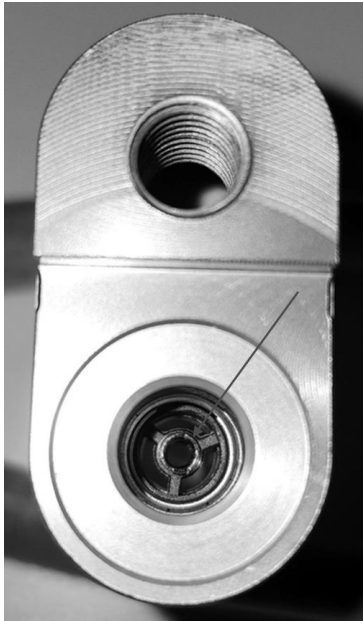
6856029

Note: The graphic above indicates that the pintle has fallen out of the check valve.

6. If any damage is noted to the check valve, it should be replaced.

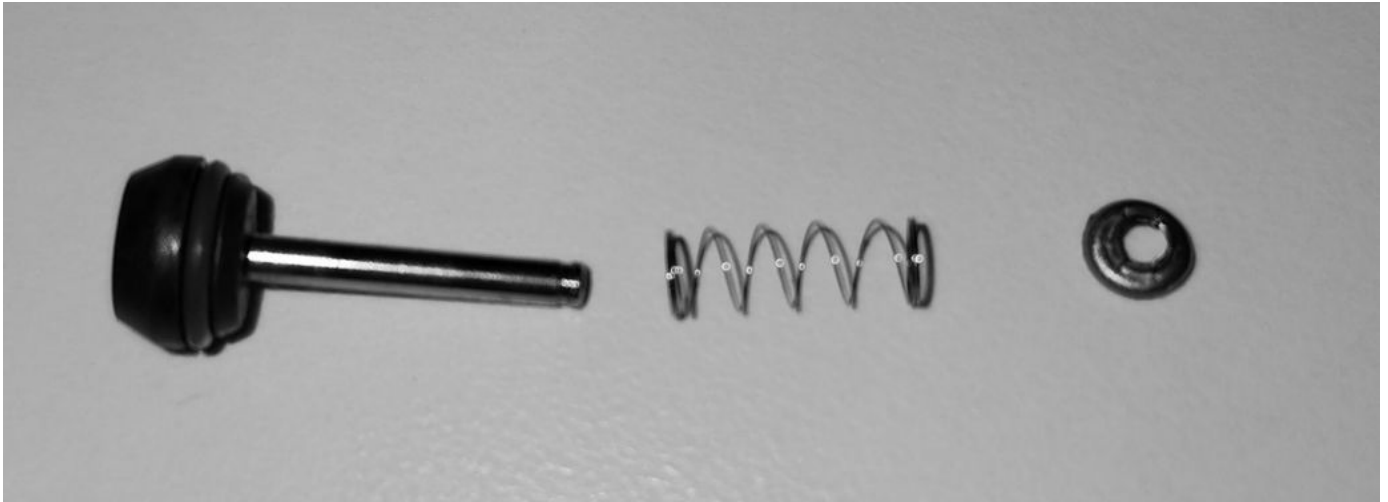
6856030

Note: All valve parts MUST be accounted for if the valve comes apart. These are the 3 components of the valve internals. If these are left in the system, it will fail again.

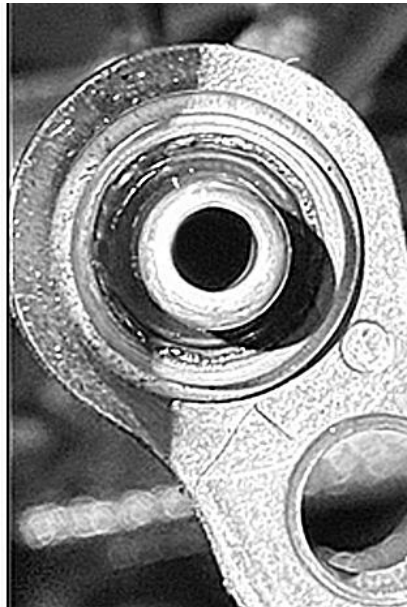
6856031

7. If no damage is noted in the valve or before replacing the valve, if it is damaged, inspect the opening in the pipe where the lower end of the check valve connects.
 - The opening should be no less than 6mm in diameter and should be centered in the pipe.
8. Test the size of the opening by attempting to insert a 6mm drill bit. See photo below of an improperly formed line

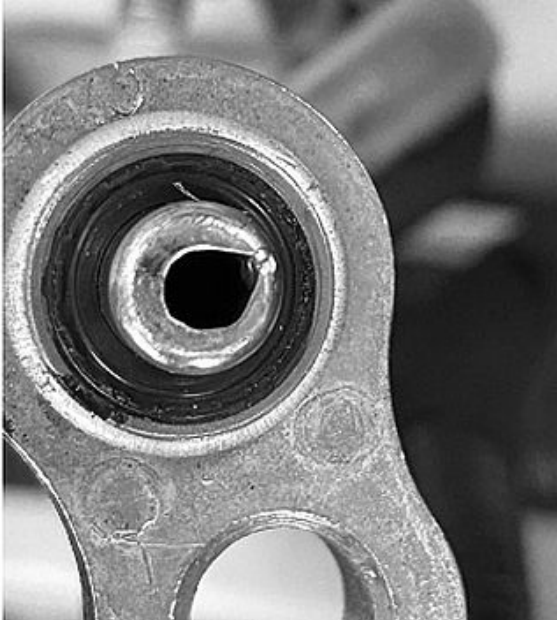
6856033

Important: If the opening is undersize or off center, it will need to be enlarged and centered using the procedure below. THERE SHOULD BE NO BURR ON THE LINE AT ALL, IT SHOULD BE EVEN AND SMOOTH ALL THE WAY DOWN THE PIPE. If the pipe is not repaired, it will damage the new valve.

- If the line is severely damaged so that it cannot be modified, it will need to be replaced.

1. Remove the pipe from the vehicle.
2. Insert a piece of a paper shop towel into the pipe to catch any shavings that may drop in.
3. Using a clean 6mm drill bit, apply only hand pressure gently reaming the hole to enlarge the opening to 6 mm and center it. (if the hole is slightly larger than 6 mm when done this is acceptable).
4. After the hole is modified, use shop air on the opposite end of the line to remove the paper towel and push out any debris.
5. Thoroughly blow the pipe out from both ends to remove any particles that may have fallen into the pipe.
6. Reinstall the pipe with a new valve, if necessary, recharge system and retest temperatures using GDS2.
7. Test drive the vehicle to confirm the repair.

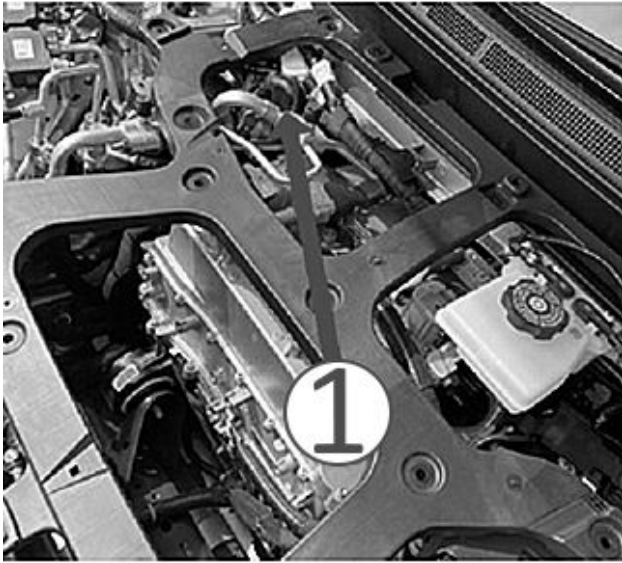
6856038

1. Inspect for the presence of a lift bracket in the area shown in the graphic above.
2. If a bracket is present, remove it and inspect the AC line for damage.
 - ⇒ If damage is found, replace the AC line.
3. Remove the bracket and discard it. This was installed for assembly plant use and is not necessary.
 - ⇒ If no damage is found, remove and discard the bracket to prevent damage to the line in the future.
