SIB 52 04 25

2025-03-19

REAR SEAT UNLOCKED CHECK CONTROL MSG RIGHT SECOND-ROW SEATBACK REST MICROSWITCH

E-Series	Model Description	Production Date
U11	X1 Sports Activity Vehicle	Vehicles produced up to March 1, 2025

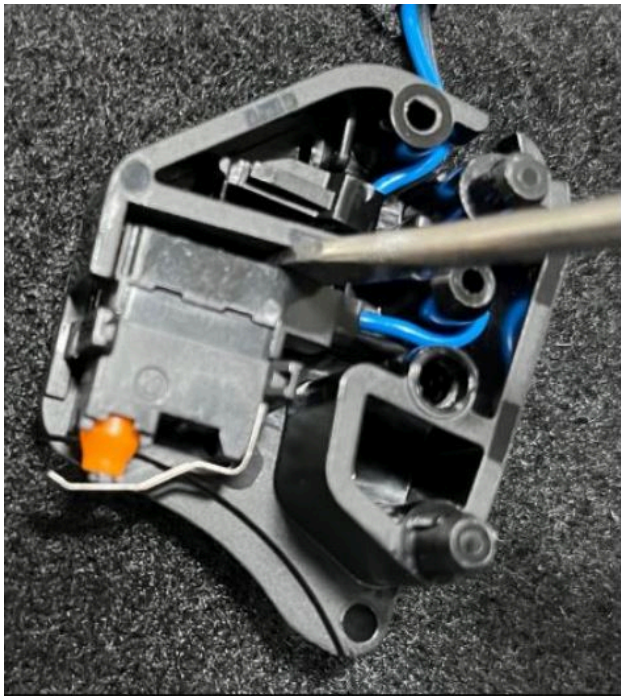
The dimensions on the original factory-installed right side second-row seatback rest microswitch assembly may not be correct. If so, this causes the microswitch to move when the seat backrest is raised to the upright seating position.

The screwdriver tip (left) points to the gap between the microswitch and the plastic housing in which it mounts.

This is the gap that must be eliminated to correct this issue. This can be done by installing a new microswitch.

If movement of the switch is found, replace the microswitch for the backrest of the right second-row seat.

1. Test operation of the microswitch 52205A3B219 for the backrest of the right second-row seat with a voltmeter to ensure there is no internal fault.
2. If movement of the microswitch is found, replace the microswitch for the backrest of the right second-row seat.
3. Retest the microswitch operation.
