SIB 01 09 24

F15 I12 PHEV HV BATTERY CELL MODULE TEMPERATURE SENSORS  
EXT LTD WTY (ELW) 10/120

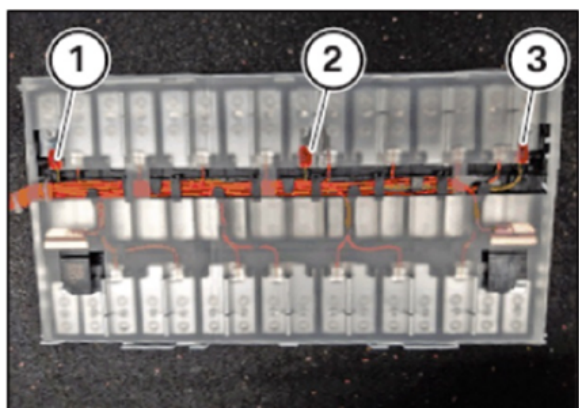
The measured value for an individual temperature sensor inside each of the HV battery cell modules is plausibility checked against all the other HV battery cell modules' temperature sensors.

Over time, the temperature sensors may fail, this can cause the measured values of one or more of the temperature sensors to deviate from specification. The vehicle's monitoring system may interpret these deviating temperature sensor values as either implausible or impermissible.

Should this occur, the corresponding Check Control Messages (CCM) will be generated and displayed, the vehicle's monitoring system may also store the corresponding fault codes, and the Malfunction Indicator Lamp (MIL) may illuminate.

If there are failed cell module temperature sensors, the test plan will instruct you to replace the applicable HV cell module's internal temperature sensors (NTC repair kit), one repair kit per cell module.
