SIB 51 07 23

UPPER AND LOWER TAILGATE DIAGNOSIS

This Service Information Bulletin (Revision 04) replaces SI B51 07 23 **dated April 2024**.

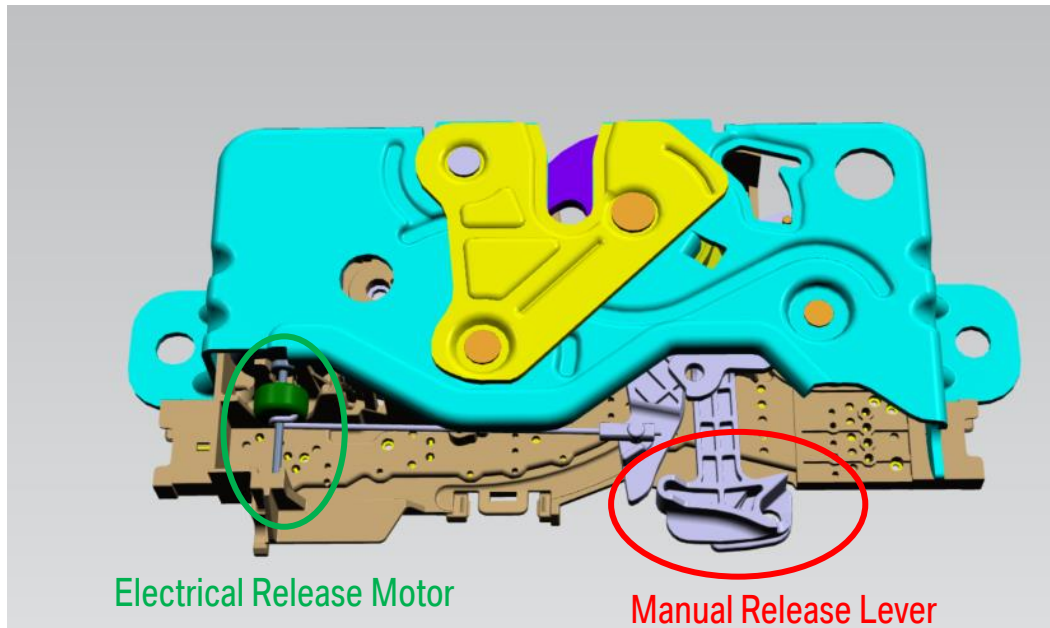
INSTRUCTION FOR LATCH RELEASE

To release the latch manually, the lower tailgate trim will have to be removed/broken. There is a lever that can be pulled directly on the latch to release it.

Note:
Emergency release: G0x Models do not have a tailgate emergency release pull.

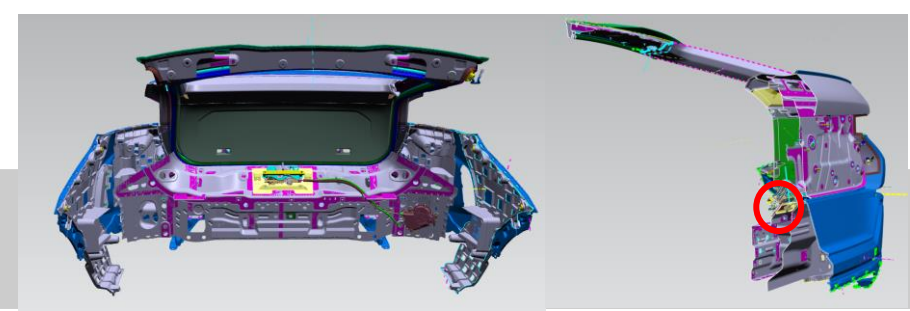
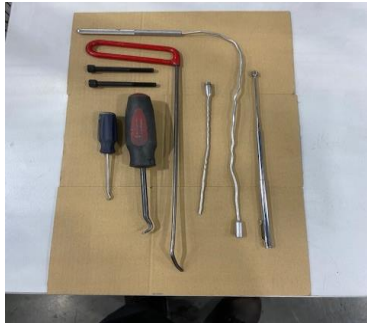
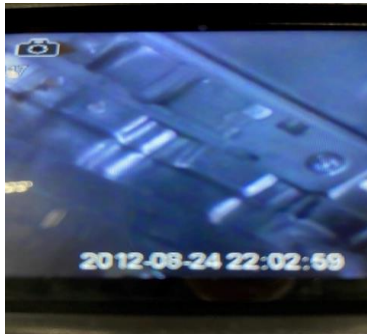
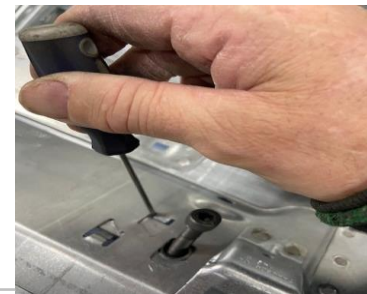
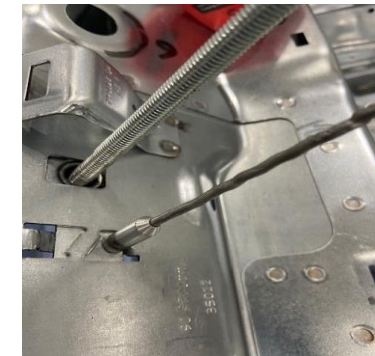
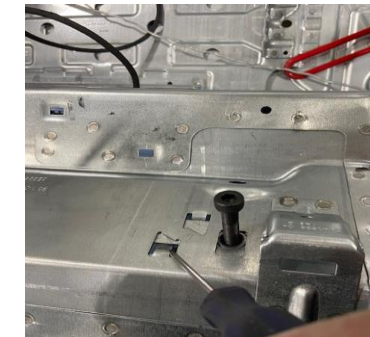
G06 TAILGATE SCA NUT PLATE REPAIR PROCESS

This nut plate is only tabbed to the body so that it can free float for adjustment (Latch).

When rework is performed on the latch or in this area, it is possible that the nut plate gets knock down into the body.

1. Use bore scope to locate fallen plate
2. Orient plate with face up and notches forward
3. With pick push the lower tabs down slightly so the plate will load on to them.

4. Hold nut plate steady with long pick, and place magnet in each of the 8x1.25 nuts to pull nut plate up evenly at the same time.
5. Carefully lift nut plate with magnets and place onto the lower tabs

6. Hold nut plate in position with magnet while installing 8x1.25 bolt to hold plate

7. While holding plate in position with bolt use pick to re-secure tabs.
8. Once plate is secured, re-install SCA latch.

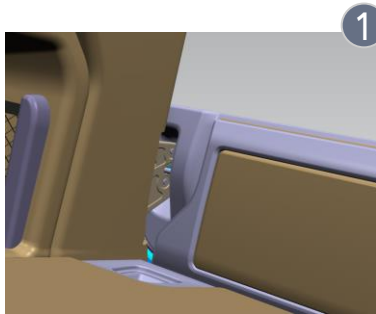
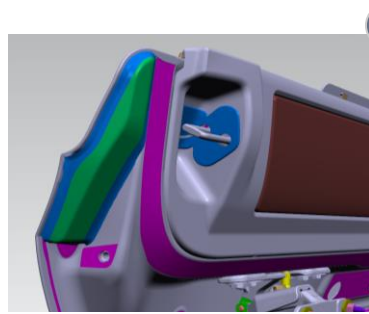
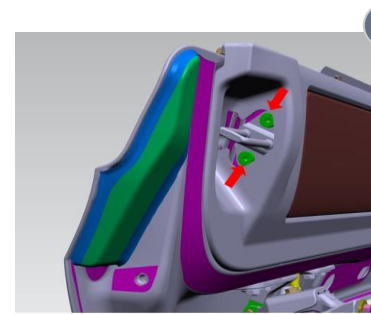
METHOD 1:

Lower Tailgate does not open fully.

Try closing the tailgate by manually pushing in the middle and check for any resistance in the latch before the SCA engages. If there is noticeable wear/resistance, striker drag is the cause.

Step 1: With tailgate closed, check position of striker in latch.

Step 2: Open latch and remove grogmet around striker.

Step 3: Loosen bolts enough to make adjustment to striker. Retighten screws, close tailgate, and check striker position in latch. Repeat this step as necessary to achieve appropriate striker position. Reinstall grogmet

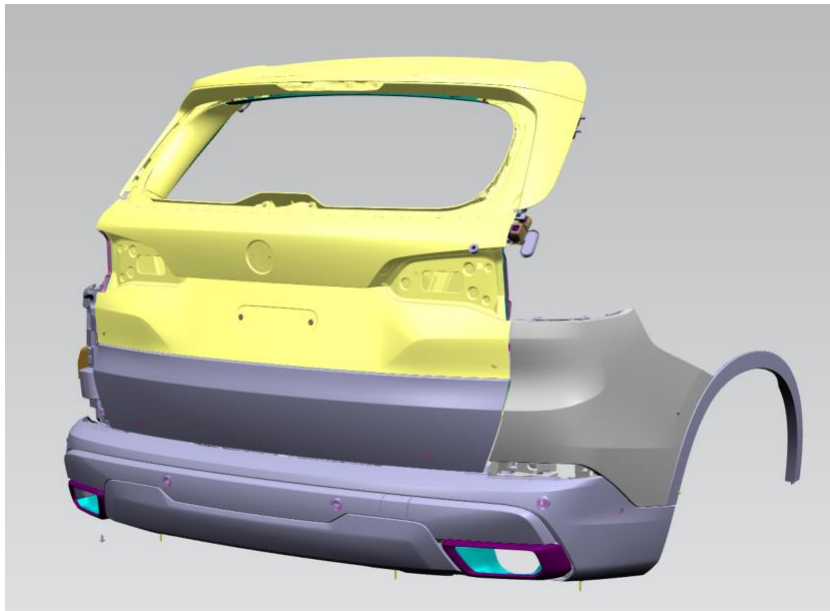
UPPER TAILGATE DOES MOVE WHILE CLOSING (45%)

Upper tailgate does move while closing (45%):

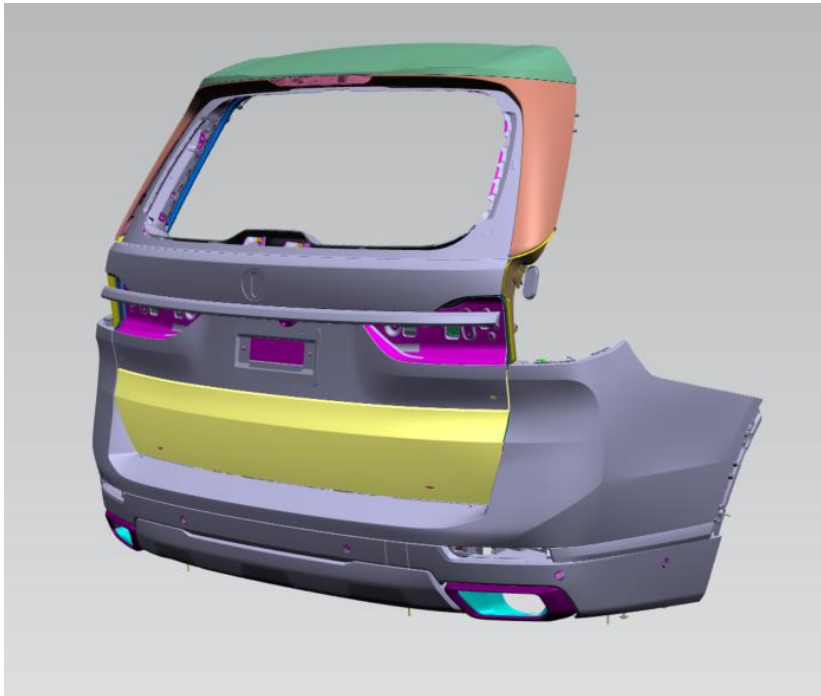
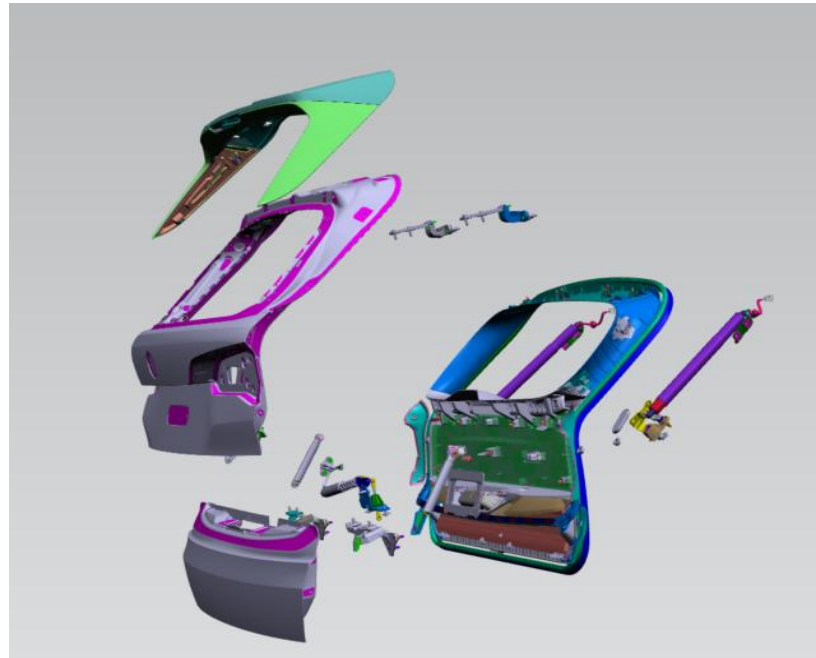
032W DELETION OF AUTOMATIC CLOSING OF LOWER SECTION OF TAILGATE

Lower tailgate is inoperative, the switches are visible for the system.

Check the vehicle VO for option code (**032W Deletion of automatic closing of lower section of tailgate**).

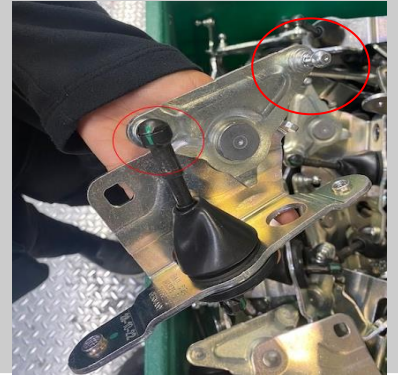
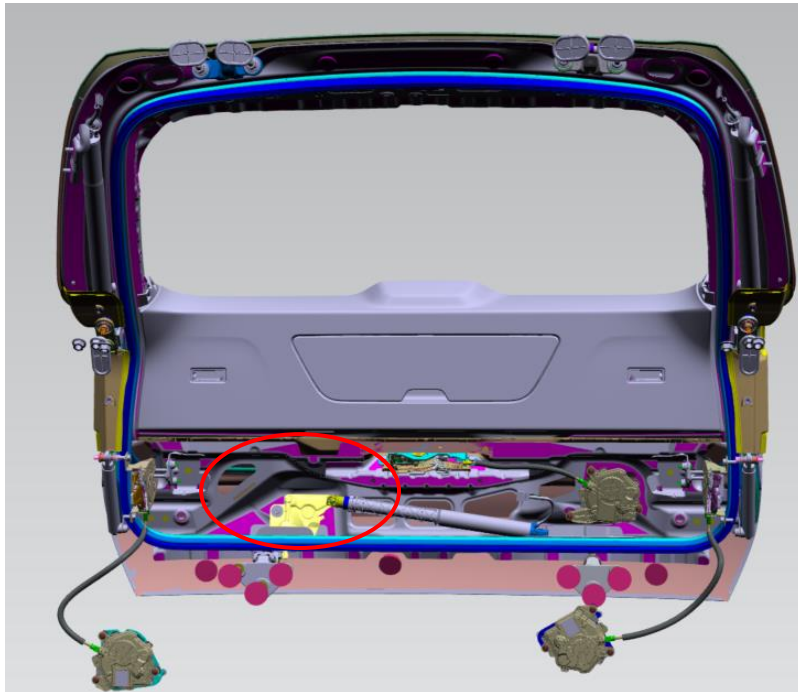
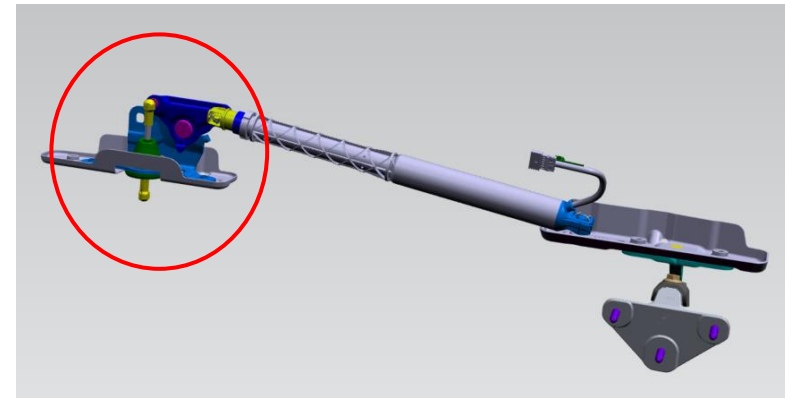
SPINDLE DRIVE CONNECTION TO LINKAGE(S).

Lower tailgate is not moving/opening when button pressed.

Recommendation:
Confirm the lower tailgate connection linkage.

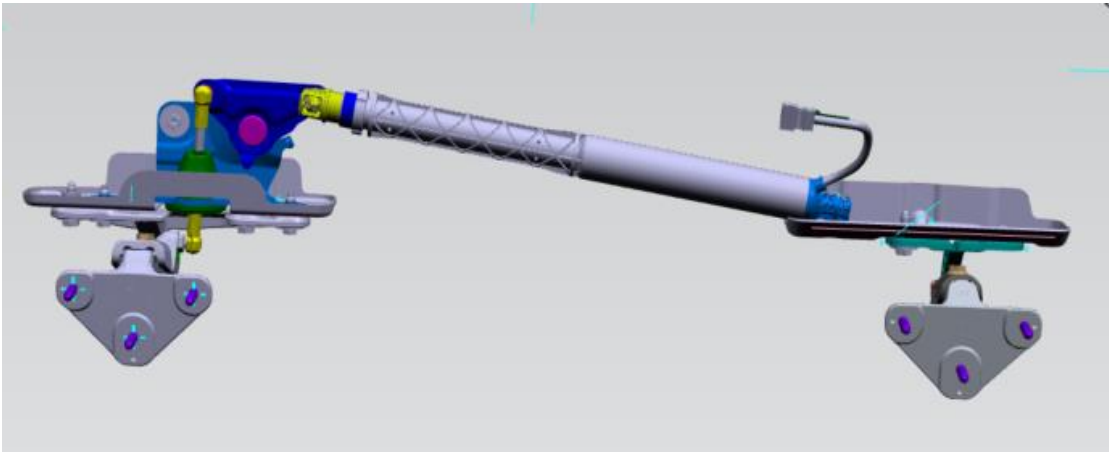
LOWER SPINDLE DRIVE (FAULTY)

Lower tailgate won't open/close.

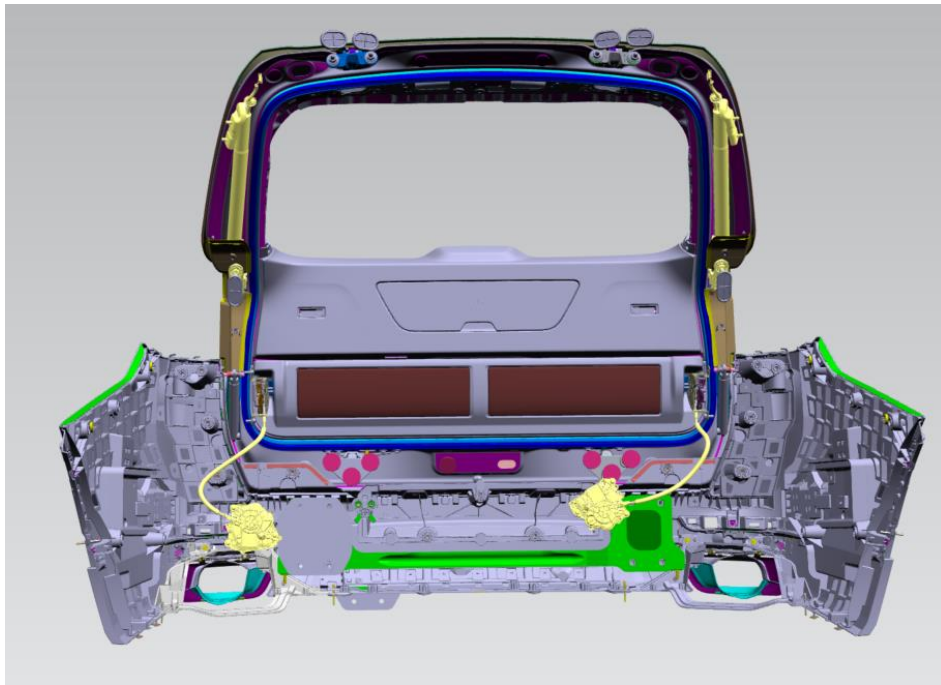
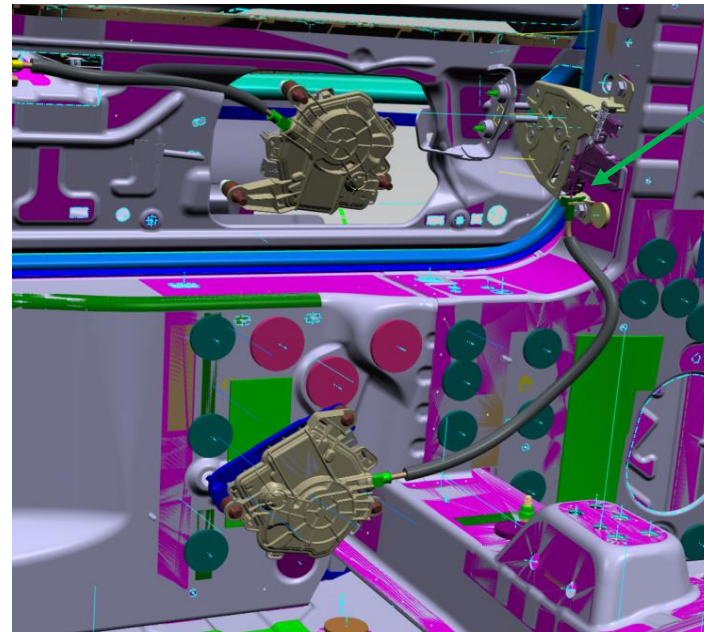
LOWER TAILGATE SCA CABLE CONNECTION TO LATCH

The tailgate soft close actuator will not pull the lower tailgate all the way in when closing.

It will open and close correctly, but not have the last pull-in. The HKFM does not see the signal from the latch that the SCA cable was pulled because the side cable is not connected (as show in the photo).

Confirm Bowden cable clip → Clip can be easily broken and if it was reassembled can create a situation with not enough tension on the cable to properly function the SCA.

Inspect the cable connection to and from the SCA.

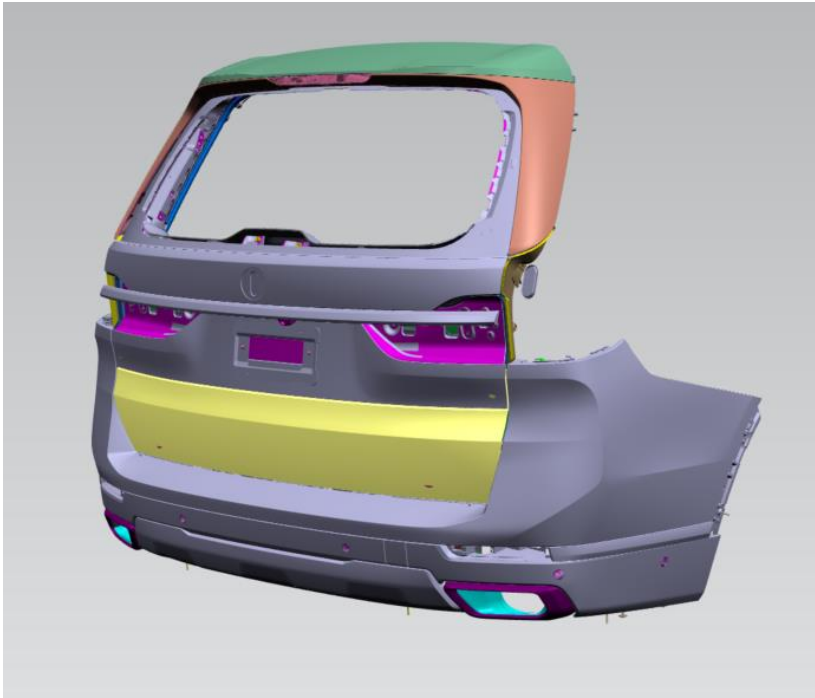
LOWER TAILGATE UNLATCHES BUT DOES NOT LOWER [ONLY WHEN LOWER TAILGATE IS ACTIVATED]

Lower tailgate malfunction, not opening intermittently.

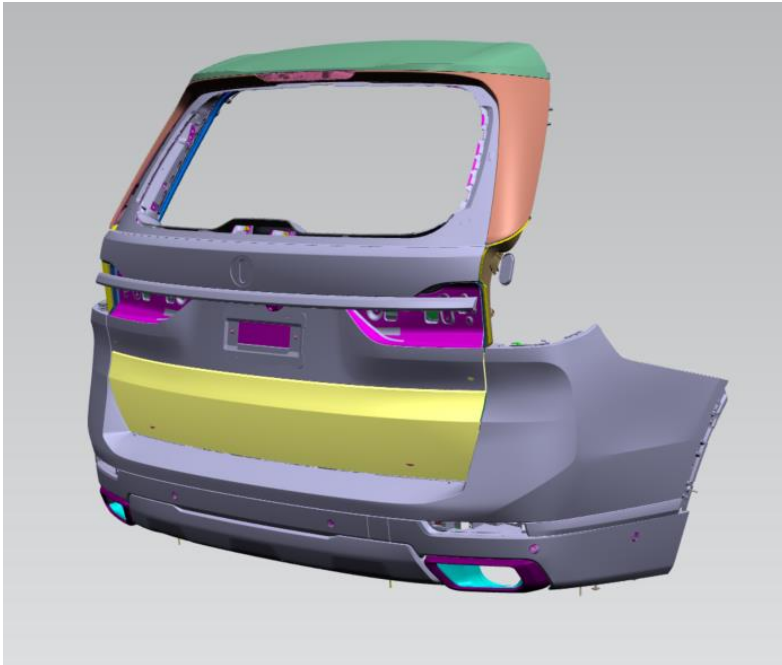
LOWER TAILGATE DOES NOT CLOSE (WHEN BUTTON PUSHED)

Lower tailgate won't open/close.

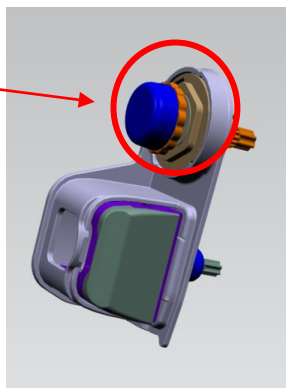
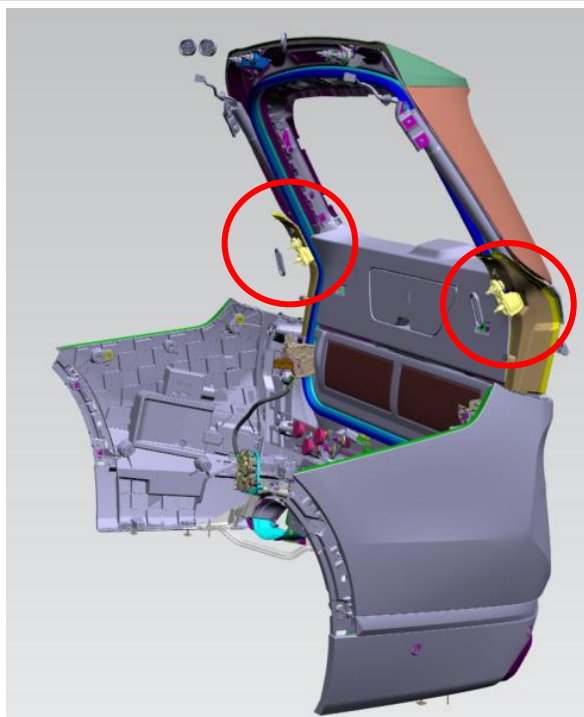
RATTLE NOISE- TAILGATE POORLY ADJUSTED

Upper tailgate poorly adjusted/fitted
Noise while driving/ static noise.

- Adjust the tailgate.
- Adjust the bump stops.
- Adjust the latch.

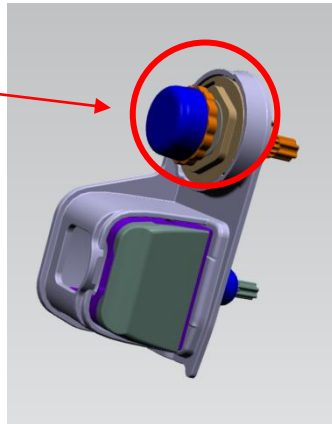
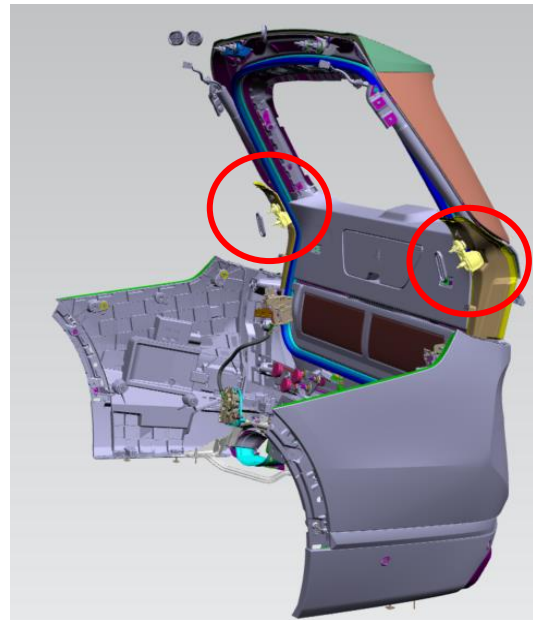
POPPING NOISE

Clunking noise while opening the tailgate.
Function noise.

- Adjust the tailgate.
- Adjust the bump stops.
- Adjust the latch.

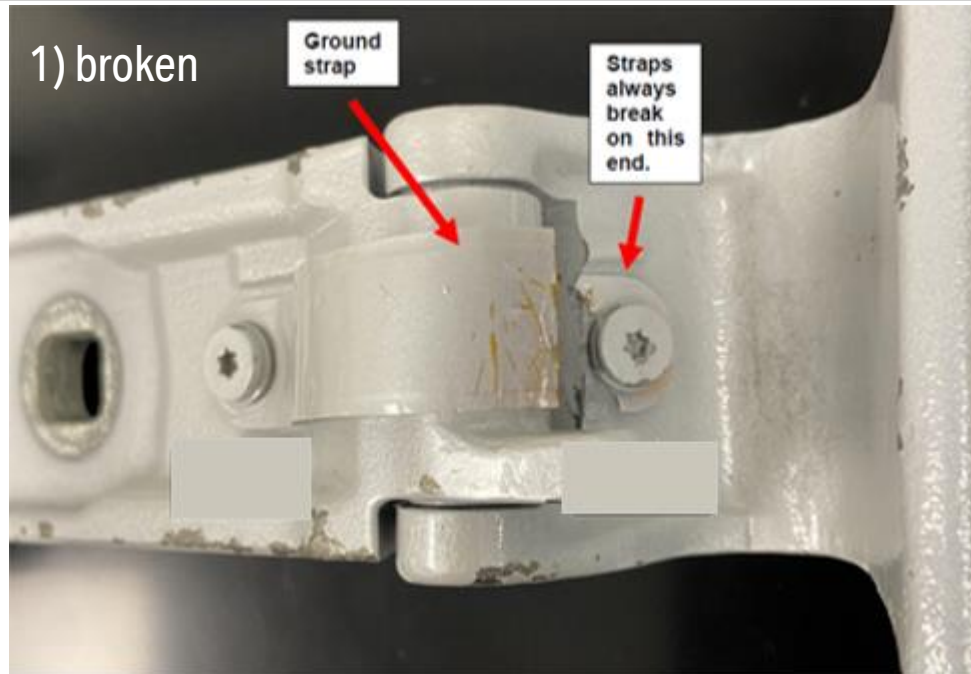
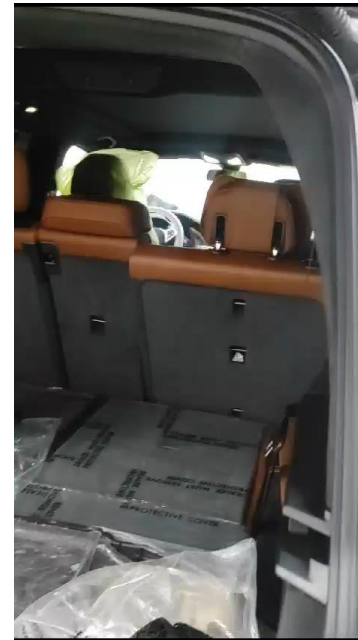
HINGE (GROUND STRAP)

Noise on Hinge

- 1) Ground strap broken
- 2) Ground strap rubbing on hinge

- 1) Replace hinge when strap is broken
- 2) Use fishbone to try flatten strap as shown in illustration below if the hinge is not broken but rubbing on hinge causing a noise

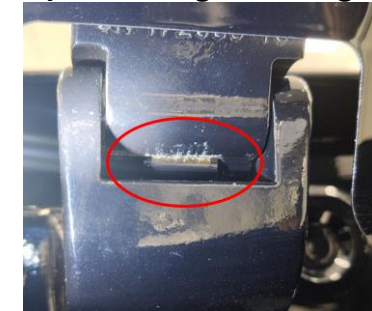
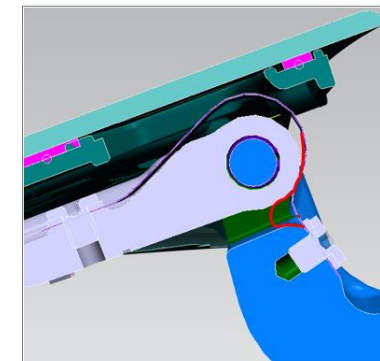
2) Ground strap rubbing on hinge

Defect status _ Masseband fold into gap of hinge

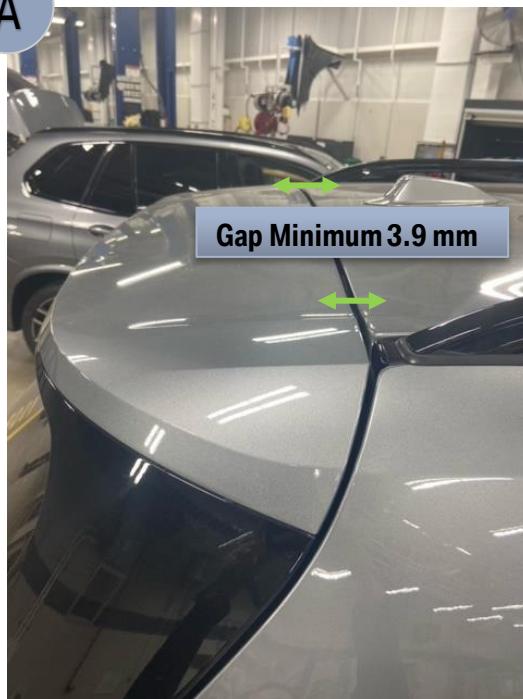
A

Scrapping/popping noise due to spoiler contacting the roof.

- A. Confirm the tailgate spoiler setting. (roof gap in hatch closed position 3.9mm minimum gap)
- B. If touching condition is mainly one side (e.g. RHS) check the single part spoiler, see illustration below for misalignment
- C. If no noticeable misalignment on single part spoiler, swap outer shims of spoiler, so that touching side has lower dimension shim.
- D. Make sure there is no over flush condition to roof!
- E. Confirm PVC condition → if excessive run off, reduce the thickness of the PVC as shown in the photo.

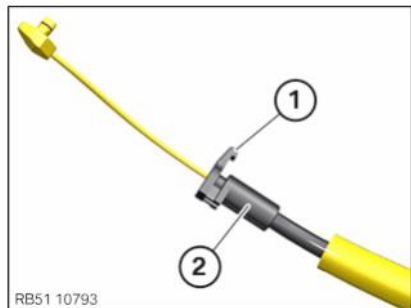
SCA (CENTER) UPPER HATCH CONNECTION

Upper hatch won't close fully into latch

- Check the retaining lug (1) on the Bowden cable (2).

- » Retaining lug (1) is damaged or not present.

Check all routing/connections of soft close / latch system and make sure the ball pins are engaged.

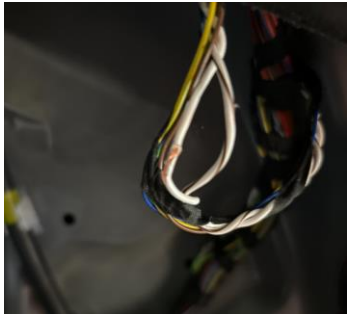
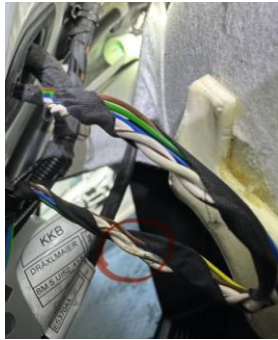
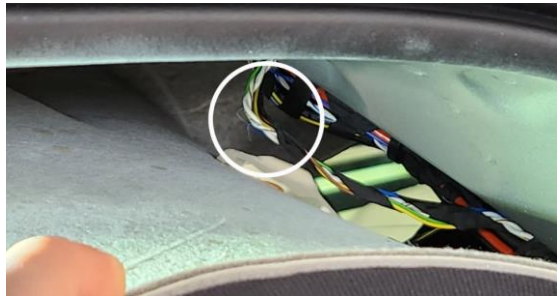
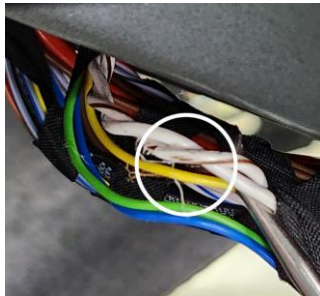
RHS

Upper Tailgate unlatches but does not open

Check for any pinched/chafed wires especially under D- pillar/headliner area (spindle harness branch main harness)
