## SIB 63 10 23

### MOISTURE/CONDENSATION IN THE REAR TAILLAMPS

### MODEL

E-Series	Model Description
G45	X3 Sports Activity Vehicle
G60	5 Series Sedan
U10	X2 Sport Activity Coupe
U11	X1 Sport Activity Vehicle

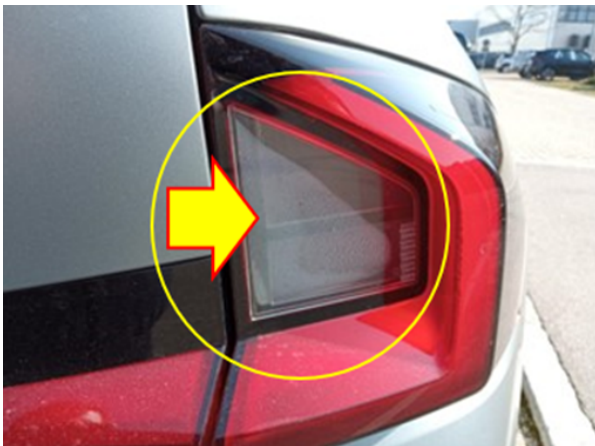
#### A. Normal/natural condensation.

Condensation is present in the inner surface in one or both (inner and/or outer) taillamps.

Water inside the taillamps can be caused by two situations:

- Thermal/environmental conditions that result in the formation of condensation is not a defect.
- Water/moisture in the taillamp housing is considered a defect.

If normal environmental conditions are the cause of the condensation, no correction is required.

- The taillamps will dissipate the condensation through venting. This venting process should be completed within 24 hours with the vehicle sitting in temperatures of 68 – 77 degrees Fahrenheit.
