REFERENCE:	TSB: 08-016-25 REV. A GROUP: 08 - Electrical	Date:	March 18, 2025	REVISION:	08-016-25
VEHICLES AFFECTED:	2025 (DT) RAM 1500 Pickup This bulletin applies to vehicles equipped with a Wireless Charging Pad (Sales Code RFX) or Dual Wireless Charging Pad (Sales Code CMS).	MARKET APPLICABILITY:			
		<input checked="" type="checkbox"/> NA		<input checked="" type="checkbox"/> MEA	
		<input checked="" type="checkbox"/> SA		<input checked="" type="checkbox"/> IAP	
		<input type="checkbox"/> EE		<input type="checkbox"/> CH	
CUSTOMER SYMPTOM:	Customers may comment on the following: <ul style="list-style-type: none"> Key Fob intermittently is not detected when the key fob is placed at or near the wireless charger. 				
CAUSE:	Radio Frequency (RF) interference

This bulletin supersedes Technical Service Bulletin (TSB) 08-016-25, date of issue January 23, 2025, which should be removed from your files. All revisions are highlighted with ****asterisks**** and updated text on how to verify Symptom/Condition.

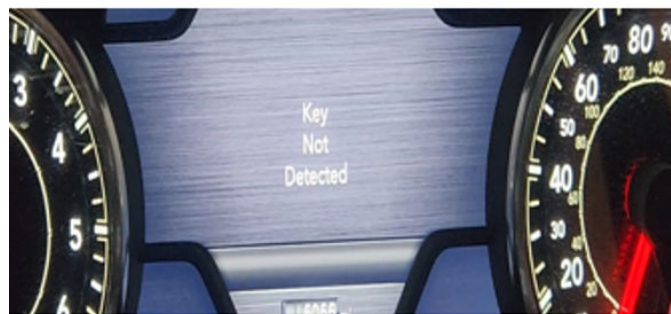
- NOTE:**
- The key fob needs to be at least 203 mm (8 in.) away from the wireless charger and/or do not put a phone on the wireless charger before the ignition is ON.
 - When the ignition is OFF and the key fob near an active wireless charger, interference can occur leading to the key fob not being detected by the vehicle **Fig. 1**.

Fig. 1
Key Not Detected

****To verify if the vehicle has this Symptom/Condition, perform the following: Remove any phones from the wireless charger. Verify if the key fob functions/is detected now. If key fob functions/is detected now, replace charger.****
