Abnormal Hood Fluttering and/or Vibration While Driving 25 mph or Higher

Service Category Vehicle Exterior

Section Body Structure

YEAR(S)	MODEL(S)	ADDITIONAL INFORMATION
2024	GX550

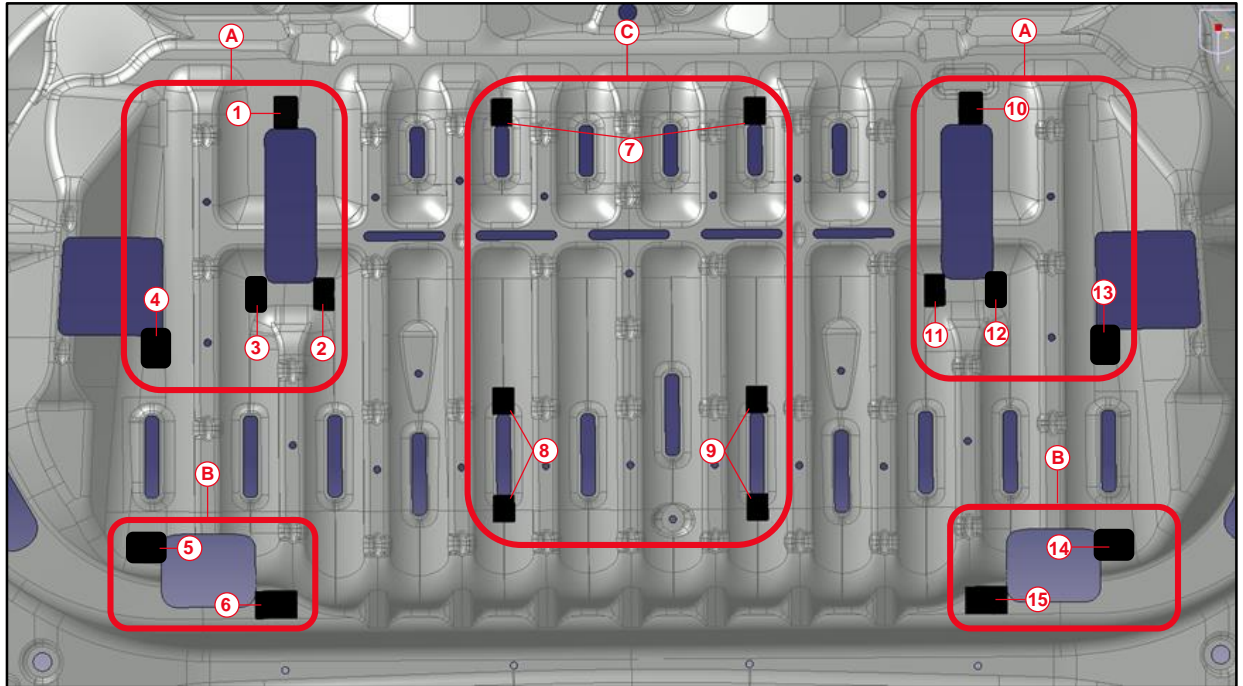
Figure 2. Hood Location for Urethane Foam

Some 2024 model year GX 550 vehicles may exhibit an abnormal hood fluttering and/or vibration while driving 25 mph or higher. The mastic between the outer panel and the hood brace may have separated. Follow the Repair Procedure in this bulletin to address this condition.

4. Prepare the hood for urethane foam installation.

- Urethane foam blocks for Section A and Section B will need 3M™ NVH Dampening Material added to the block before it is added in between the outer hood panel and hood brace.
- Section C does NOT receive 3M™ NVH Dampening Material before installation.

- Use scissors to cut the C1 urethane foam block in half lengthwise.
- Place the two halves at their corresponding locations between the outer hood and hood brace. See Figure 2.
- Repeat these steps for C2 and C3.

- Immediately insert each block into its corresponding location between the outer hood and hood brace. See Figure 2.
