<b>REFERENCE:</b>	<b>TSB:</b> 08-071-25 <b>GROUP:</b> 08 - Electrical	<b>Date:</b>	March 20, 2025	<b>REVISION:</b>	—
<b>VEHICLES AFFECTED:</b>	<b>2024 (LB) Dodge Charger</b> This bulletin applies to vehicles equipped with 400V G2500 FR/RR Elec Drive Motors (Sales Code ELD).			<b>MARKET APPLICABILITY:</b>	
				<input checked="" type="checkbox"/> NA	<input checked="" type="checkbox"/> MEA
				<input checked="" type="checkbox"/> SA	<input checked="" type="checkbox"/> IAP
				<input checked="" type="checkbox"/> EE	<input checked="" type="checkbox"/> CH
<b>CUSTOMER SYMPTOM:</b>	<p>Customers may experience a Malfunction Indicator Lamp (MIL) illumination and the vehicle may exhibit/set one or more the following Diagnostic Trouble Codes (DTCs):</p> <ul style="list-style-type: none"> <li>• P167B-00 - Controlled System Shutdown.</li> <li>• P0CA6-00 - Hybrid/EV Battery Charging Current High.</li> </ul> <p><b>NOTE: If the following DTCs are present/active in the BPCM, Battery Pack replacement will be required. Guided Diagnostics will prompt you for the repair action if the diagnostic is present on the vehicle.</b></p> <ul style="list-style-type: none"> <li>• P0AA1-00 - Hybrid/EV Battery Positi

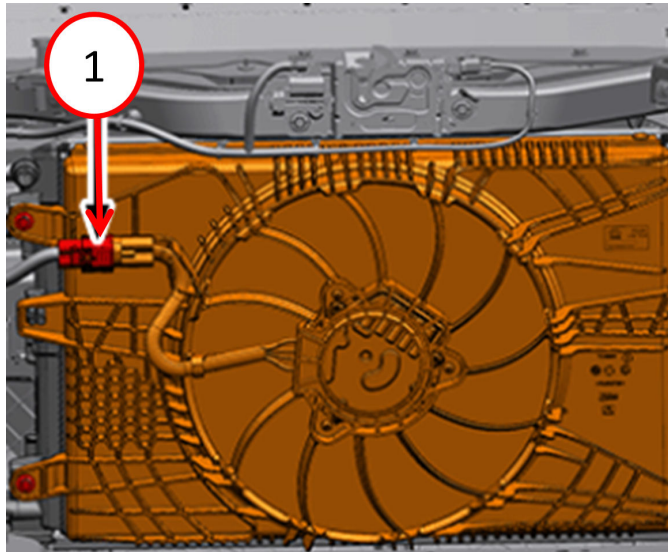
**Fig. 1**  
Cooling Fan Assembly

1 - Wire Harness To Disconnect/Connect

4. Disconnect the cooling fan wire harness connector [Fig. 1](#).

21. Connect the cooling fan wire harness connector [Fig. 1](#).
