## Technical Service Bulletin (TSB) High Voltage Wiring Repair

| REFERENCE: | TSB: 08-082-25<br>GROUP: 08 - Electrical | Date: | March 21, 2025 | REVISION: | — |
| VEHICLES AFFECTED: | 2021 - 2024 (JL) Jeep Wrangler<br>This bulletin applies to vehicles equipped with the 2.0L I4 DOHC DI Turbo PHEV Engine (Sales Code ECX). | | | MARKET APPLICABILITY:<br><div><input type="checkbox"/> NA<input type="checkbox"/> MEA</div> <div><input type="checkbox"/> SA<input type="checkbox"/> IAP</div> <div><input type="checkbox"/> EE<input checked="" type="checkbox"/> CH</div> | |
| CAUSE: | Water intrusion | | | | |

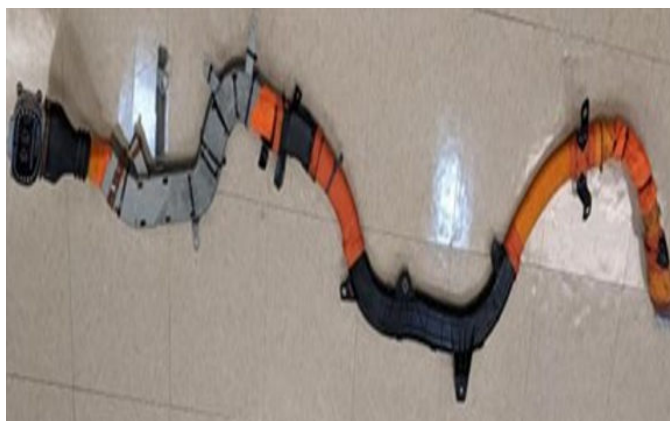
**Fig. 1**  
HV Cable Harness

2. Inspect the PIM to P2 HV cable harness for rub through or damage near the transmission driveshaft CV joint shield.

3. Is the HV cable harness damaged or rubbed through near the transmission driveshaft CV joint shield?
4.
  - YES>>> Replace the PIM to Transmission HV cable harness. Proceed to [Step 17](#)
  - NO>>> Proceed to [Step 5](#).
5. Using a suitable protective cover and tape, protect both ends of the HV cable harness connectors to prevent dust and contaminants from entry [Fig. 2](#).
6. Remove the plastic zip tie on the HV cable harness connector rubber sleeve [Fig. 2](#).

1. Remove the PIM to Transmission HV cable harness [Fig. 1](#). Refer to the detailed service procedures available in DealerCONNECT/Service Library under: Service Info> 12 - Electrified Powertrain System / High Voltage Battery / Cables / Removal and Installation.

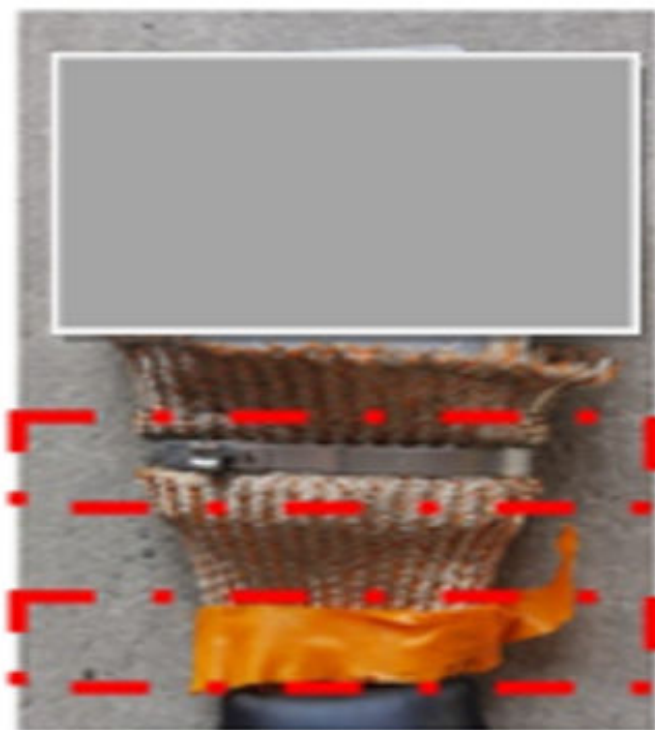
**Fig. 5**

Proper HV Cable Harness Connector Mesh And Clamp Positioning

- If the oxidization is too severe and cannot be cleaned, sand polish the groove, (**DO NOT over polish**).
  - Use the air compressor gun to blow away the dust and make the area clean.
12. Put back the metal mesh shielding layer around the HV cable harness connector and use the original metal clamp to secure the connector and shielding layer. Wrap with electrical tape [Fig. 5](#).

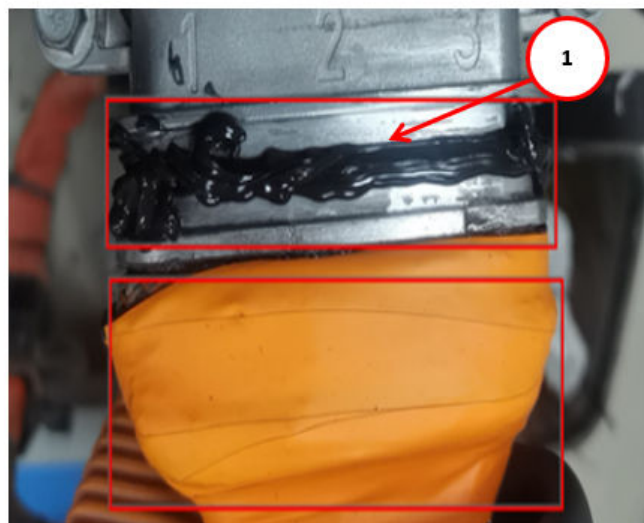
**Fig. 6**

HV Cable Harness Connector Sealed Using Darbound 2598

1 - Sealed HV Cable Harness Connector

13. Apply Darbond 2598 sealing compound evenly around the tightening area between the HV cable harness connector and the rubber sleeve in Zone A [Fig. 4](#) and [Fig. 6](#).
