# HYUNDAI

## Technical Service Bulletin

GROUP <b>BODY ELECTRICAL</b>	NUMBER <b>25-BE-005H</b>
DATE <b>MARCH 2025</b>	MODEL(S) <b>SEE BELOW</b>

**SUBJECT:** HORN ASSEMBLY REPLACEMENT  
(WARRANTY EXTENSION Z03)

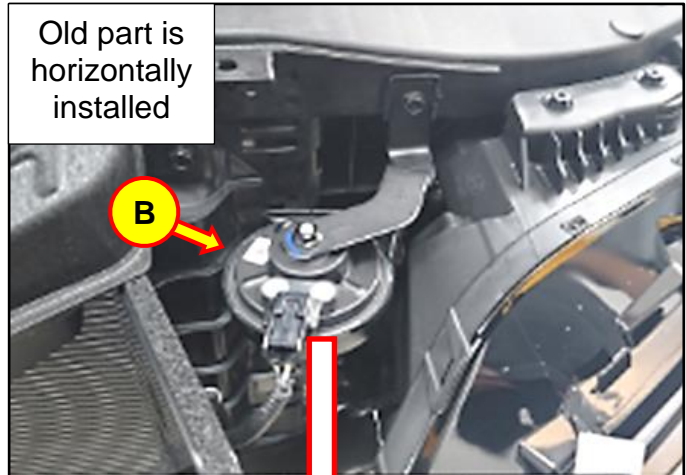
Old part is horizontally installed

3. Replace both horns (high and low) in a vertical orientation by connecting the horn connectors to the external wirings.

Ensure the horns (high and low) are installed vertically with the bell holes facing downward to prevent water intrusion.

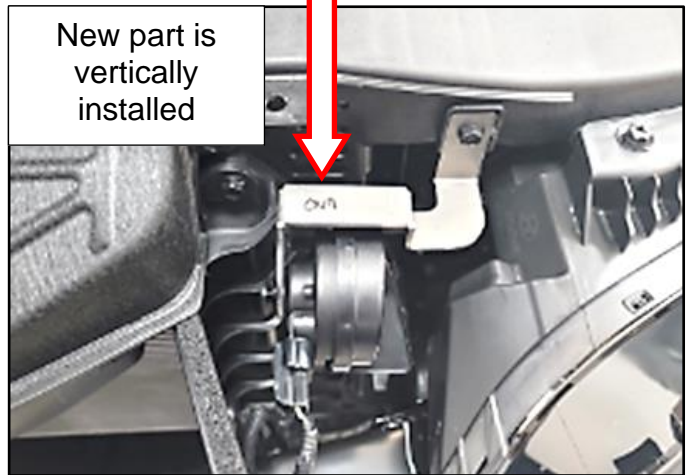
New part is vertically installed
