Technical Service Bulletin (TSB) Water Infiltration From Door Liner

REFERENCE:	TSB: 23-013-25 GROUP: 23 - Body	Date:	March 21, 2025	REVISION:	23-057-24
VEHICLES AFFECTED:	2024 (FG) FIAT 500e This bulletin applies to vehicles built on or after June 25, 2024 (MDH 0625XX) and on or before **September 25, 2024 (MDH 0925XX)** .	MARKET APPLICABILITY:			
		<input checked="" type="checkbox"/> NA		<input checked="" type="checkbox"/> MEA	
		<input checked="" type="checkbox"/> SA		<input checked="" type="checkbox"/> IAP	
		<input checked="" type="checkbox"/> EE		<input type="checkbox"/> CH	
CUSTOMER SYMPTOM:	Customers may experience the following: <ul style="list-style-type: none"> Passenger side kick plate and/or front carpet wet. 				
CAUSE:	Door liner damaged during assembly

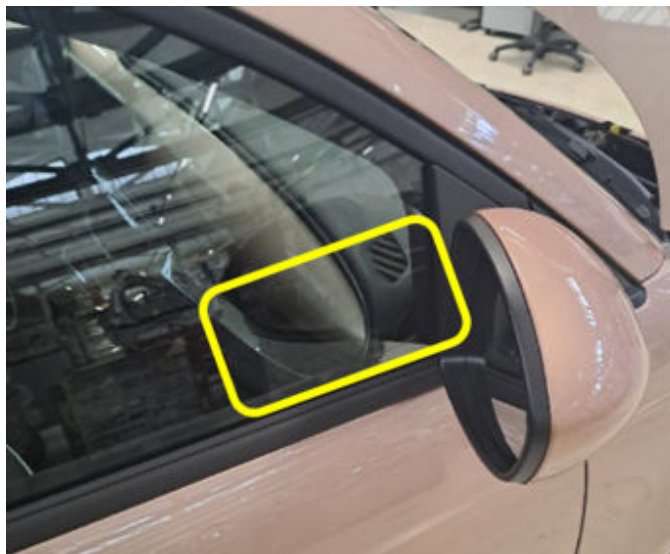
Fig. 1
Area To Water Test

1. With the window rolled all the way up and door completely closed, apply a water stream to the selected area in [Fig. 1](#) for five minutes.

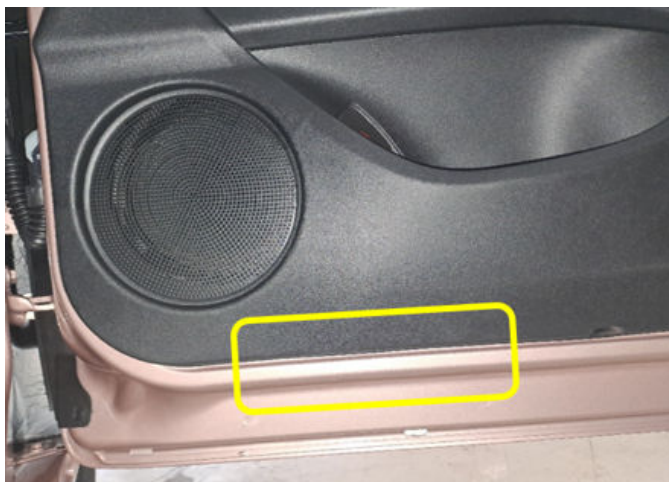
Fig. 2
Area Of Potential Leak

2. Open the door and check the area in [Fig. 2](#) for wetness/drips.

3. Is there wetness/drips at the area?
 - YES >>> Proceed to [Step 4](#).
 - NO >>> This bulletin is complete. Use Inspection LOP (23-20-22-AH) to close the active RSU.
4. Replace the door liner. Refer to the detailed service procedures listed in DealerCONNECT>Service Library under: 7005E10 - Front Side Door Interior Panel - R.R.
