**Technical Service Bulletin (TSB)**  
**Powertrain Control Module (PCM)**  
**Wiring Harness Contacting PCM Bracket**

<b>REFERENCE:</b>	<b>TSB:</b> 08-086-25 <b>GROUP:</b> 08 - Electrical	<b>Date:</b>	March 22, 2025	<b>REVISION:</b>	—
<b>VEHICLES AFFECTED:</b>	<b>2024 - 2025 (M6) Jeep Compass</b> <b>2024 - 2025 (H6) Jeep Meridian</b> This bulletin applies to vehicles built on or after April 01, 2024 (MDH 0401XX) and on or before February 05, 2025 (MDH 0205XX) equipped with the 2.0L I4 Turbo Diesel Engine w/ ESS (Sales Code EBS) and the 6-Speed C635 Manual Transmission (Sales Code DE1).			<b>MARKET APPLICABILITY:</b>	
				<input type="checkbox"/> NA	<input type="checkbox"/> MEA
				<input type="checkbox"/> SA	<input checked="" type="checkbox"/> IAP
				<input type="checkbox"/> EE	<input type="checkbox"/> CH
<b>CUSTOMER SYMPTOM:</b>	<b>Customers must experience a Malfunction Indicator Lamp (MIL) illumination and the vehicle must set the following Diagnostic Trouble Code (DTC):</b> <ul style="list-style-type: none"> <li>• P0235 - Turbocharger Pressure Sensor Signal Circuit Short To Ground.</li> <li>• P0521 - Plausibility Monitoring Between Two Engine Oil Pressure Switch Inverted Mou

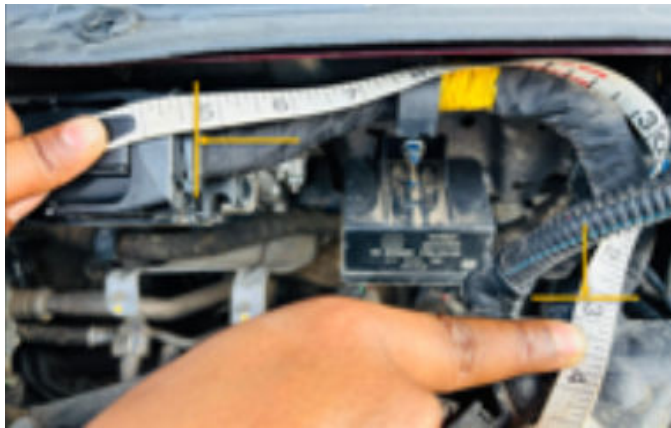
**Fig. 1**  
**PCM Harness Measurement**

**NOTE: Measuring point: From PCM Connector to channel edge Fig. 1, Fig. 2.**

1. Measure the PCM harness wiring harness length.

2. Is the wiring harness damaged and/or is the harness length longer than 250 mm (9.8 in.)?
  - YES>>> Proceed to [Step 3](#).
  - NO>>>The harness is ok. Perform further diagnostics.
3. Is the wiring harness damaged?
  - YES>>> Proceed to [Step 4](#).
  - NO>>> Proceed to [Step 5](#).
4. Replace the PCM wire harness.
5. Tape up the harness [Fig. 3](#).
