GENERAL MOTORS  
DCS7187  
URGENT - DISTRIBUTE IMMEDIATELY

Subject: N242479150 - Service Update  
Door Water Leak

Models: 2024-2025 Chevrolet Corvette

## N242479150 Door Water Leak

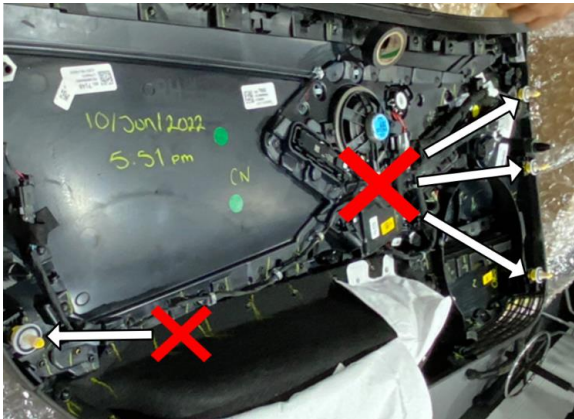
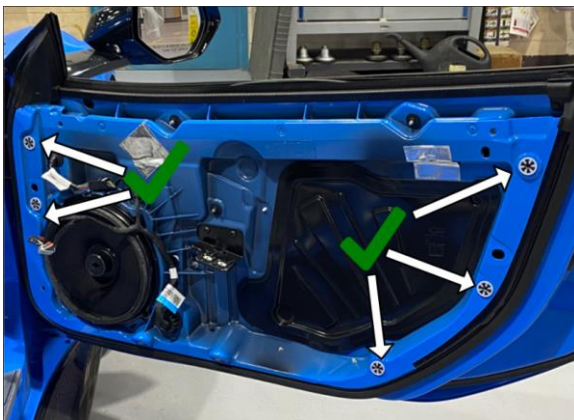
**Important:** When removing the Front Side Door Trim Panel, if the white outer retaining clip pulls away from the door structure and stays attached to the yellow part of the retainer, replace both the white and yellow retainers in each instance it occurs.

1. Remove the RH AND LH Front Side Door Trim. Refer to *Front Side Door Trim Replacement* in SI.

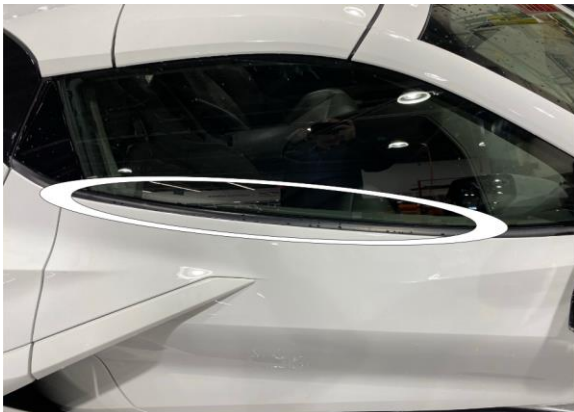
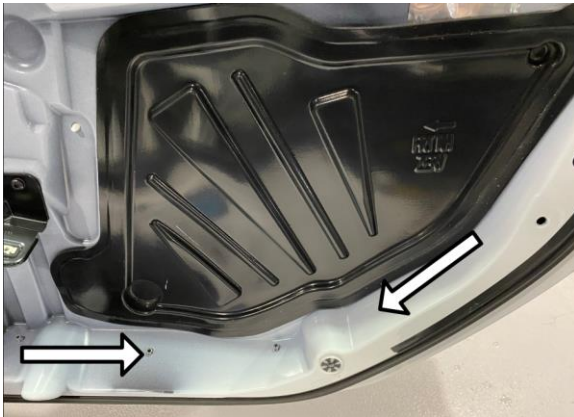
- Using a water hose, spray the RH front side door window for 2-3 minutes, then inspect the RH Front Side Door Water Deflector for leaks within the arrows pictured above.
  - If the RH Front Side Door Water Deflector is leaking water, proceed to Step 3.
  - If the RH Front Side Door Water Deflector is NOT leaking water, proceed to Step 7.

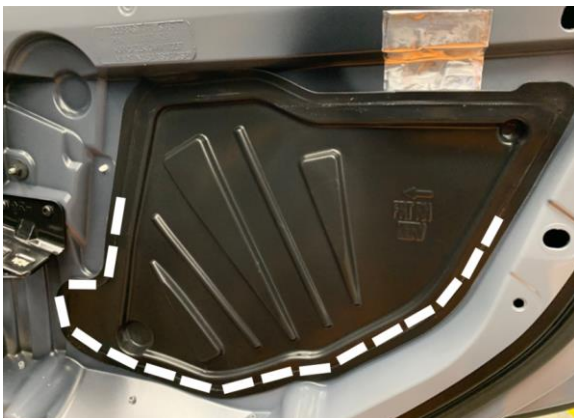
6770592

**Important:** When adhering the water deflector to the door panel, ensure that there is good adhesion on the 3 to 9 o'clock area as shown above. Failure to do so may result in water leaks.

- Replace the RH Front Side Door Water Deflector. Refer to *Front Side Door Water Deflector Replacement* in SI. Proceed to Step 4 after completing.

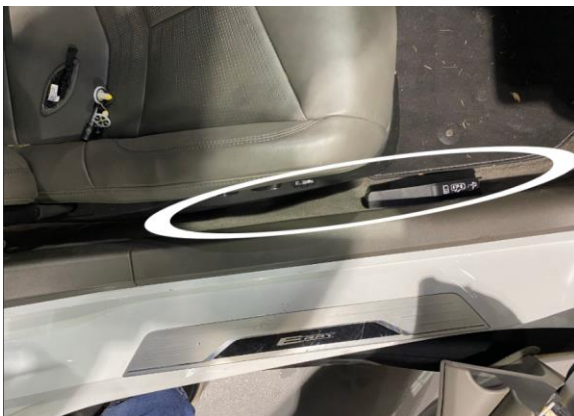
6781962

**Note:** If the front floor carpet has signs of mold, discoloration, mildew, etc., proceed to Step 6 to replace the front floor carpet panel. DO NOT attempt to dry the carpet in this condition.

- Inspect the RH Front Floor Panel Carpet for signs of water intrusion.

- If the RH Front Floor Panel Carpet has signs of water intrusion, but NOT irreversibly damaged by mold, discoloration, mildew etc., proceed to Step 5.
- If the RH Front Floor Panel Carpet has signs of irreversible water damage, such as mold, discoloration, mildew, etc., proceed to Step 6.
- If the RH Front Floor Panel Carpet DOES NOT show any signs of water intrusion, proceed to Step 7.

**Important:** After drying the carpet, if permanent water damage, such as discoloration, is discovered, proceed to Step 6 to replace the Front Floor Panel Carpet.

5. Dry the RH Front Floor Panel Carpet using the steps below.
  - 5.1 If you observe puddles of liquid on the carpet face, use a wet vacuum to remove the excess moisture.
  - 5.2 Blot the face of the carpet with a towel in order to absorb as much moisture as possible.
  - 5.3 Point a fan at the affected area and air dry the carpet.
  - 5.4 After drying the carpet, if permanent water damage, such as discoloration, is discovered, proceed to Step 6. Otherwise, proceed to Step 7.
6. Replace the RH Front Floor Panel Carpet. Refer to *Front Floor Panel Carpet Replacement - Right Side* in SI. Proceed to Step 7 after completing.

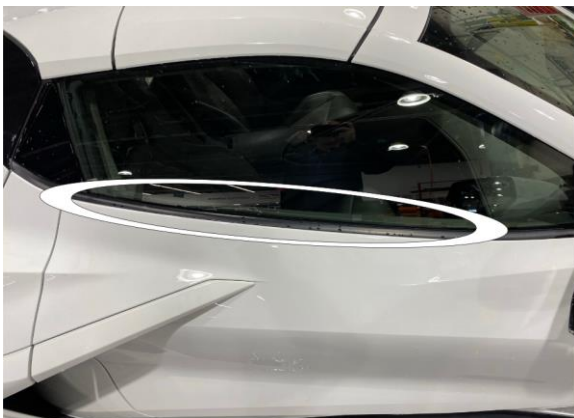
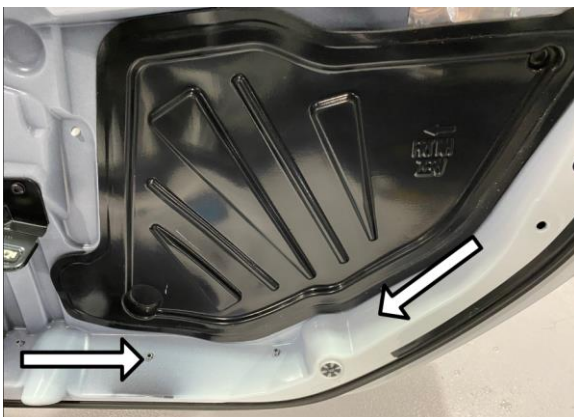
7. Using a water hose, spray the LH front side door window for 2-3 minutes, then inspect the LH Front Side Door Water Deflector for leaks within the arrows pictured above.
  - If the LH Front Side Door Water Deflector is leaking water, proceed to Step 8.
  - If the LH Front Side Door Water Deflector is NOT leaking water, proceed to Step 12.

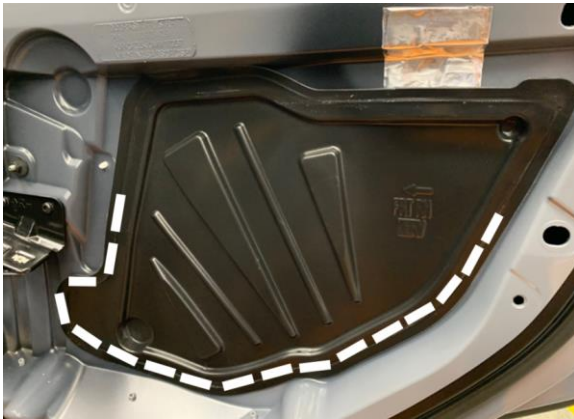
6770592

**Important:** When adhering the water deflector to the door panel, ensure that there is good adhesion on the 3 to 9 o'clock area as shown above. Failure to do so may result in water leaks.

8. Replace the LH Front Side Door Water Deflector. Refer to *Front Side Door Water Deflector Replacement* in SI. Proceed to Step 9 after completing.

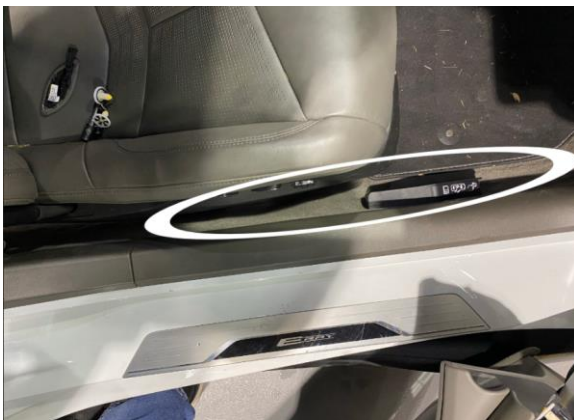
6781962

**Note:** If the front floor panel carpet has signs of mold, discoloration, mildew, etc., proceed to Step 11 to replace the front floor panel carpet. DO NOT attempt to dry the carpet in this condition.

9. Inspect the LH Front Floor Panel Carpet for signs of water intrusion.
  - If the LH Front Floor Panel Carpet has signs of water intrusion, but NOT irreversibly damaged by mold, discoloration, mildew, etc., proceed to Step 10.
  - If the LH Front Floor Panel Carpet has signs of irreversible water damage, such as mold, discoloration, mildew, etc., proceed to Step 11.
  - If the LH Front Floor Panel Carpet DOES NOT show any signs of water intrusion, proceed to Step 12.

**Important:** After drying the carpet, if permanent water damage, such as discoloration, is discovered, please proceed to Step 11 to replace the Front Floor Panel Carpet.

10. Dry the LH Front Floor Panel Carpet using the steps below.
  - 10.1 If you observe puddles of liquid on the carpet face, use a wet vacuum to remove the excess moisture.
  - 10.2 Blot the face of the carpet with a towel in order to absorb as much moisture as possible.
  - 10.3 Point a fan at the affected area and air dry the carpet.

- 10.4 After drying the carpet, if permanent water damage, such as discoloration, is discovered, proceed to Step 11. Otherwise, proceed to Step 12.
11. Replace the LH Front Floor Panel Carpet. Refer to *Front Floor Panel Carpet Replacement - Left Side* in SI.
12. Install the RH and LH Front Side Door Trim. Refer to *Front Side Door Trim Replacement* in SI. No further action is required.
