# Technical Service Bulletin

<b>Topic</b>	Bentayga and New Flying Spur Hybrid - DTC P103A00 evident - Engine Oil Fuel Portion Too High
<b>Market area</b>	Australia E04 Bentley rest Asia and Australia (6E04),China 723 Volkswagen (Anhui) Automotive CO (6723),China 796 VW Import Comp. Ltd (Vico), Beijing (6796),Germany E02 Bentley rest Europe (6E02),Japan E03 Bentley Japan (6E03),Russian Federation 935 Volkswagen Group RUS (6935),United Kingdom E01 Bentley UK (6E01),United States E05 Bentley USA and rest America (6E05)
<b>Brand</b>	Bentley
<b>Transaction No.</b>	2062365/5
<b>Level</b>	EH
<b>Status</b>	Released for publishing
<b>Release date</b>	Mar 4, 2025

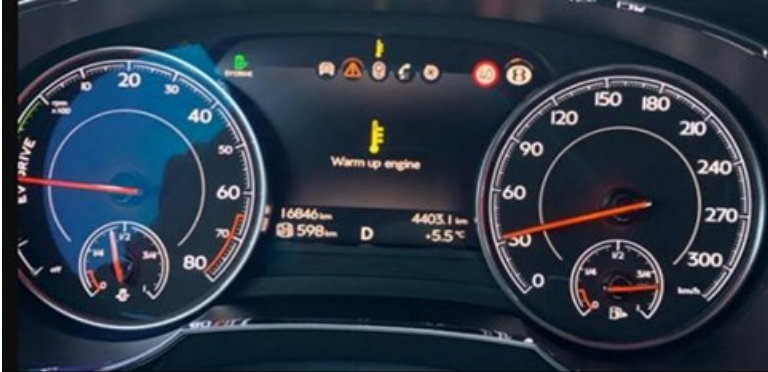
Figure 1

- Warning message within the DIP
- The message asks the customer to 'warm up engine' accompanied by a yellow warning (Figure 1) No other symptoms are experienced.

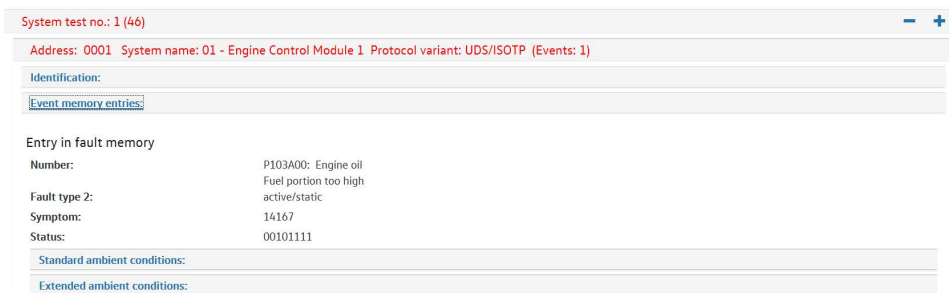
Figure 2

- DTC P103A00 evident - Engine Oil Fuel Portion Too High (Figure 2)

The warning is caused by the level of unburnt fuel in the engine oil. This value is calculated by the Engine Control Module (ECM) and is based on the driver usage pattern

The more cold starts the Internal Combustion Engine (ICE) is exposed to the higher the chance of fuel making its way into the engine oil via the cylinders

When the fuel calculation reaches the pre-programmed amount this then causes the DTC to be triggered

1) The operative should navigate to and read the following IDE values using ODIS

2) Referring to the Rep.Gr 17- Check the engine oil level *NOTE: Ensure the method within Rep.Gr 17 is followed*

3) Drive the vehicle in SPORT mode for 30 KM (***Observing all local speed limits***) with enthusiastic driving to reduce the fuel MWB value (IDE09531) to less than 50 grams

- In the event the MWB value (IDE09531) has been successfully reduced (Lower than 50 grams) Erase the applicable DTC's
