Technical Service Bulletin

Topic	Bentayga V8 Kovomo - DTC P304300 with symptom code (10061) - Fuel Pump Mechanical Malfunction - MIL lamp
Market area	Australia E04 Bentley rest Asia and Australia (6E04),China 723 Volkswagen (Anhui) Automotive CO (6723),China 796 VW Import Comp. Ltd (Vico), Beijing (6796),Germany E02 Bentley rest Europe (6E02),Japan E03 Bentley Japan (6E03),Korea, (South) E08 Bentley South Korea (6E08),United Arab Emirates E06 Bentley Middle East and Africa (6E06),United Kingdom E01 Bentley UK (6E01),United States E05 Bentley USA and rest America (6E05)
Brand	Bentley
Transaction No.	2062092/4
Level	EH
Status	Released for publishing
Release date	Mar 4, 2025

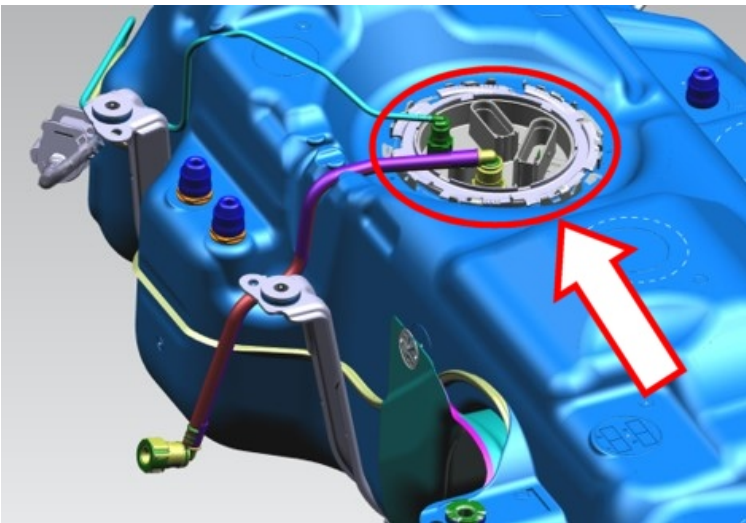
Figure 1

4) Conduct a visual inspection of the fuel pump delivery module (Top) for any obvious signs of damage (Figure 1)

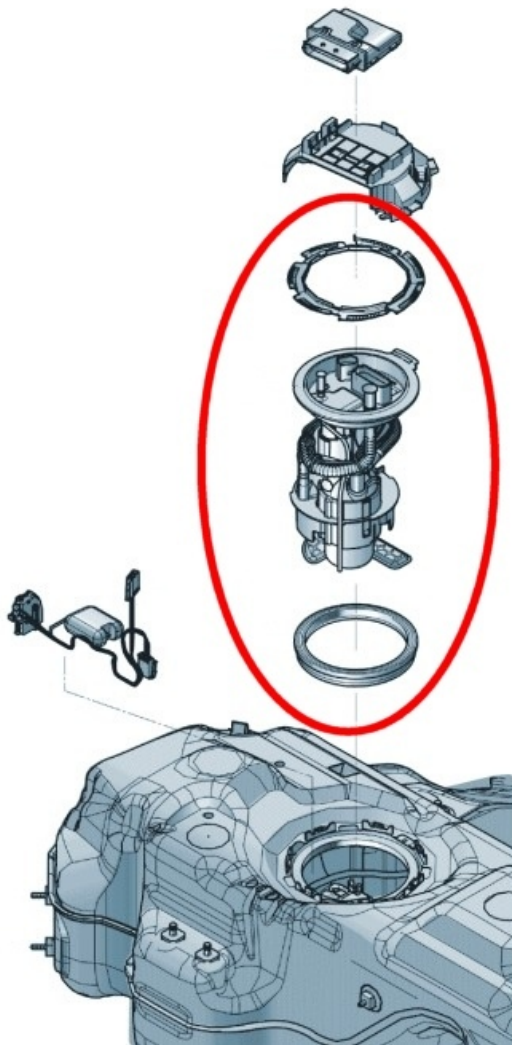
Figure 2

DTC P304300 – with symptom code (10061) - Fuel Pump Mechanical Malfunction evident

5) Should all the advised checks detailed in steps 1 to 4 be to specification – Replace the Fuel Delivery Module within the fuel tank (Figure 2) - Refer to Repair Group 20 Fuel supply, gas operation / 4.0L V8 TSI / Fuel pump, fuel level sensors, and jet pump (RH) – To remove and fit
