GROUP	MODEL
Voluntary Emissions Service	2021-2024MY
Campaign	K5 (DL3a)
	w/1.6L T-GDI
NUMBER	DATE
SC288 (Rev 5, 3/19/2025)	April 2024

# VOLUNTARY EMISSIONS SERVICE CAMPAIGN

FUEL TANK AND/OR PCSV CHECK VALVE INSPECTION/REPLACEMENT + ECU SW UPGRADE (SC288)

This bulletin provides information to inspect the fuel evaporative system and, if necessary, replace the fuel tank and/or the Purge Control Solenoid Valve (PCSV) check valve on certain 2021-2024MY K5 (DL3a) vehicles equipped with a Gamma II 1.6L T-GDI engine, produced from March 27, 2020 through October 17, 2023. This bulletin also provides information to upgrade the ECU software logic. The subject vehicles may experience fuel tank swelling due to an issue with the PCSV check valve, which results in pressurized air to flow into the fuel tank. This may cause the Check Engine Light to illuminate, and in some cases, the engine to run rough, and/or an inability to refuel. These conditions may cause the vehicle to release air pollutant which exceed Federal and California standards.

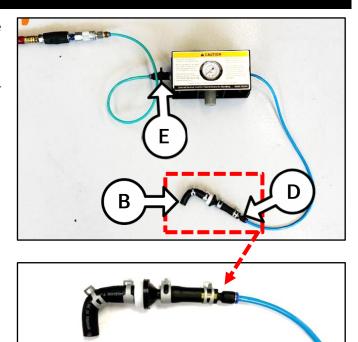
- 5. Submerge the open end of the PCSV check valve (B) hose in water and confirm NO air bubbles are present.
  - Bubbles ARE present (NG), proceed to the 'Inspection Procedure: (Fuel Tank Bands and Service Cover)' (page 5).
  - NO bubbles present (OK), perform the 'ECU Upgrade Procedure' (page 8).

Note: DO NOT submerge the PCSV check valve (B) in the water. ONLY the hose is to be submerged in the water.

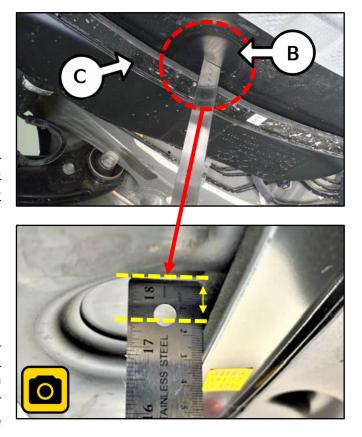
Using a ruler, measure the gap between the fuel tank (B) and the  $\overline{\text{TOP}}$  of  $\underline{\text{BOTH}}$  fuel tank bands (C), as shown.

- If the gap between the fuel tank and the TOP of the fuel tank bands measures 24mm or LESS (OK), skip to complete the following:
  - 1. Replace the PCSV Check Valve
  - 2. ECU Upgrade Procedure (Page 8)
- If the gap between the fuel tank and the TOP of the fuel tank bands measures 25mm or MORE (NG), attach one clear photo using KDS Tablet Warranty Claim Attachment Tab of the NG measurement, then proceed to step 3.

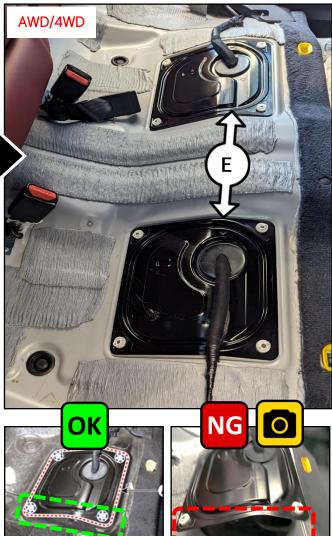
- 4. Inspect the seat floor to fuel pump service cover (E) (4 sides) for any gaps:
  - If a gap is NOT present (OK), the cover is seated flush with the seat floor panel, then proceed to replace both the PCSV check valve and Fuel Tank (page 12).

After completing the two replacements, perform the 'ECU Upgrade Procedure' (page 8).
  - If a gap IS present (NG), the cover is lifted/detached from the seat floor panel, create a Techline Repair Assistance (RA) case, and attach one clear photo using KDS Tablet Warranty Claim Attachment Tab of the NG condition to the Techline case and Warranty Claim.
