Technical Service Bulletin

Topic	Bentayga V8 Kovomo and V6 (Hybrid) - Fuel Pressure Regulation - Numerous DTC's
Market area	Australia E04 Bentley rest Asia and Australia (6E04),China 723 Volkswagen (Anhui) Automotive CO (6723),China 796 VW Import Comp. Ltd (Vico), Beijing (6796),Germany E02 Bentley rest Europe (6E02),Japan E03 Bentley Japan (6E03),Korea, (South) E08 Bentley South Korea (6E08),United Arab Emirates E06 Bentley Middle East and Africa (6E06),United Kingdom E01 Bentley UK (6E01),United States E05 Bentley USA and rest America (6E05)
Brand	Bentley
Transaction No.	2062080/10
Level	EH
Status	Released for publishing
Release date	Mar 4, 2025

Bentayga - V8 Kovomo and V6 (Hybrid)

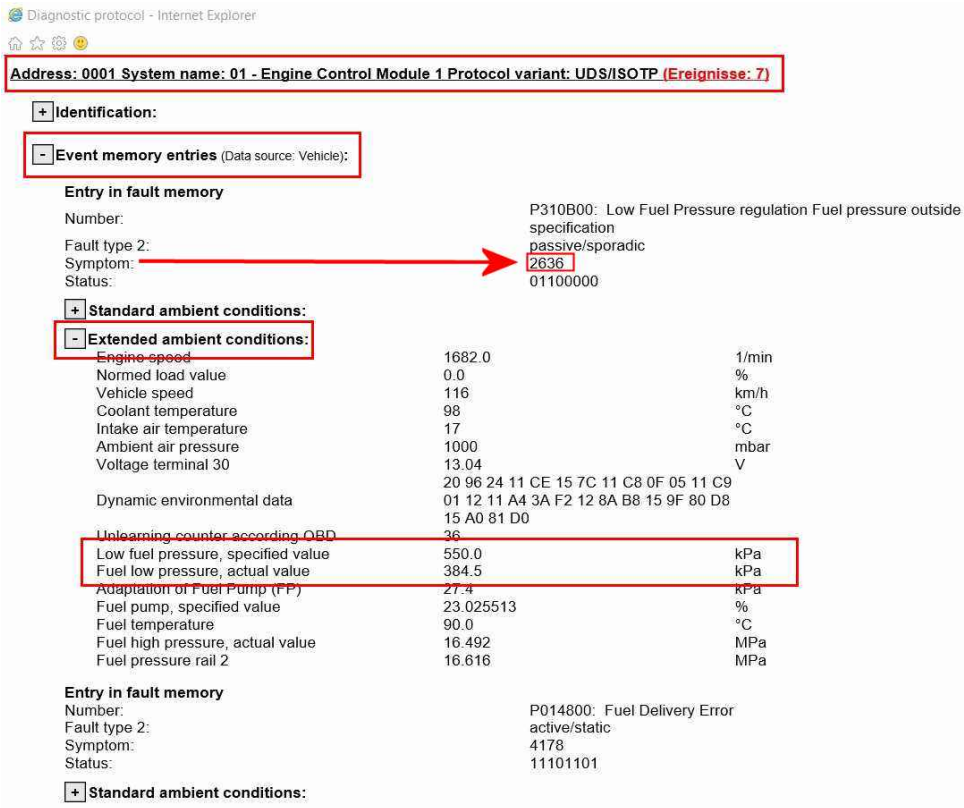
Figure 1

2) Check **"Low fuel pressure, specified value"** and **"Fuel low pressure, actual value"** within the fault memory, refer to ECU **"01 – Engine Control Module 1"** - From **"Extended ambient conditions"** note the values of the **"Low fuel pressure, specified value"** and **"Fuel low pressure, actual value"** as shown in Figure 1.
