Technical Journal

White patch defect in paint from protection cover

| REF NO: TJ 36655.2.0 | ISSUING DEPARTMENT: Technical Service | CAR MARKET: United States and Canada | |

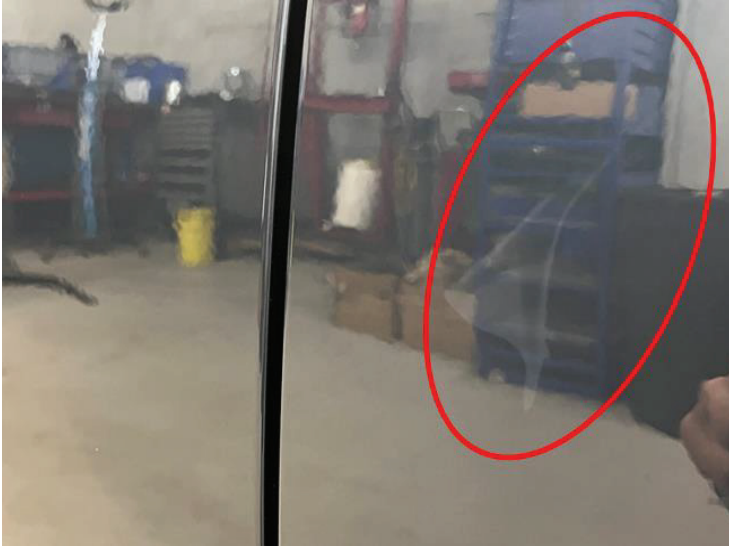
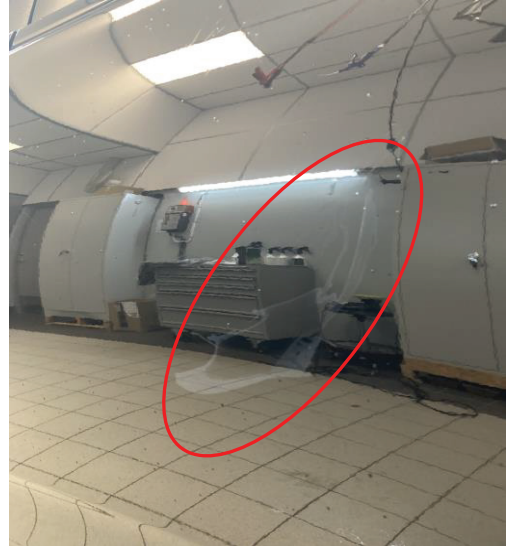
TJ-36655

If experiencing milky stripes/white patch defects in the paint when the ragard or vehicle cover is removed, please see advice under "Service".

*If milky stripes/white patch defects occur when the rapgard or vehicle cover is removed, do NOT polish, wax or repaint the area. The defect can be removed by exposure to outside daylight for 48hrs. Or an infrared (IR)-radiator can be used, carefully heat up the area to a temperature of 50-70°C (122-158°F) for 30 minutes. Note! The temperature of paintwork must not exceed 100°C (212°F). For example pictures of the defect, see attachment TJ-36655.pdf.

To prevent these defects from occurring, please follow the instruction of how to remove the rapgard in a correct way. Instruction to be found in VIDA with below address:
