Technical Journal Title Upper front suspension creaking/knocking noise		Ref. No. TJ 36512.7.0	
Issuer (Dept.) Technical Service		Issue Date 10/25/24	Status Date 2/17/25
Car Market United States and Canada	Partner 3 US 7510 Volvo Car USA	Function Group 7233	
Function Description Mounting		Page Page 1 of 3

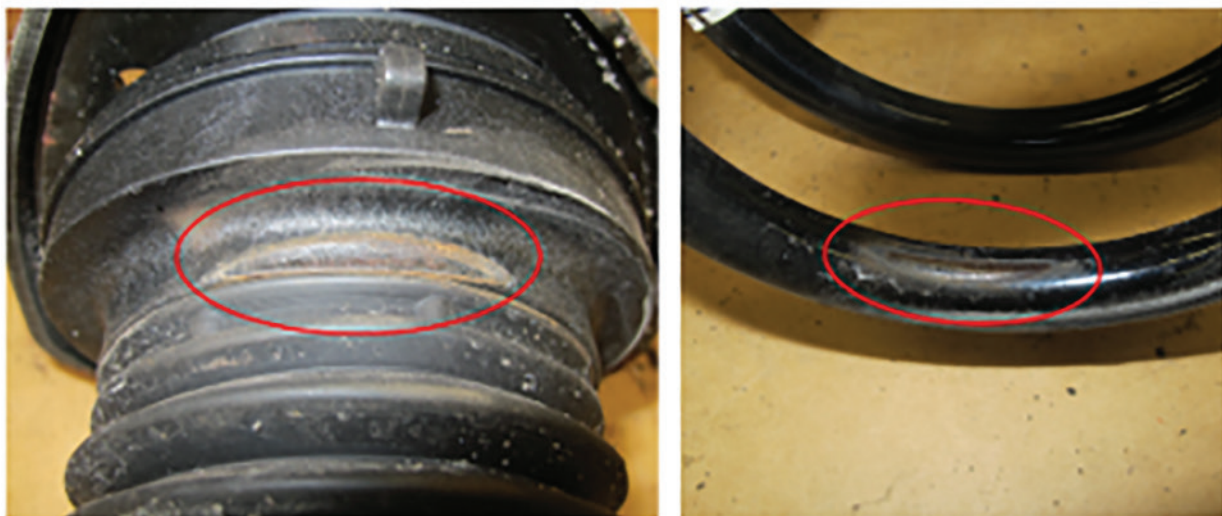
- During acceleration/braking ([knocking noise.MOV](#) and picture 1)
- During (slowly) driving over bumps and into turns ([knocking noise.MOV](#) and picture 1)
- During turning to left or right when standing still ([Creaking noise.mp4](#) and picture 2)
- During parking maneuvering ([Creaking noise.mp4](#) and picture 2)

*If there is a confirmed creaking/knocking noise from the upper front suspension.
Please follow VIDA to replace the upper bearing.
