Technical Journal

Technical Journal Title EX90 Software download issues - temporary solutions (Key Tag info Included)		Ref. No. TJ 37071.5.0	
Issuer (Dept.) Technical Service		Issue Date 2/6/25	Status Date 2/17/25
Car Market United States and Canada	Partner 3 US 7510 Volvo Car USA		Function Group 3018
Function Description Software		Page Page 1 of 8

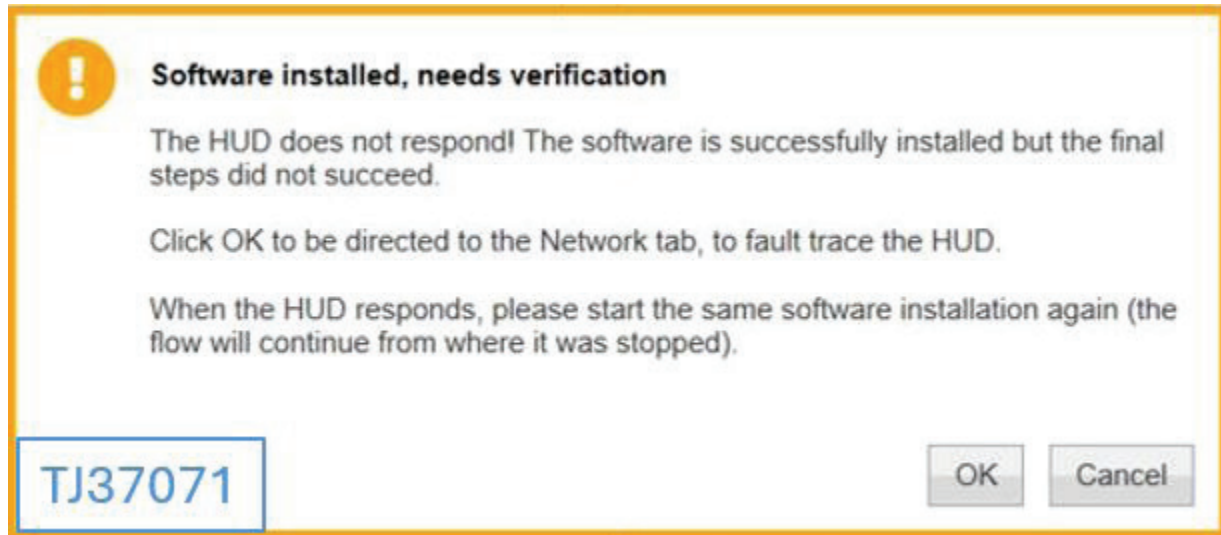
- General VIDA warning messages, example “no response HUD” (picture HUD) after PDS upgrade:
If the warning message appears after PDS installation, please perform a reset of vehicle under Advanced Test Option in VIDA and check if the ECU is in Default, if not repeat this step 2 more times.
If problems still occur, contact RTS through a Support Needed vehicle report in TIE.

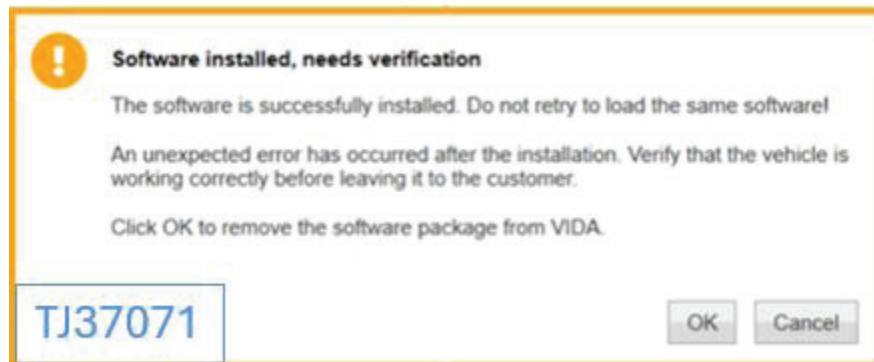
- #6. PDS upgrade yellow message – not complete!
After PDS is done with yellow message “..SW installed needs verification..” (picture VIDA Yellow message), perform the following steps:

- Click “OK” or “Cancel” on the error message.
 - Revoke the software.
 - Re-download the PDS.
Check key tag pairing again.
- #7. General VIDA warning messages:

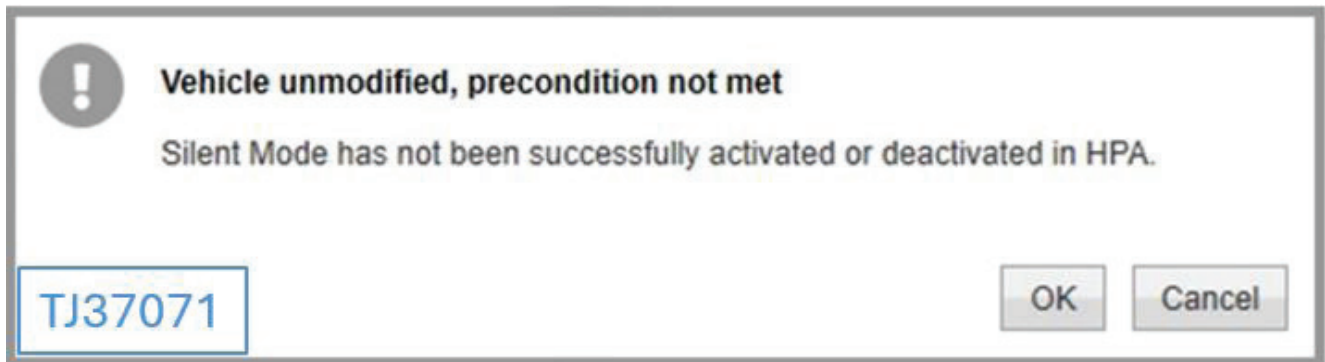
- #2. If SWDL fails due to Silent mode (picture VIDA1_EX90), follow this:
- *• Check if HLCM is in fail safe mode under “Components” - “High- to Low-voltage Converter Module (HLCM)” - “Diagnostic Sequences” - “Recovering HLCM from fail save mode”

- Check VIUP (PGWM and PGWA) is in Default. If not, follow “Recover VIUP/D failed SWDL” under point #3 below.
 - Check that HVBM is in Default.
 - a. If it is not in Default, perform a 12V reset with VIDA for more than 10 minutes.

- b. If it is in Programming, perform a reload of HVBM.
 - Check that HVB SOC is above 2%. If not, charge the HVB.
 - *• If all of the above is okay and SWDL still fails due to Silent mode, open the VIDA diagnostic sequence under “Service Functions” - “Disconnect Main Battery” and deactivate and activate HLCM converting and try again.
If the issue still remains, contact RTS through a Support Needed vehicle report in TIE.

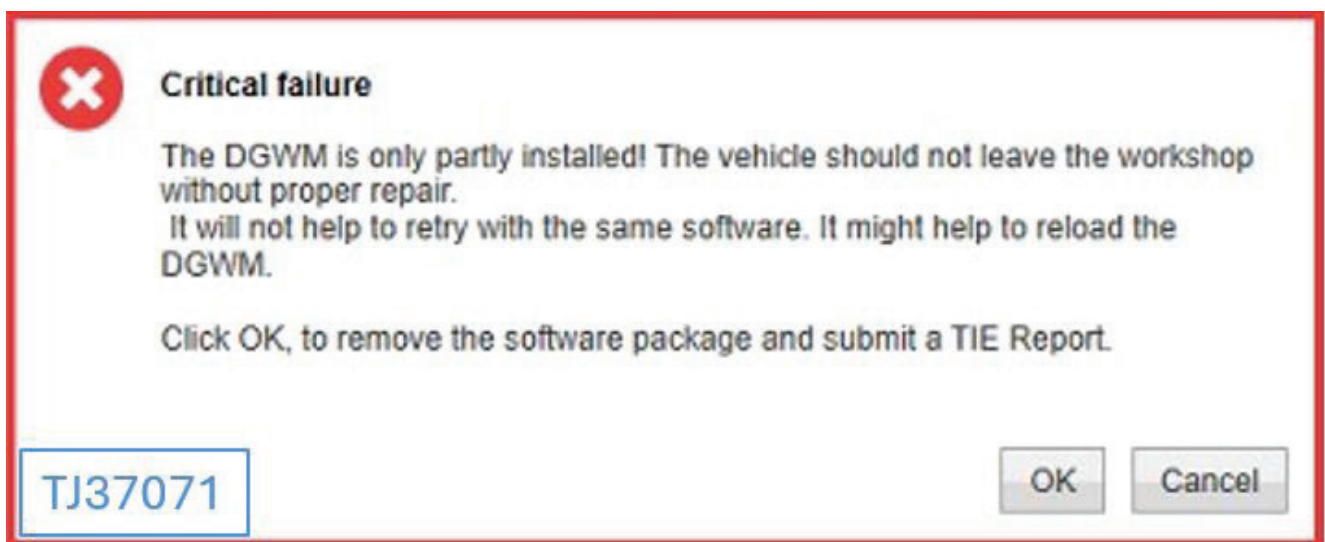
- #3. If SWDL failed due to the VIUP/D being partly installed (picture VIDA2_EX90), follow this:
Check if VIUP/D is in Programming or Not responding.
- a. If VIUP/D is in Programming:

- aa. Perform a 12V reset with VIDA diagnostic sequence under “Service Function” - “Disconnect Main Battery”, 30 minutes.
 - ab. Reload VIUP/D.
 - b. If VIUP/D is not responding:

- ba. Perform a 12V reset with VIDA diagnostic sequence under “Service Function” - “Disconnect Main Battery”, 30 minutes. (try at least 3 times).
 - bb. If we get VIUP/D in Programming, perform a reload.

- bc. If VIUP/D is still in not responding, contact RTS through a Support Needed vehicle report in TIE.
- How to do a 12V hard reset if 12V reset with VIDA fails (step #2 & #3):
Alt a:

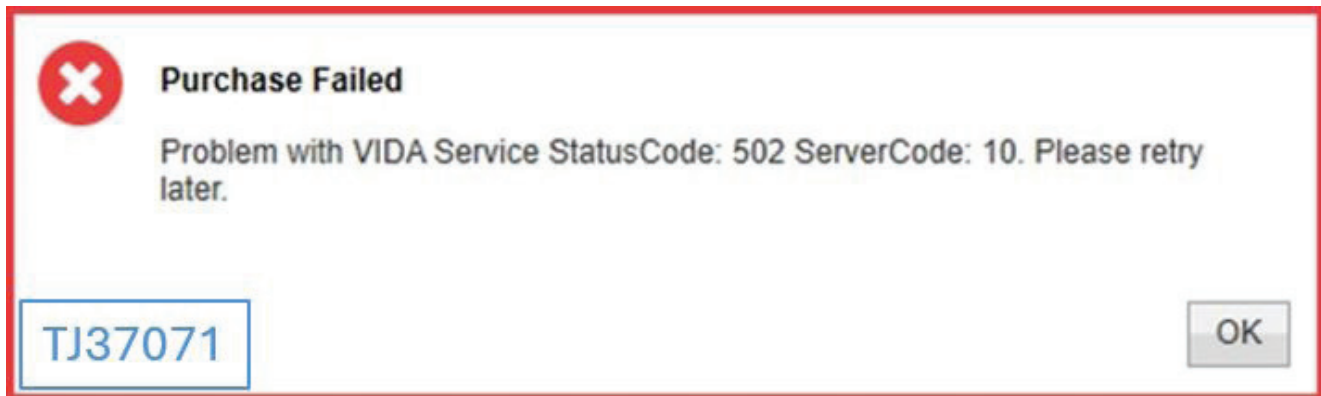
- #4. If there is a VIDA message “Purchase Failed - StatusCode: 502 ServerCode: 10” (picture VIDA3_EX90)
Contact RTS through a Support Needed vehicle report in TIE.

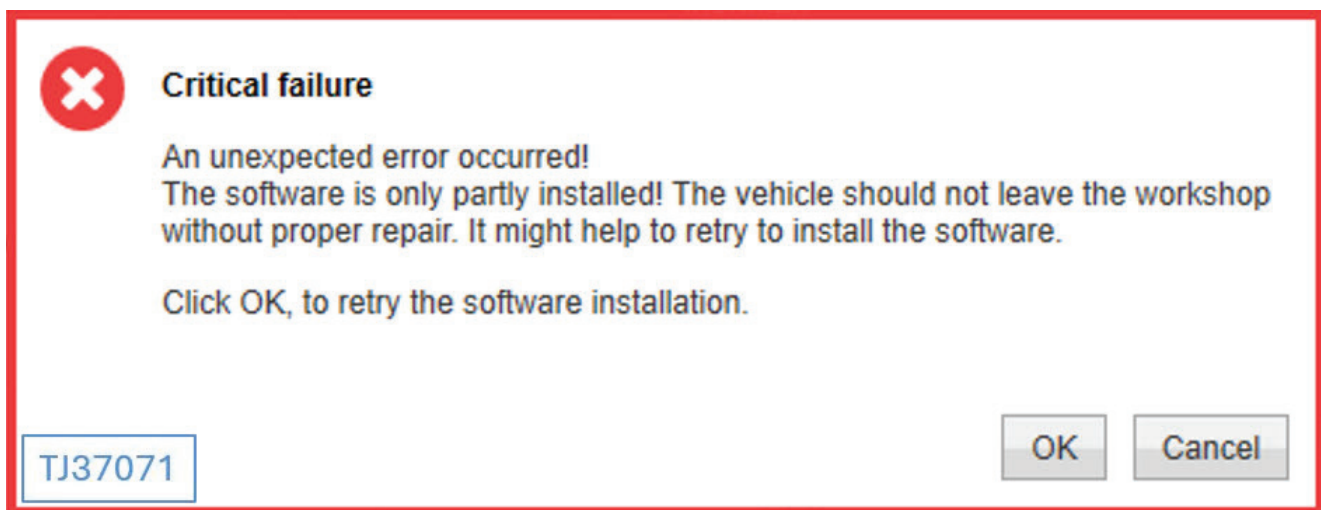
- General VIDA warning message, example “Critical failure” (picture VIDA4_EX90)
If the warning message appears in the beginning of PDS installation follow below:
If usage mode is “Convenience” make sure that no one is seated in the car and try again.
If the problem still exists, turn off climate in CSD.
If problems still occur, contact RTS through a Support Needed vehicle report in TIE.

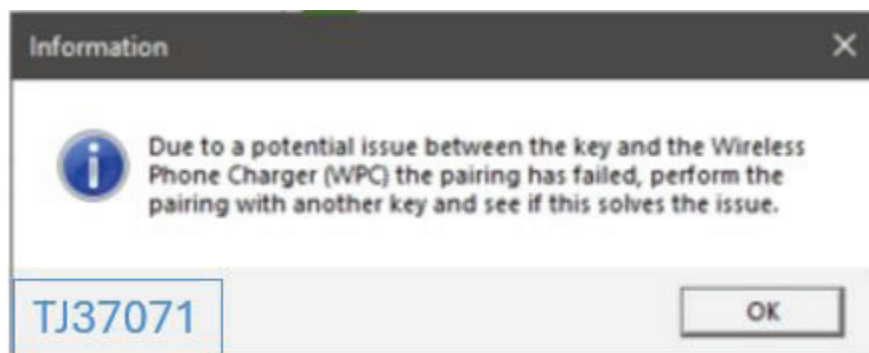
- Pairing of key tag fails:
If you get message in VIDA, “...potential issue between key and Wireless Phone Charger...” (picture WPC), perform a TCAM reload, “Yes” to replace hardware.
Then retry pairing.
