# Technical Service Bulletin

<b>Topic</b>	Engine cooling system over cooling - One or a combination of DTC's may be evident P218100 - P1BB400
<b>Market area</b>	Bentley: worldwide (2WBE),China 796 VW Import Comp. Ltd (Vico), Beijing (6796)
<b>Brand</b>	Bentley
<b>Transaction No.</b>	2075140/2
<b>Level</b>	EH
<b>Status</b>	Released for publishing
<b>Release date</b>	Mar 12, 2025

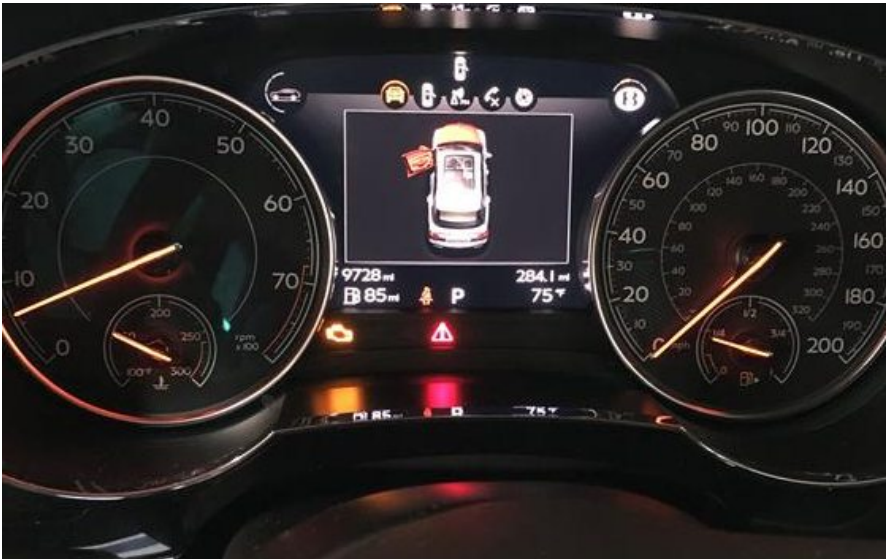
Figure 1

- DTC P218100 - Cooling System Performance and / or DTC P1BB400 Cylinder head temperature too low is stored in the Engine Control Module (ECM)
- Emission Control Lamp illuminated on the Driver Instrument Panel (Figure 1)

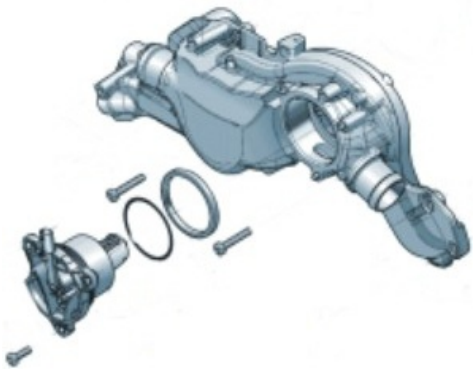
Figure 2

It is possible for the engine coolant thermostat to corrode over time, this corrosion is due to an adverse reaction of the thermostat material with the engine coolant

The corrosion and subsequent build-up of debris prevents the correct operation of the thermostat when closing, resulting in over cooling. The ECM triggers a DTC when the target engine temperature is outside of the specified parameter

1) Replace the engine coolant thermostat (Figure 2) - Refer to 19 - Engine cooling - Coolant regulator (Thermostat insert) (V8 biturbo) - To remove and fit
