Technical Service Bulletin

| Topic | Engine light in the DIP - Various oxygen sensor / Fuel ratio DTC's logged within the Engine Control Module(s) |
| Brand | Bentley |
| Transaction No. | 2075331/2 |

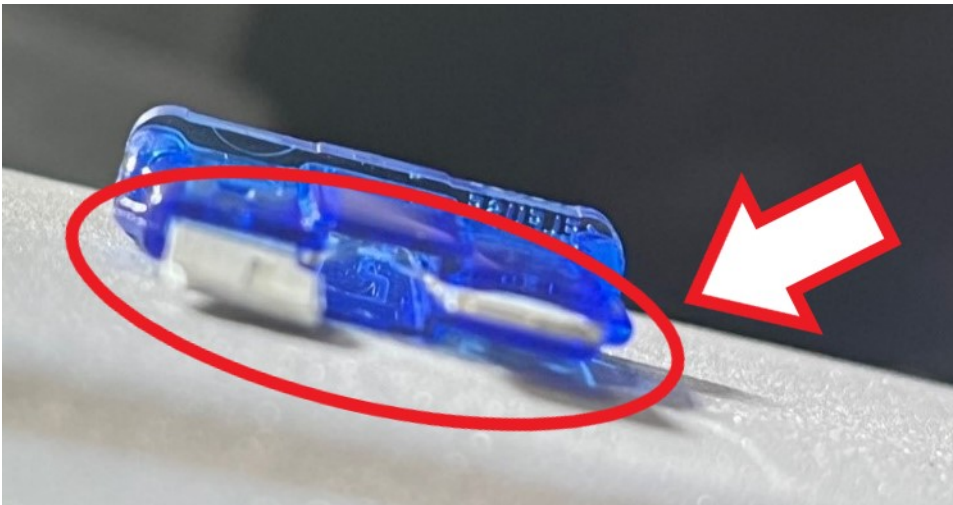
- Fuse - Check for damage / bent fuse blade(s)

Hint: The fuse blades shown in Figure 1 are damaged / bent, in this scenario the fuse must be renewed, ensure both blades are aligned to both terminals before fitting the fuse

Hint: In this scenario the terminals must be repaired / replaced (depending on damage) once repaired / replaced the fuse must be renewed, ensure both fuse blades are aligned to both terminals before fitting the fuse
