Technical Service Bulletin

| Topic | Engine overheating - Warning in the DIP (V8 Kovomo) |
| Brand | Bentley |
| Transaction No. | 2061369/9 |

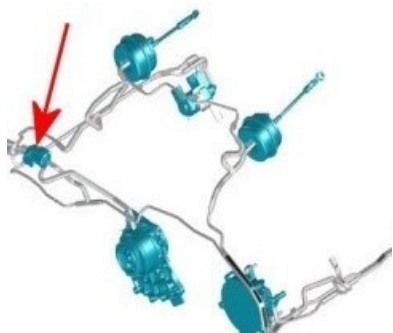
Figure 1 - Bentayga

To allow the engine coolant to heat as quickly as possible (from cold start) coolant delivery from the mechanical coolant pump is interrupted by switch valve N649

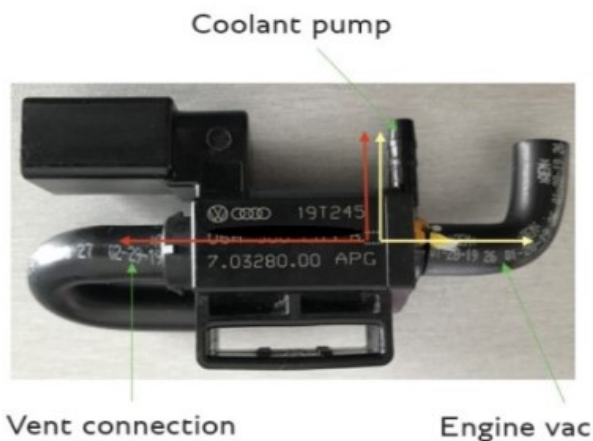
Figure 3

NOTICE
 The correct operation of N649 (Figure 3) is as follows

Un-energised state (Ignition off) - Coolant pump connected to vent connection (red arrows)

Energised state (Ignition on) - Engine vacuum connection to coolant pump (yellow arrows)
