Case Number: S2523000021

Release Date: March 2025

Symptom/Vehicle Issue: Power Liftgate Drive Unit (PDU) Servicing Information.

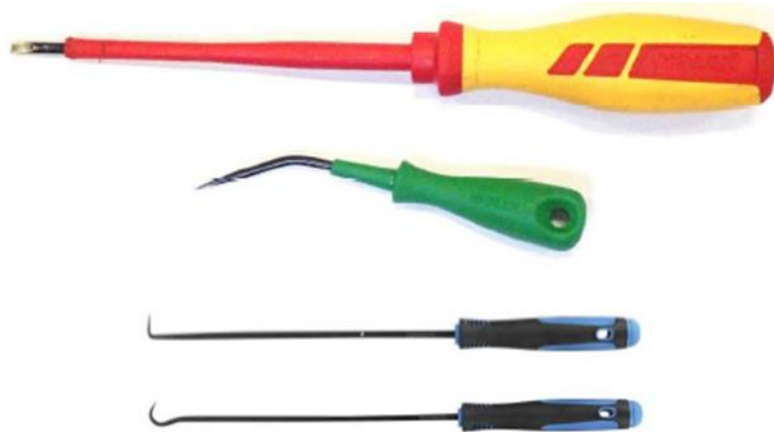
Discussion: A review of returned parts show many parts have damage to the ball socket, spring clips, and connectors due to improper removal methods at time of servicing. Review the below information in addition to the standard remove and install detail in Service Library. Refer to Service Library 08 - Electrical / 8N - Power Systems / Power Liftgate / DRIVE UNIT, Power / Removal and Installation

Figure 1 : Screwdriver and hook tooling for disassembly

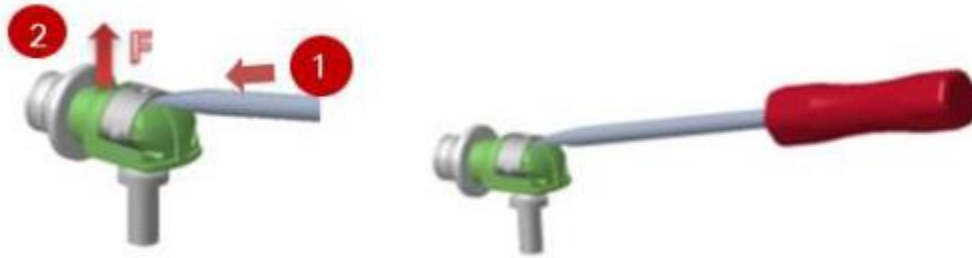
Fig 1

Releasing Yoke Spring To Allow Removal Of Prop.

<<<Note>>> Retention Yoke Spring Should Stay With The Gate Prop.

4. Disassembly the ball cups refer to Fig 1.

The ball cups are removed using a slotted screwdriver (blade width 2 - 3 mm) Position this at a flat angle in the gap between the flat/groove of the ball cup and the yoke spring.

Disassembly is carried out by lifting the ball cup from the ball stud without force.

Caution: The yoke spring must not be completely dismantled or lifted too high, as this can damage the yoke spring.

The ball cup on the hinge side (upper) should always be removed first.

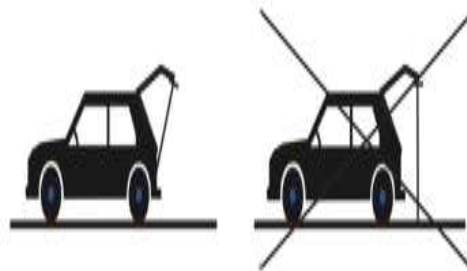
<<<Note>>> Do not support the tailgate with a support rod to the shop floor. Changes to the vehicle's weight could cause the gate to over travel leading to damage of the hinge. the active and passive sides by overbending the tailgate. (if the load in the vehicle changes, e.g. due to a person getting in, the body is lowered while the tailgate remains in the same position). Refer to Fig 2

The tailgate must be mechanically secured to the vehicle's rear cargo floor.
