Technical Service Bulletin

GROUP CAMPAIGN	NUMBER 25-01-025H
DATE MARCH 2025	MODEL(S) SANTA FE (MX5A)

SUBJECT: SEAT HEATER UNIT (SHU) SOFTWARE UPDATE
(SERVICE CAMPAIGN TCV)

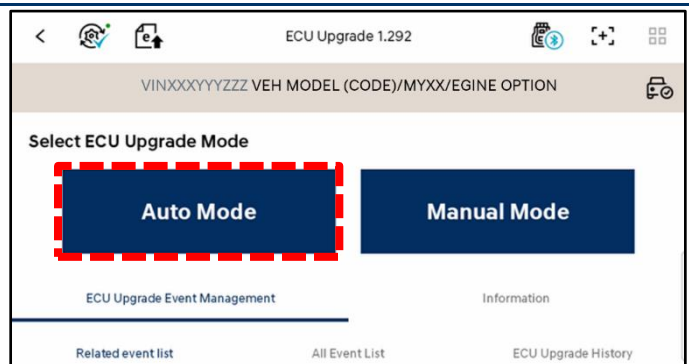
1. Perform the ECU update in **Auto Mode**.

Use the **ID Check** to verify the ROM ID before updating the software.

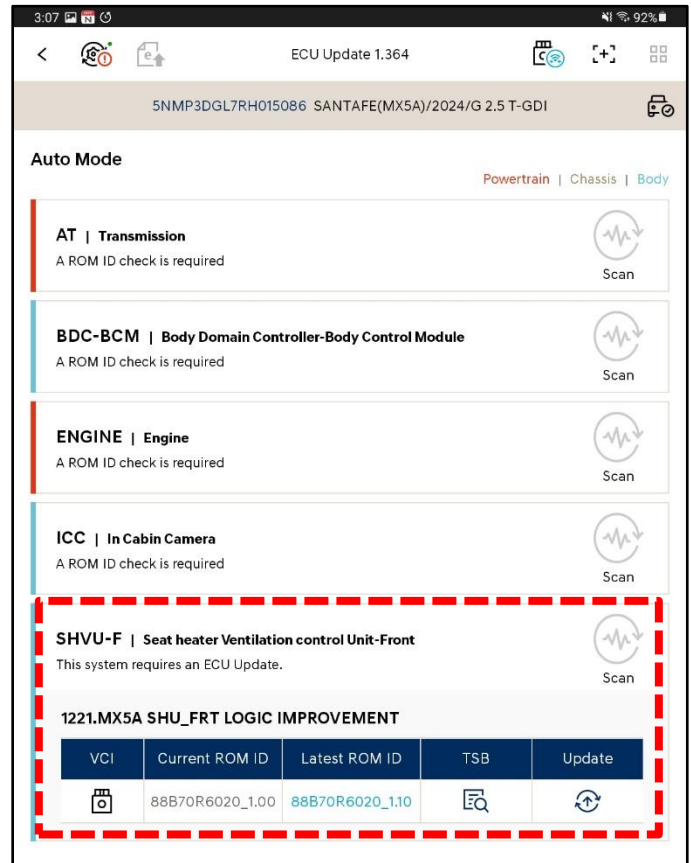
2. Select the **SHVU_F** system to scan the vehicle's current ROM ID.

Check the current ROM ID version and compare it to the ROM ID Information table before attempting to perform the software update.

If the update fails, please remove the power connector or the battery (-) connector from the indoor fuse box for at least **5 seconds** and reassemble it to retry the update.

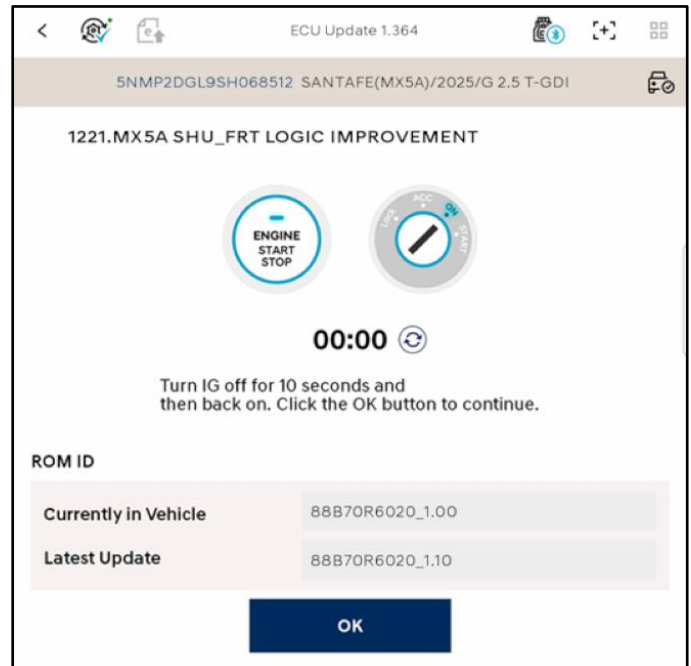
3. After the ECU update process shows 100% complete, follow the prompts on the screen to cycle the ignition **OFF** for at least **10 seconds** to reset the control unit (certain models may take up to **30 seconds**).

Use the **Refresh** button to reset the timer.

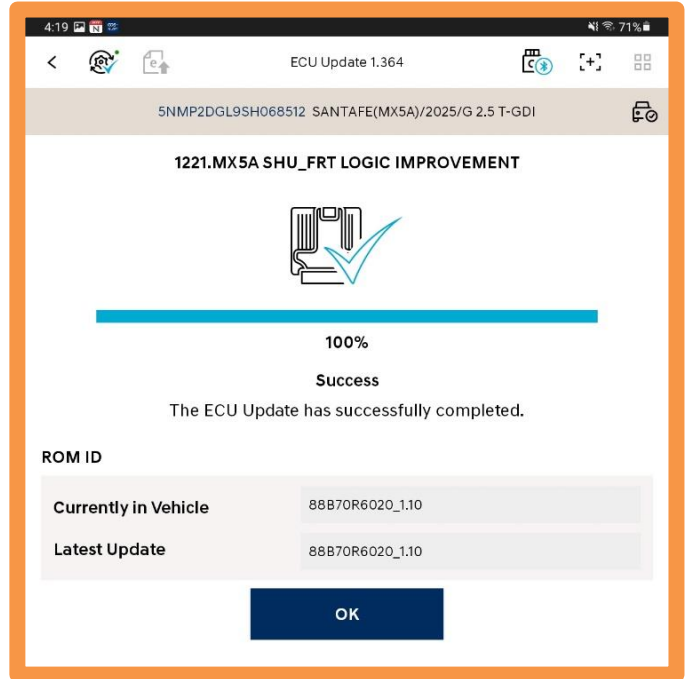
Take a screenshot of the ECU update complete screen using your tablet and upload to STUI.

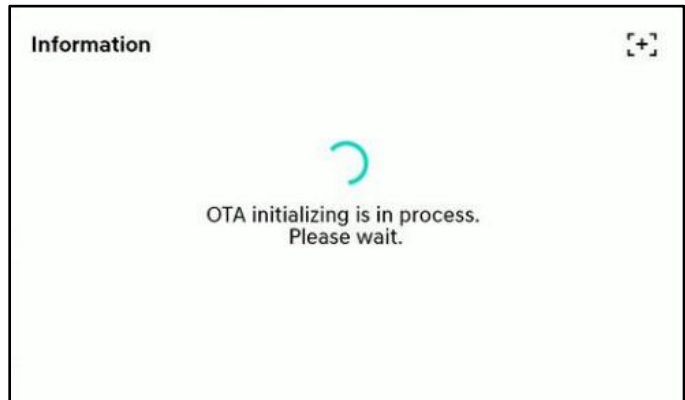
5. After clicking **OK**, the OTA Initialization process will begin.

- If OTA initialization performs automatically, then proceed with the service procedure.
- If the OTA initialization fails, **connect GDS-Smart > S/W Management > Central Communication Unit (CCNF) > OTA Initialization**

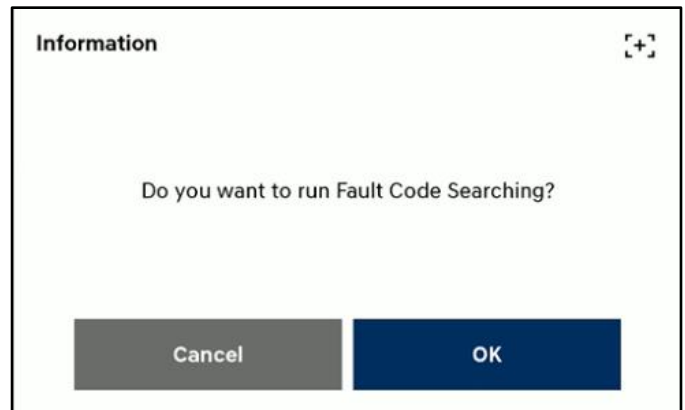
6. Perform an **All Systems Fault Code** search and erase DTC history that had incidentally occurred from the ECU update.

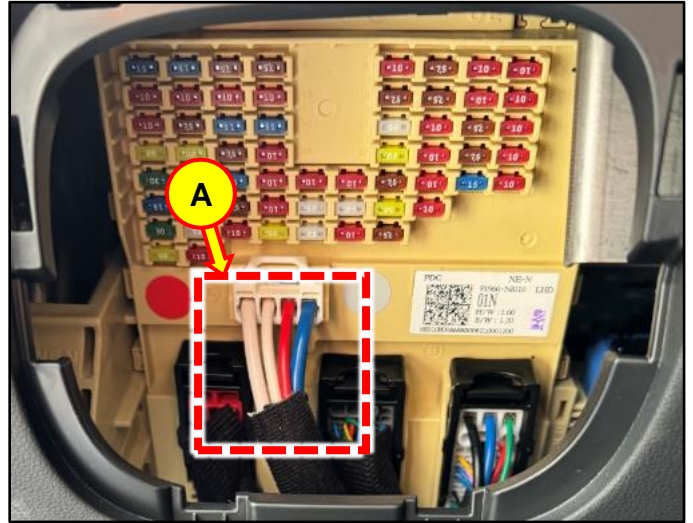
7. Disconnect the power connector (A) of the indoor fuse box, wait at least **5 seconds**, then reconnect it.

Alternatively, disconnect the negative (-) **12V** battery terminal, wait **5 seconds**, then reconnect it.
