FROM: Maserati TSO

Customer Service Notification 773 M182 MHEV – ECM Software Update

DATE: March 24, 2025

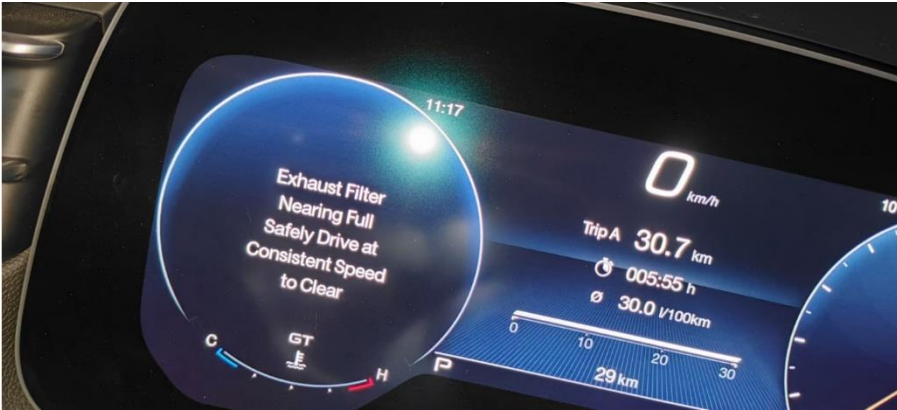
NOTE: Following the update, the following message may appear on the screen in some very rare cases.

This message does not indicate any technical problems with the car and simply suggests that an extra-urban cycle should be performed at cruising speed to facilitate spontaneous GPF regeneration.

Technically, this message is activated when the GPF is about 50% full, in a non-critical condition. In some cases, the message may appear on pre-delivery vehicles if frequent cold engine start/stop cycles have been performed. Again, this message is to be regarded as a technical suggestion and should in no way be seen as a vehicle malfunction.

The reason why this warning has been implemented in this new software version is to inform the customer in good time so that the vehicle can be kept in perfect working order. Therefore, no further action is required by the workshop should this message appear following the update.

We also ask you to inform the customer of both the new warning function and the possible need to drive an extra-urban cycle.
