## SERVICE BULLETIN

**APPLICABILITY:** 2015-21MY WRX/STI 2.5L Turbo MT

**NUMBER:** 09-131-25

**SUBJECT:** Diagnosis Procedures for DTCs P2404 & P0420

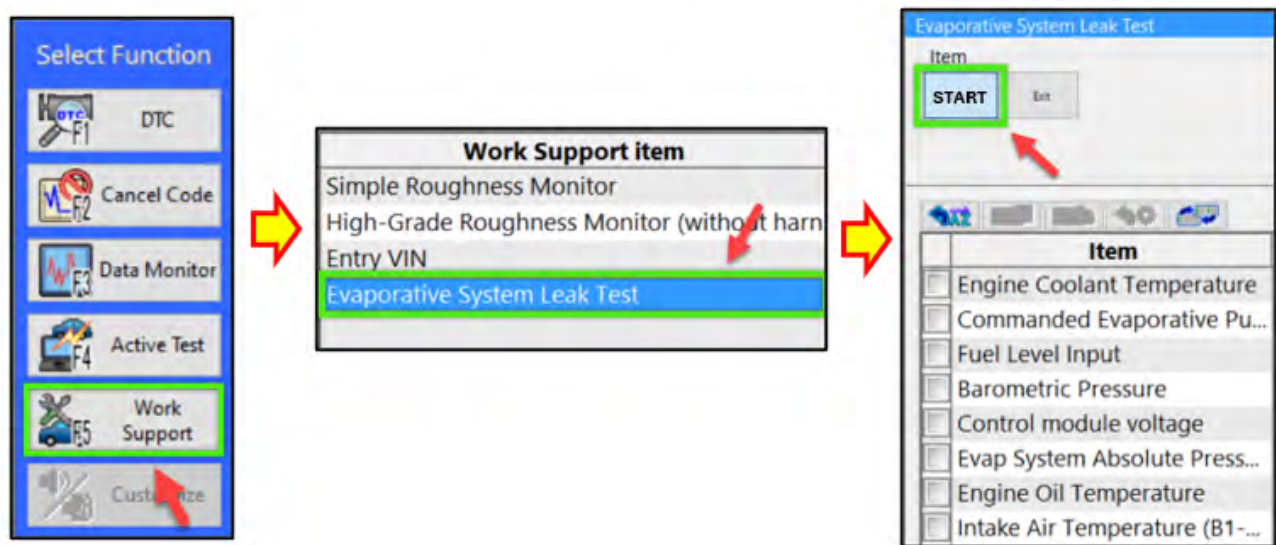
**STEP 4:** Connect the vehicle to a recommended power supply. See APPENDIX A for addition information regarding power supply. Using SSM, perform the Evaporative System Leak Test. Collect and save all data.

Once the evaporative system leak test is complete, check the DTCs and examine the vacuum value results. Record the value shown in the row labeled MID: \$3C, TID: \$C4, and Scaling ID: \$FE. This value should be lower than -0.26 PSI.

Value Must Be Lower  
Than -0.26 PSI

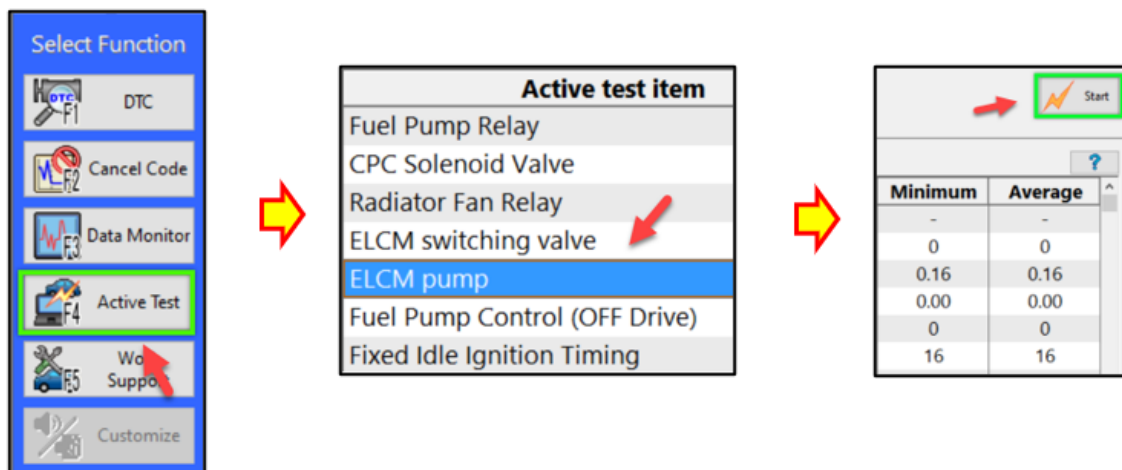
**STEP 6:** Using SSM, perform the ELCM Pump Active Test for a period of 35 minutes or more. See APPENDIX A for addition information regarding power supply.

Once the ELCM Pump Active Test has been performed for a period of 35 minutes or more, repeat the Evaporative System Leak Test outlined in STEP 4. Check the DTCs and the vacuum value results.
