SERVICE BULLETIN

APPLICABILITY: 2019-24MY Ascent

NUMBER: 12-260-25

SUBJECT: Loose Fitting A-Pillar Trim Panel

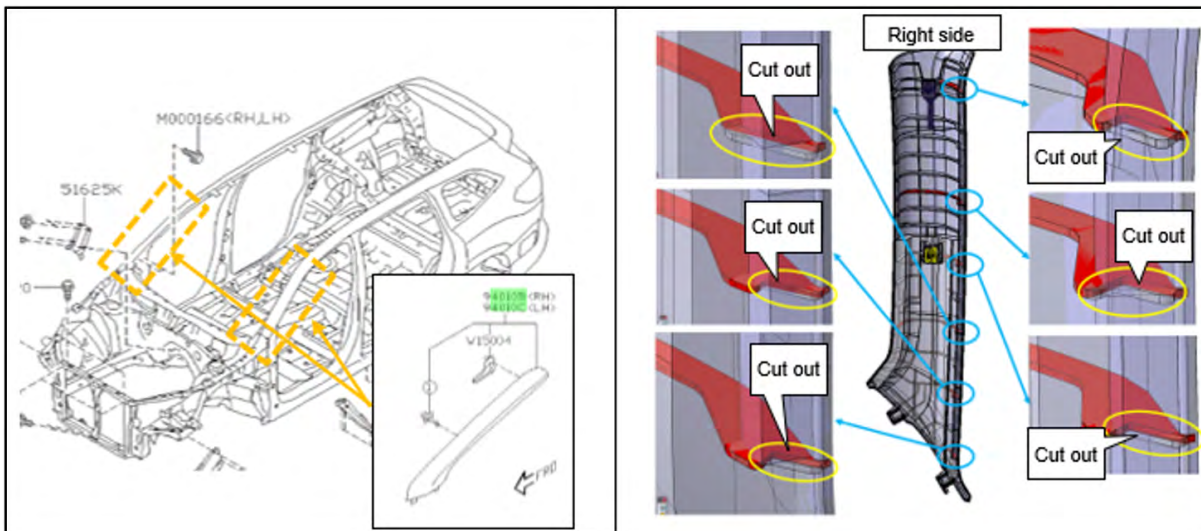
DESCRIPTION OF DESIGN CHANGE:

Additional cut outs have been added to the internal ribs of the A-Pillar trim to provide better clearance and reduce any pressure against the vehicle body.

This bulletin announces the design change made to the left and right A-Pillar trim panels. This design change was developed to address cases of loose fitment. The internal ribs of the trim panels have been reshaped to prevent interference with the vehicle body. If A-Pillar trim panel loose fitment is confirmed, replace both A-Pillar trim panels with the parts listed in this bulletin.
